# AusNet

## Transmission Line Structures

Asset Management Strategy

| Document number: | AMS 10-77 |

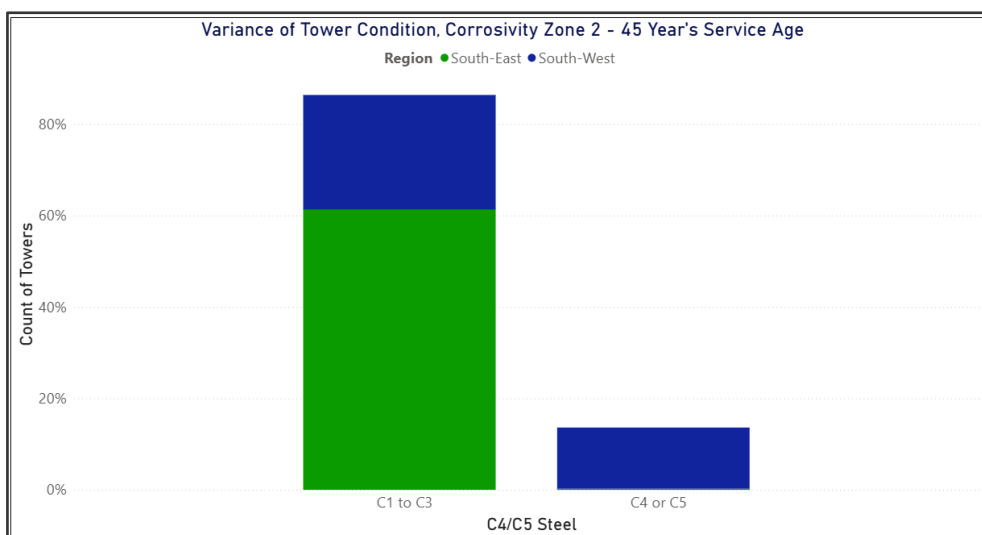
**Figure 21: Variance of Tower condition, Corrosivity Zone 2, 45-years' Service age**

Corrosivity Zone 2 also encompasses a broad geographic area, and recent observations suggest it can be further subdivided into distinct higher and lower corrosivity regions. Analysis shows that tower conditions in the Southwest Zone 2 are in significantly worse condition than those in Southeast Zone 2. Figure 21 below illustrates this, showing 45 years old towers with C5 steelwork concentrated exclusively along Victoria's Southwest corridor. This variation is likely driven by differing pollution sources. The Southwest region is subject to salt laden air and prevailing coastal winds, which contribute to accelerated corrosion. In contrast, the Southeast, particularly the Latrobe Valley, saw industrial pollution which may have declined in recent years with industry shutdowns, contributing to slower corrosive degradation.

The proposed asset replacement program will prioritise the replacement of the most severely affected towers in Corrosivity Zone 3 (High) and refurbishment in Corrosivity Zone 2 along the Southwest corridor, including the replacement of individual C5 condition members.

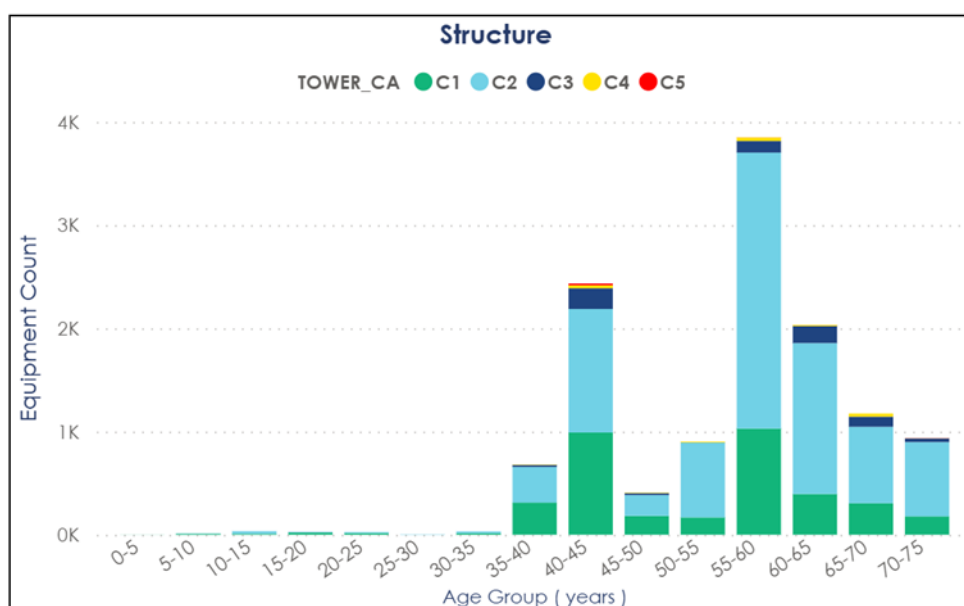
**Figure 22: Structure Condition across Service Life**

Figure 22 shows the condition of the tower fleet throughout its service life. C1 (Very Good) condition structures are distributed almost evenly across service age brackets 35 - 75 years, while C2 (Good) condition structures predominantly fall within the 55 - 60 years' service range. The majority of C3 (Average) condition assets are older than 40 years while C4 (Poor) condition assets typically exceed 55 years' service life with the exception on the HYTS-APD structures which are between 40 to 45 years old.

While Victoria generally has a benign climate that supports long asset life, localised areas particularly in the Southwestern corridor are experiencing more severe weather events and accelerated corrosion. Consequently, the HYTS-APD towers appears in the C5 (Very Poor) category at an earlier service age of 45 years.

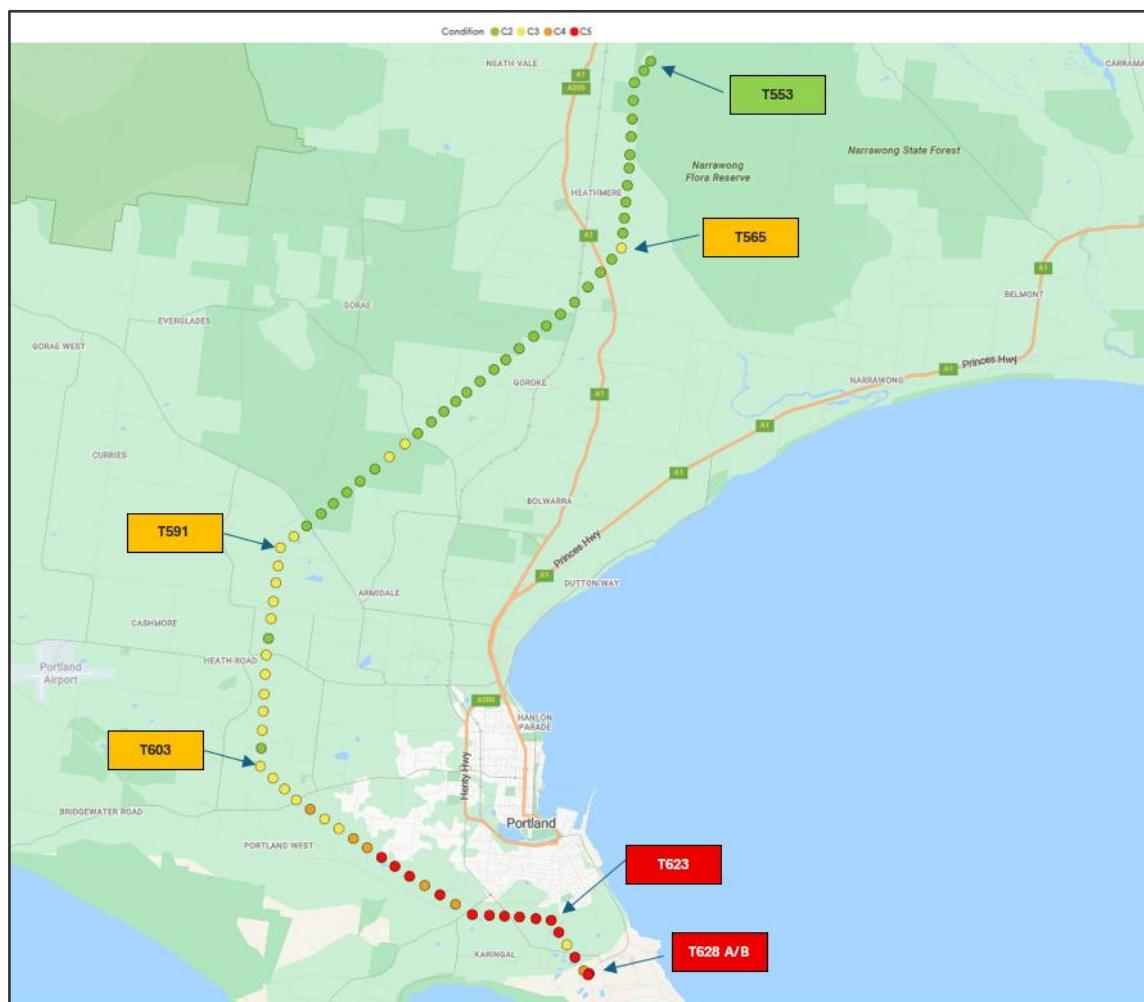
Fig 23: HYTS-APD 500kV towers' Condition Score

The overall tower condition assessment is summarised below in Figure 23,

- 14 towers assessed overall as C5 (Very Poor) condition, with a very high percentage of C5 rated critical members and bolts
- 6 towers assessed overall as C4 (Poor) condition" 5 towers have a high percentage of C5 rated critical members and bolts
- 8 towers rated overall as C3 (Average) condition", all with medium level of C5-rated critical members and bolts
