K-BIK Power Pty Ltd

REVIEW OF ASSETS FOR REPLACEMENT OF SUBSTATIONS WITHIN JEMENA'S NETWORK

Report Reference Number: **VIC-JEM-008-R1/V1.0**

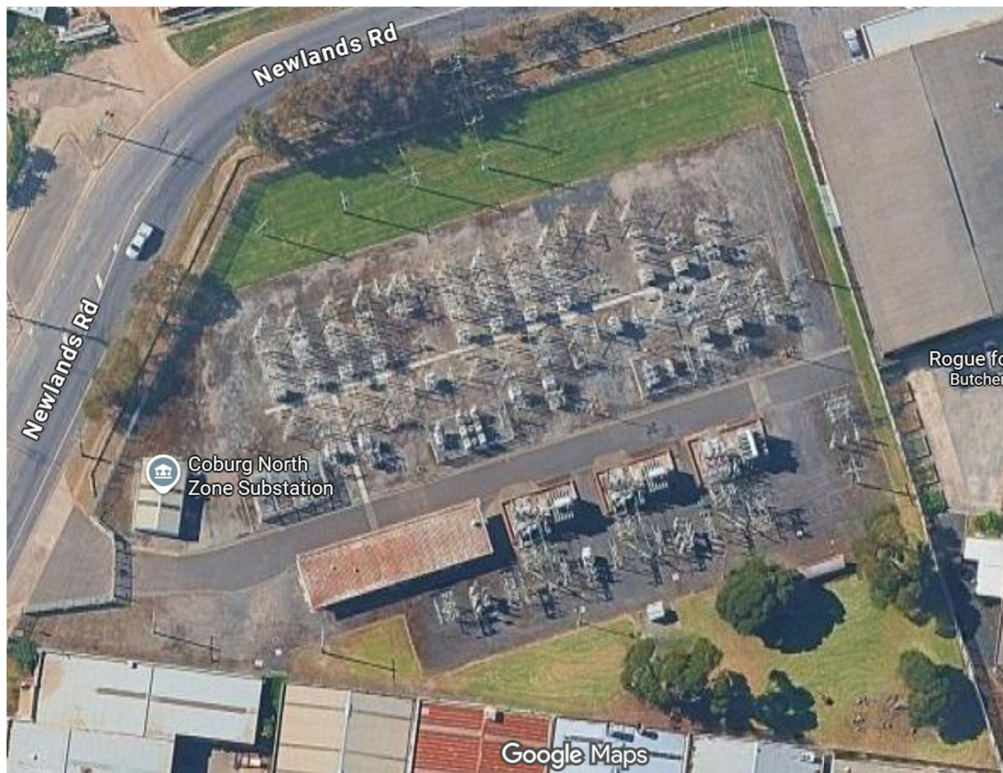
As can be seen from the google maps image CN is an open switchgear type substation. The southern side shows the 3 power transformers and the incoming 66kV feeders with 66kV circuit breakers and isolators. On the northern side of the substation is the 22kV switchyard. The 22kV circuit breakers are indoor breakers housed in outdoor enclosures and connected to the 22kV busbars.

This type or design of substation is no longer built as it presents significant safety risks to maintenance and operational staff. The 22kV switchgear is also exposed to the elements and creates a reliability issue as it ages and subjected to intense storm activity.

Replacement of any single primary plant item within the 22kV yard may require a crane for lifting the asset. As can be seen there is almost no space to access any component closely and so an extended boom crane would be needed, and a larger section of the substation would be required to be offline whilst the asset is removed and replaced. This means that the substation availability at that time would be very limited, and loads would need to be transferred to other substations for extended periods.

If a 22kV circuit breaker/switchboard, disconnect or instrument transformer failed catastrophically then it is also likely that surrounding assets could be damaged by shrapnel for the explosive failure. This would then create a situation where a larger portion of the substation is offline for an extended period whilst repairs are undertaken.

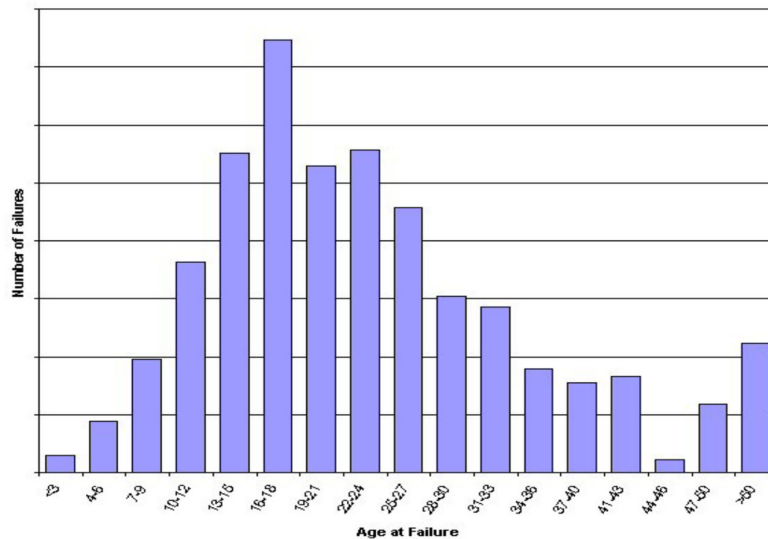
Figure 1 | Transformer Failure histogram based on age.

Many power transformers survive for sixty or even eighty years. However, the majority of them fail in their middle years. FM Global have published a histogram of typical transformer ages at failure and these are shown in Figure 1 below.

When looking at Figure 1 most transformers fail in their middle years which seems to contradict the Bathtub curve in Figure 2. This is not the case because at any point in time, the majority of the transformers (and even switchgear and other assets) on a network are in their middle years. Most mature networks have an average age of between 25 to 35 years (total age of all the assets divided by total number of assets).

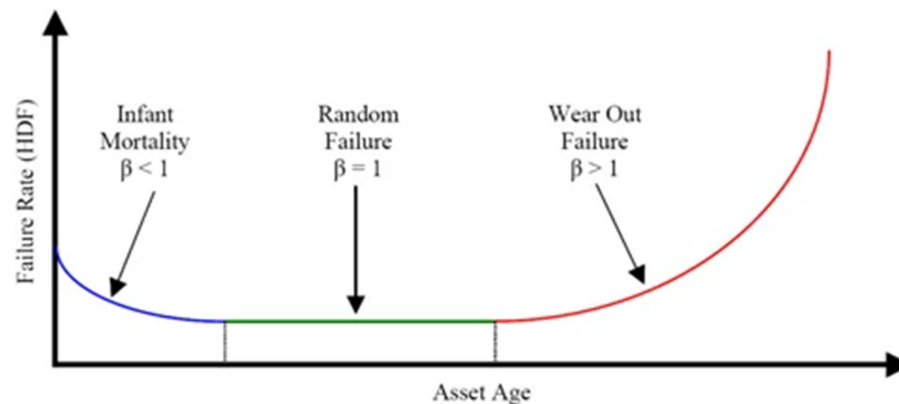
Figure 2 | Typical transformer bath-tube curve for failure rates.

Like other power equipment, transformers have a moderate possibility of failing at start-up (infant mortality), followed by a low possibility of failure during most of their lives, with an increase in failure probability over the last quarter of their operational lives. This characteristic is referred to as the Bathtub Curve as shown in Figure 2 below.

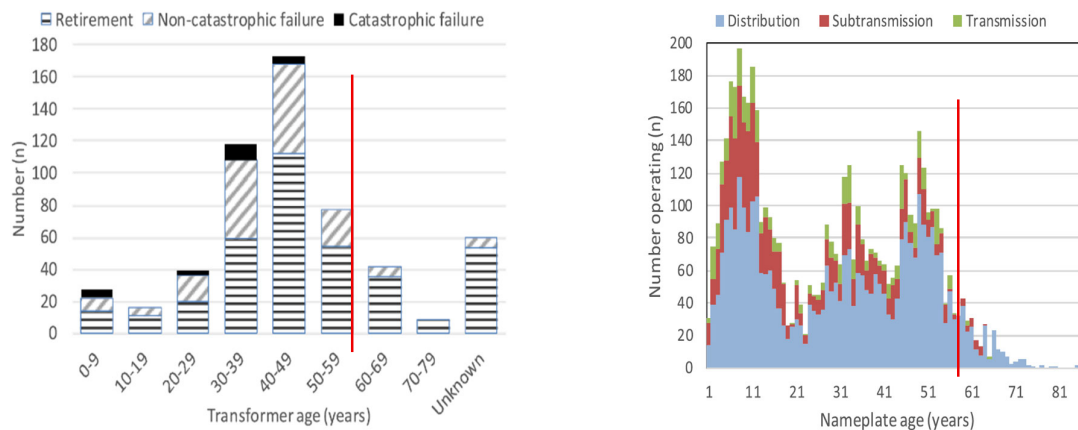
Figure 3 | Extracts of Figure 1 (left) and Figure 2 (right) of D. Martin et al paper.

Australia (Figure 2 Martin report) and the number and age of all the failed or retired transformers recorded. CN is marked with a red line in each chart.

To get a better view of any change in probability of a transformer failures, random failures on the system should always be viewed against the age distribution profile and barring any network abnormalities. The above graphs indicate that when the number of failed units is considered within any age group, versus the total units in that respective age group, there is an increase in failure probability with age (like that described by the Bathtub Curve). In these graphs, the number of transformers older than 51 years drops off rapidly but the failure rate is quite high when comparing to the failure rates of transformers in the 1 to 20 year and 30-50-year ranges.

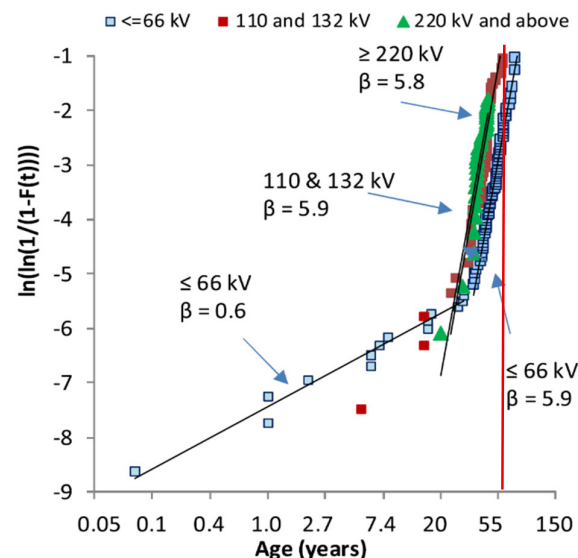
Figure 4 | Extract of Hazard Plot Figure 5 of D. Martin et al paper.

This is also better shown by Martin et al, in their hazard plot Figure 5 for failure rates of Australian transformers in poor condition and as provided above. The Jemena CN transformers 1 and 2 age (59 years) are marked with a red line.

The transformers and to the same extent the switchgear and substation primary plant discussed within this report generally fall within the 55– 65-year range. Therefore, their probability of failure is increasing rapidly. If there is to be a replacement of the equipment, then this is likely to take circa 3 to 5 years to complete which would then have the assets close to the 65-70-year age and at significantly high risk of failure. Additionally, and as explained above the transformers have issues with the IFT and strength (DP) of the paper. As these deteriorate and as seen on the Weibull curve in Figure 4 above the risk of failure will continue to increase substantially.

With the CN ZSS transformers marked with a red line on the curve it is seen that these transformers are in the higher risk end of the curve. Below in Figure 5 the Weibull analysis has been plotted to show the results on a normal scale of Probability of failure against the age of the transformers.

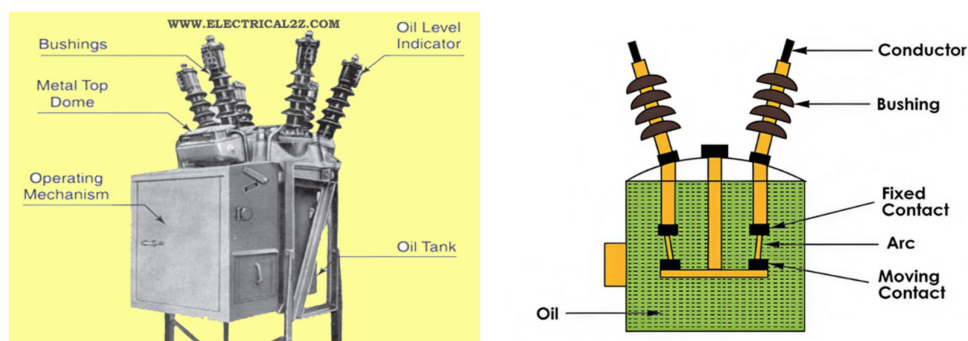
Figure 6 | Typical 66kV Bulk Oil CB and Component diagram

At CN ZSS the 66kV circuit breakers are older bulk oil style similar to that shown in Figure 6 below and were manufactured in 1952 but placed into service in 1966. These breakers were known to contain small levels of PCBs and whilst no immediate information was made available for this report it will be assumed that they contain <9ppm of PCBs. When they fail, it is generally related to the HV bushings, the loss of insulating mediums (paper & oil) or broken/ worn operating mechanisms. They tend to fail either catastrophically or by remaining closed. The latter does not cause an explosion or fire as the breaker simply does not open and the system relies on the upstream breaker to clear a fault.

The main tank on the breakers has a seal around the base of the lid which tends to deteriorate after 30 years and allows moisture to enter the main oil system. The diagram on Figure 6 below shows the components of a bulk oil circuit breaker and a typical style as used at CN ZSS.

As mentioned above there are two major consequences of a failure either an explosive failure or a failure to open. An explosive failure occurs when the moving contacts do not open correctly, or the oil has deteriorated to the point that it no longer can safely extinguish the opening arc. When this happens generally the lid or bushings are ejected under extreme pressure and the oil is expelled. With the oil spray, an arcing fault and air available the result is an explosive failure with a fire.

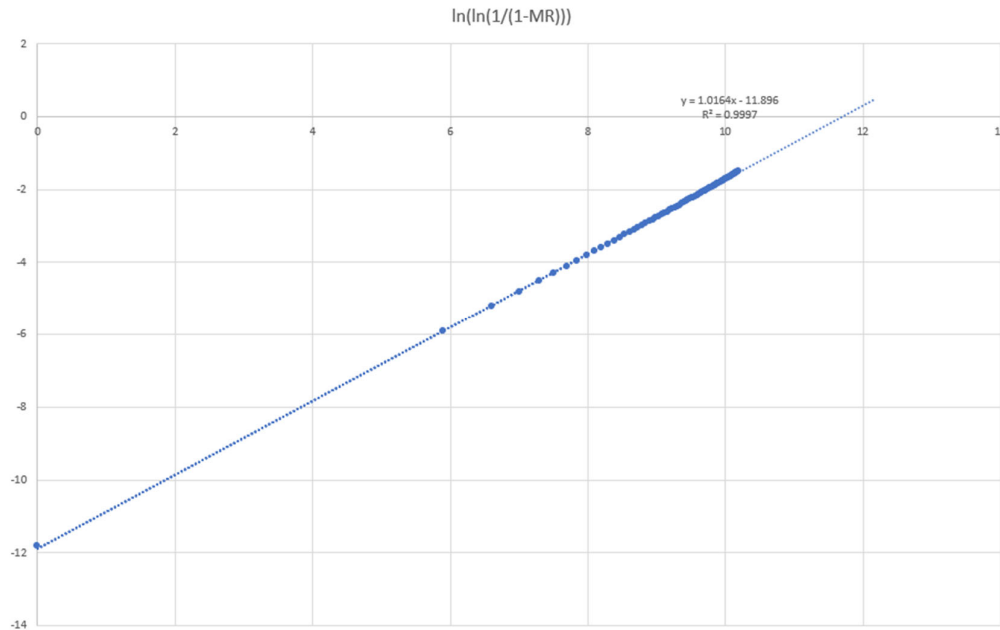
Figure 9 | CN ZSS 22kV switchboard Weibull shape parameter

Using these statistics the β shape parameter value was calculated by the slope of the Weibull log-log plot shown below in Figure 9. The best fit line was $y=1.0164x+11.896$ which provided the shape

In the present state there is a 83.57% probability that Jemena will have one of these old 22kV CB panels fail in the next 12 months. If the breakers are not retired by age 73 then that probability of failure will increase to 87.73% probability of a failure in that year.

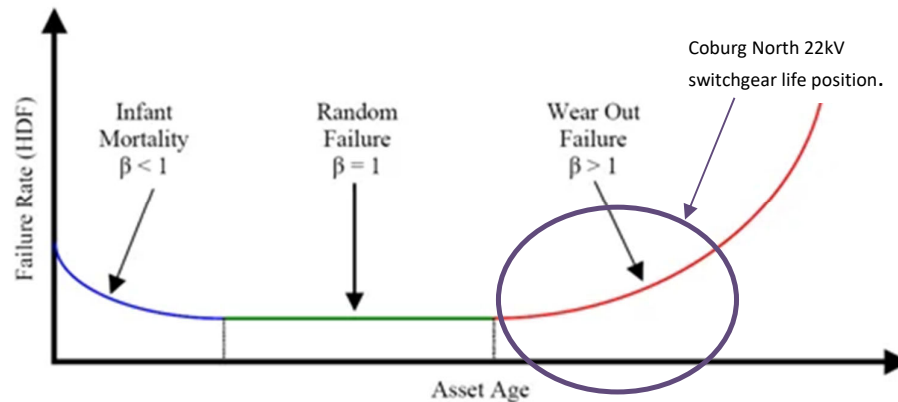
Figure 11 | Typical transformer bath-tube curve for failure rates.

Whilst these values are quite high, they represent the risk associated with the age of the switchgear. If reviewing this with respect to the typical bathtub curve as per Figure 2 and repeated in Figure 11 below, the switchgear has entered the wear out phase of the curve. This means that it now has a more finite end of life and that the risk of a failure continues to increase sharply.
