# Powerlink 2027-32 Revenue Proposal

CP.02170 Chinchilla Substation Replacement

# T013 CHINCHILLA

## PRIMARY PLANT CONDITION ASSESSMENT REPORT

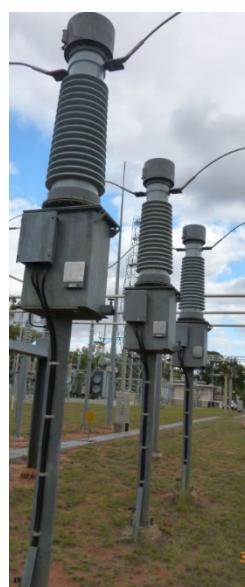
Figure 20 - CT

The CTs installed in this bay have been in service for 41 years and A & C phase have recently developed slight oil leaks originating from the site glass gauge area. Though they are still

testing satisfactorily in their oil sample tests, considering that they are in porcelain housing and have increased trend of explosive failures with catastrophic safety consequences after 37 years in service, it is recommended that these instrument transformers are decommissioned from site.

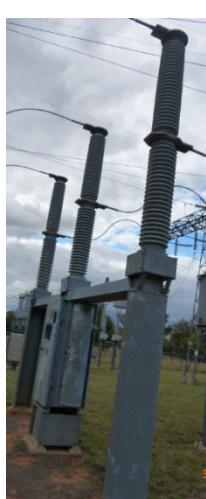
Figure 22 - CB

**Recommendation:** Based on the above observations, it is recommended to replace the circuit breaker in the next 3 years, as its failure will result in triggering CB fail leading to loss of load of Chinchilla substation and loss of both feeders and F7394 and Transformer T4 for an extended period (due to the CB not being supported and no spare parts being available and the CB replacement most likely requires replacement of structure and foundations). In addition, the failure would potentially result in significant SF6 gas leak, causing environmental damage. No explosive failures of this type of circuit breaker were recorded in Powerlink.

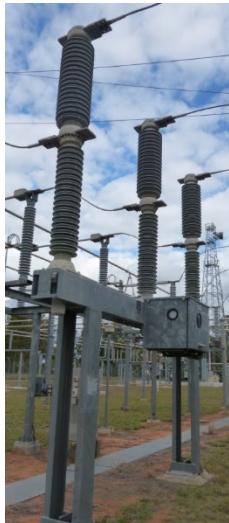
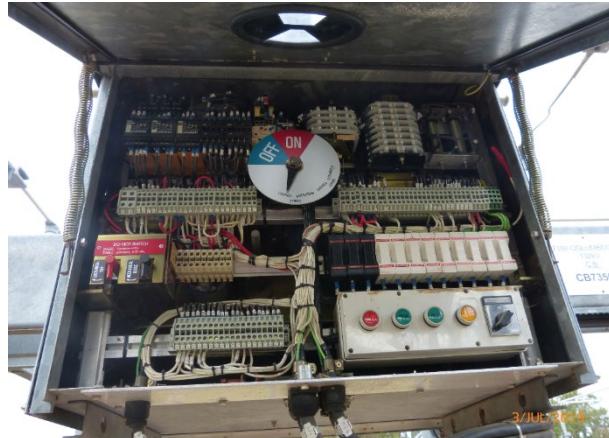
Figure 26 - CB

The circuit breaker in this bay is a Sprecher Energie installed in 1990. It has a motor wound operating mechanism with spring used for energy storage and SF6 gas for insulating medium. Maintenance records from 2012 show no major issues with this CB and visibly this CB seems to be in good condition. Sprecher has stopped manufacturing high voltage CBs and sourcing

spare parts is an issue. This type of CB is no longer manufactured by the manufacturer and hence obsolete. This CB was in service for the last 35 years and it is estimated that this CB has a remaining service life of 5-10 years.

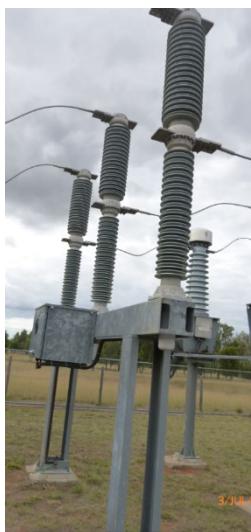
Figure 27 - CB

The circuit breaker in this bay is a Sprecher Energie installed in 1990. It has a motor wound operating mechanism with spring used for energy storage and SF6 gas for insulating medium. Maintenance records from 2012 show no major issues with this CB and visibly this CB seems to be in good condition. Sprecher has stopped manufacturing high voltage CBs and sourcing spare parts is an issue. This type of CB is no longer manufactured by the manufacturer and hence obsolete. This CB was in service for the last 35 years and it is estimated that this CB has a remaining service life of 5-7 years. As this CB does not have sufficient service life to be installed in a new bay, the CB should be decommissioned, and any usable spare components should be retained as spares.

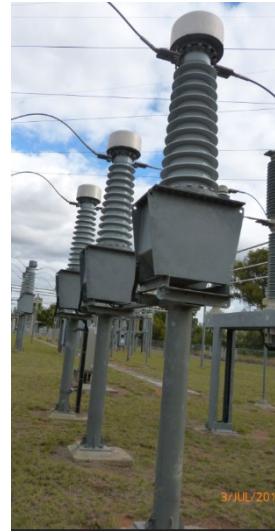
Figure 28 - CT

The CTs, although visually in reasonable condition, have been in service for 33 years and considering they are in porcelain housing and have an increased trend of explosive failures with catastrophic safety consequences after 37 years in service, it is recommended that these instrument transformers are decommissioned.

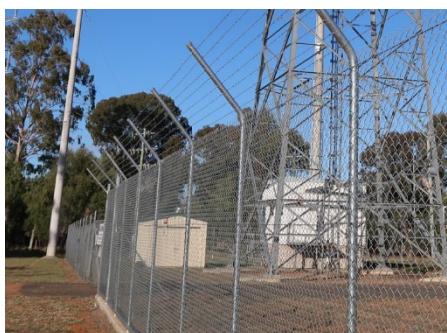
Figure 32 - New section of fence

The new part of the fence has only the bottom rail. Top of the fence is bent outwards with 8 strands of barbed wire on top of the fence. The total fence height is 3 metres. As shown in Figure 22. This part of the fence is in as new condition. This fence is per Powerlink's latest standard.

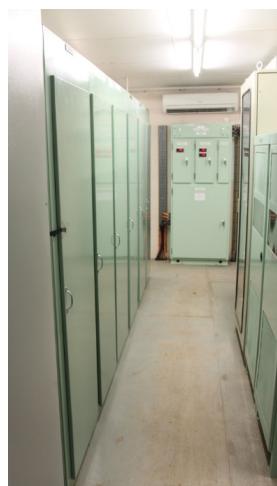
Tight control building

The combined protection and control building is the main entry of the substation and contains all Powerlink and Energy Queensland secondary systems for 132/110/33kV assets. There is no any spaces available for future secondary system replacement in the existing buildings.

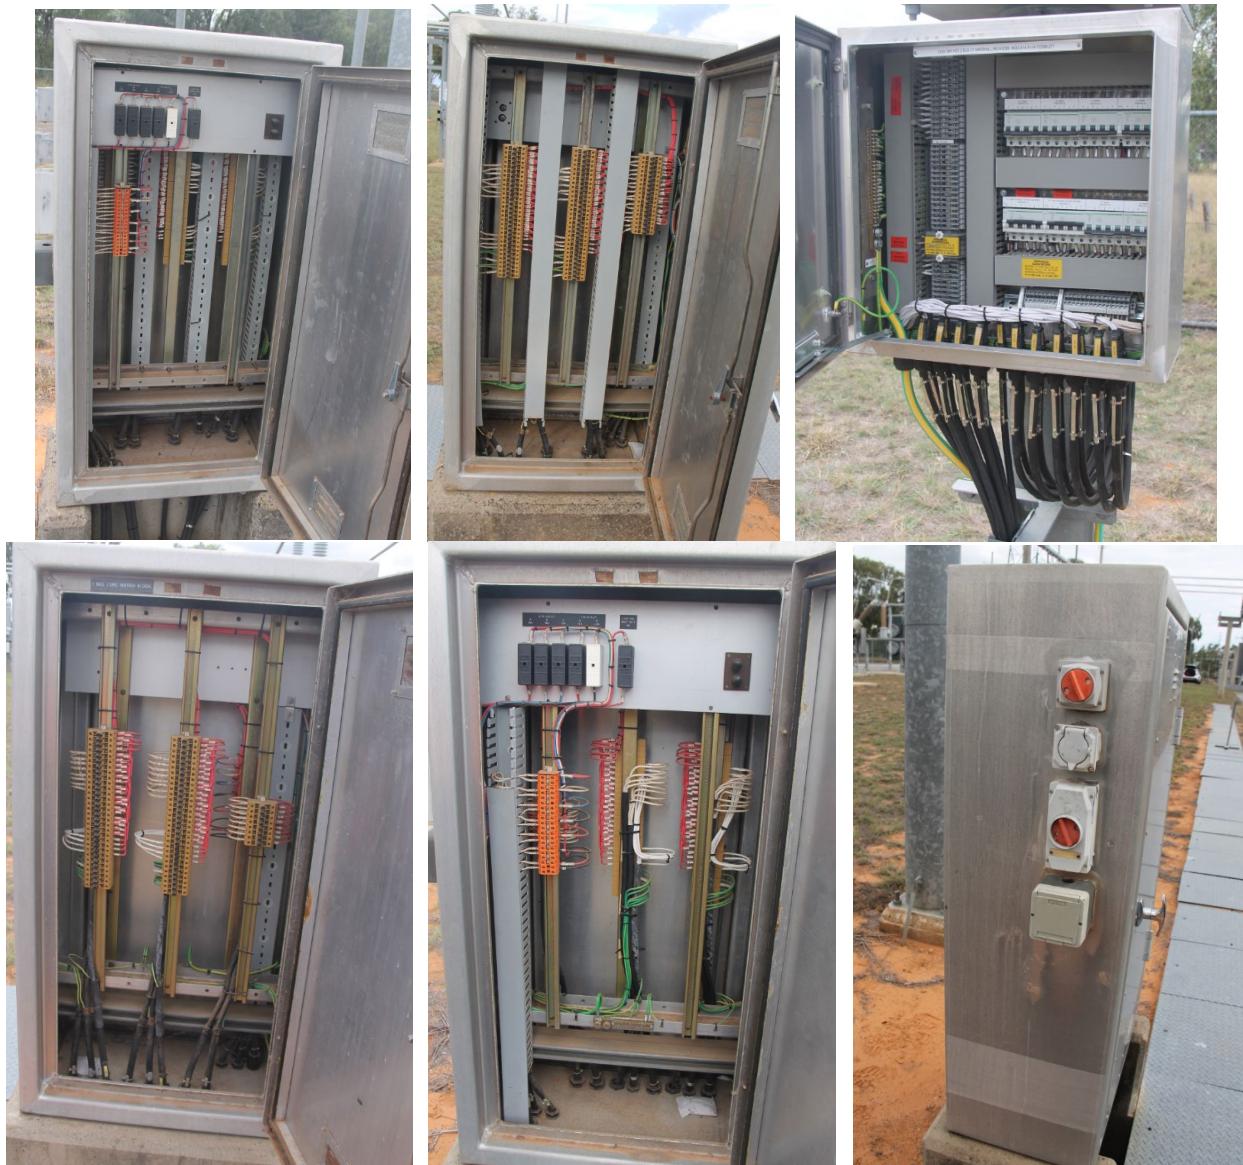
132kV bus zone marshalling kiosk and VT cubicle

Marshalling kiosks for 132kV 1 & 2 bus zone (except the VT box) were originally built in 1985. Orange coloured Utilux terminals in the bay marshalling cubicles are showing signs of embrittlement. They should be replaced with major secondary system replacement. The physical disconnect terminals for CT circuits for bay marshalling kiosks need to be replaced to mitigate CT

open circuit risks with major secondary system replacement according to SU0031 New Physical Disconnect Terminals for CT Circuits. Associated control cables will reached the end of asset life and need to be replaced between 2020-2025. Fuses used on associated marshalling kiosks do not provide safety and monitoring features and make the event investigation more difficult. Maintenance on these fuses is expensive. These fuses should be replaced with MCBs to improve the performance of circuitries according to current design standard. Bus 2 VTs were installed in 2013. There are no condition driven replacement required for VT boxes until 2048.

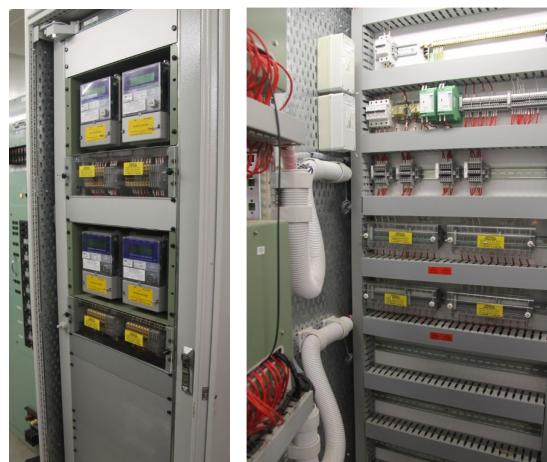
Metering panels at T013 Chinchilla

EDMI energy metering devices MK3 are utilized to meter 3 & 4 Transformer. These equipment were installed under CP.02110 Chinchilla and Columboola 132kV metering in 2013. There are no condition-driven replacement required until 2033.

However, metering data is currently interrogated via 3G netowrk. Powerlink has developed a solution to migrate metering to IP based metering. All meters with dial-up connection need to be migrated to IP based meter with major secondary system replacement.

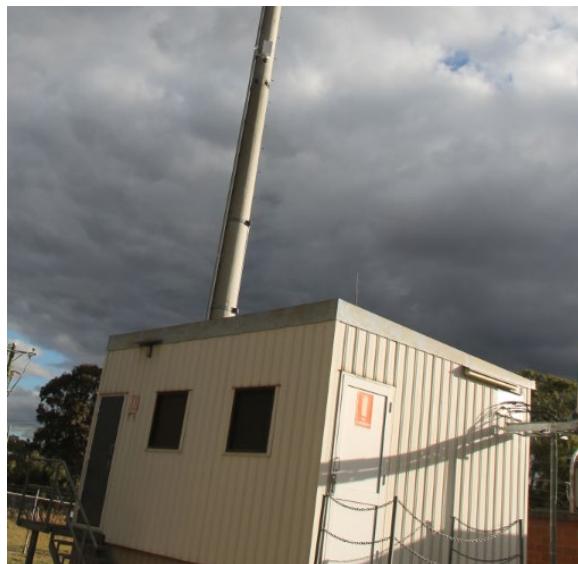
OpsWAN was installed to remotely interrogate Powerlink secondary systems in 2013. These devices are in fair condition and there is no condition-driven replacement required until 2023.

OpsWAN camera

- Implement dedicated Powerlink SCADA system based on DNP/IP
  - Implement HMI
  - Replace all OpsWAN equipment (including all OpsWAN cameras)
  - Provide timing clock for Powerlink secondary systems

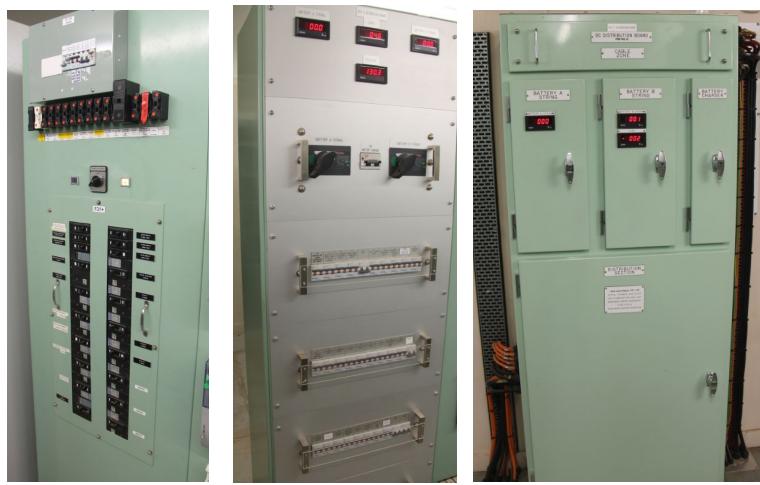
Both AC distribution boards and DC distribution boards have a few spares available and are owned by Energy Queensland.

AC and DC distribution boards

- Review the existing AC and DC arrangement and provide Powerlink AC and DC supply if required
3. Carry out following replacements by 2033:-
  - Replace all metering equipment based on IP metering

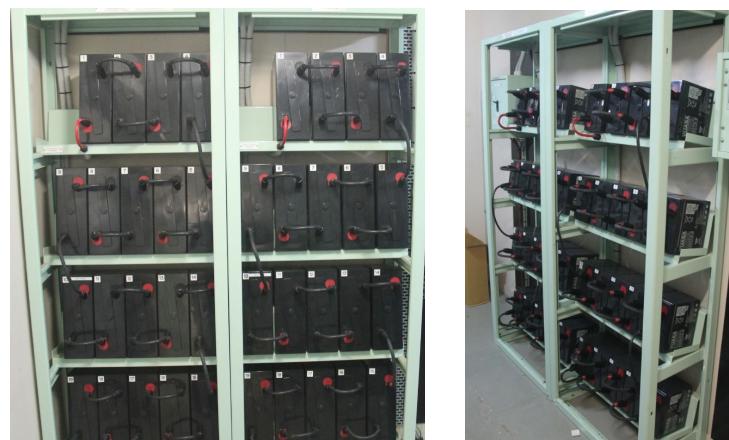
Both dual 125VDC and 48VDC battery banks are owned by Energy Queensland. This arrangement should be reviewed with major secondary system replacement according to current Powerlink standards.

**125VDC Batteries**

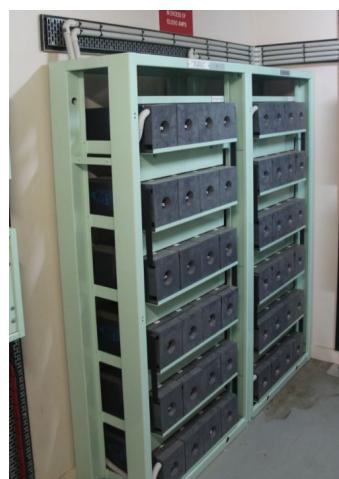
**48VDC Batteries**

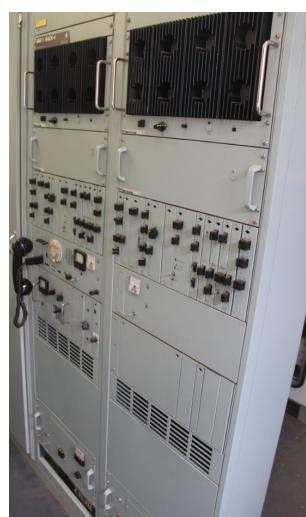
Communication systems at T013 Chinchilla consist of PLC technology which has limitations for protection scheme implementations.

**PLC equipment for Feeder 7168 and 7183**

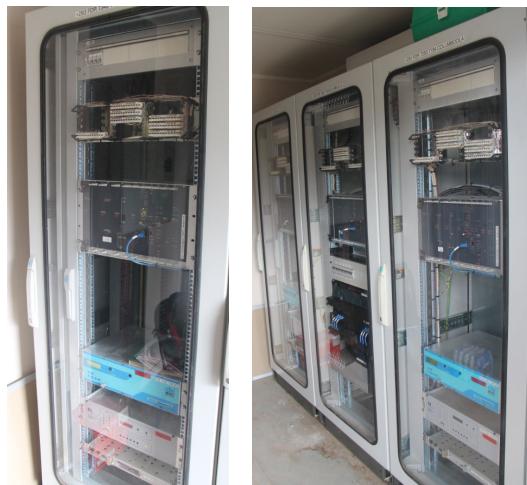
PLC equipment for Feeder 7349 and 7350
