Powerlink 2027-32 Revenue Proposal

CP.02478 South Pine Transformer 5 Replacement

Transformer Condition Assessment

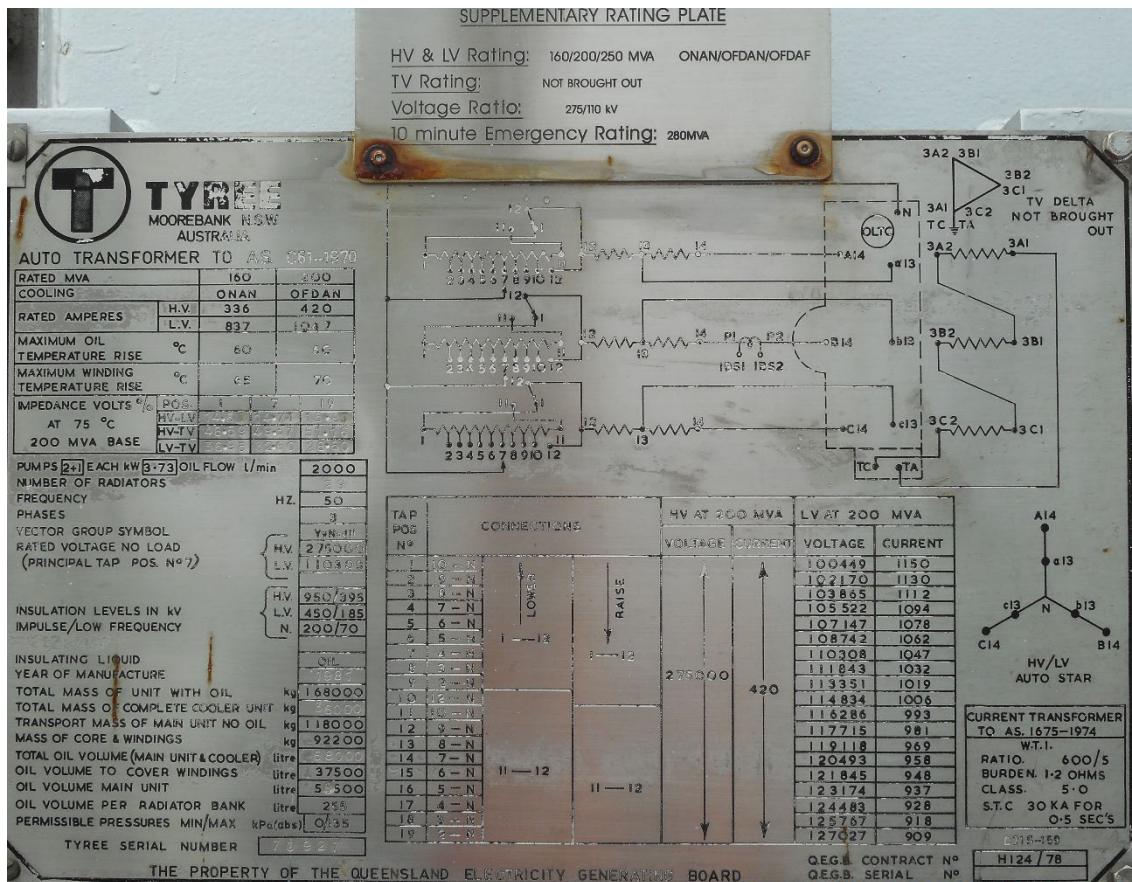
Figure 2: Transformer Name Plate Diagram with supplementary uprating plate due to the addition of fans.

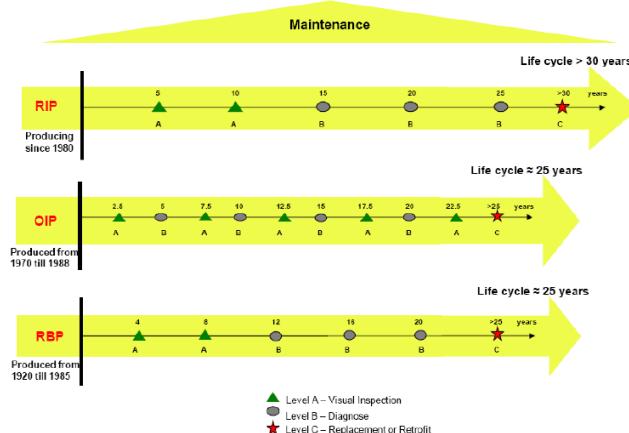
Figure 22: Bushing life expectancy provided by the bushing manufacturer.

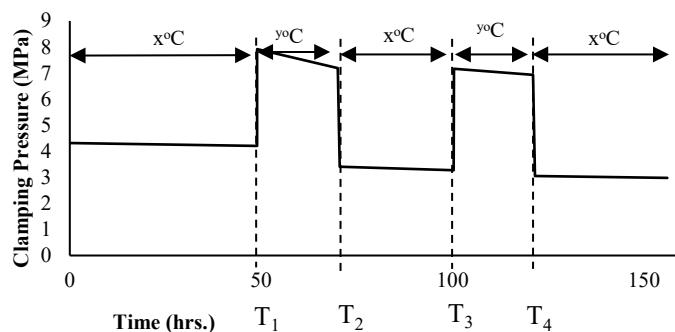
- (a) The top clamping structure for this 1980 design is known to be unacceptable by today's standards.
- (b) Even with a calculated 1.5% moisture content in the internal winding insulation system partially migrating in and out of the clamped structure due to changes in transformer load, there will be some slight loss of clamping pressure due to the type of phenomena shown in the figure below. It is realised that the load changes are not normally as sharp as in the diagram but the overall cyclic effect is the same. The electromechanical forces exerted on the winding structure due to periodic through faults can have the same accumulative effect.

Figure 32: Example of the effect of cyclic compression on a clamped insulation structure.

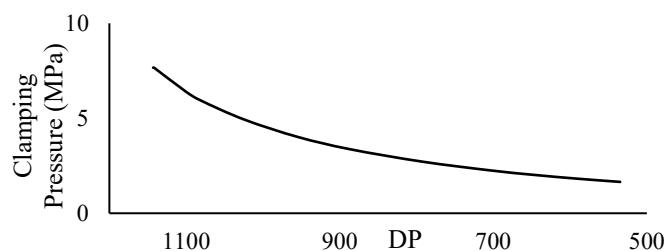
- (c) A drop in the internal cellulose average insulation mass indicated by the change in DPv from possibly 1150 down to an AVERAGE of about 462 will lower the winding residual clamping pressure but by how much is uncertain unless measured.

Figure 33: Example of the effect of loss of DPv on Clamping Pressure.

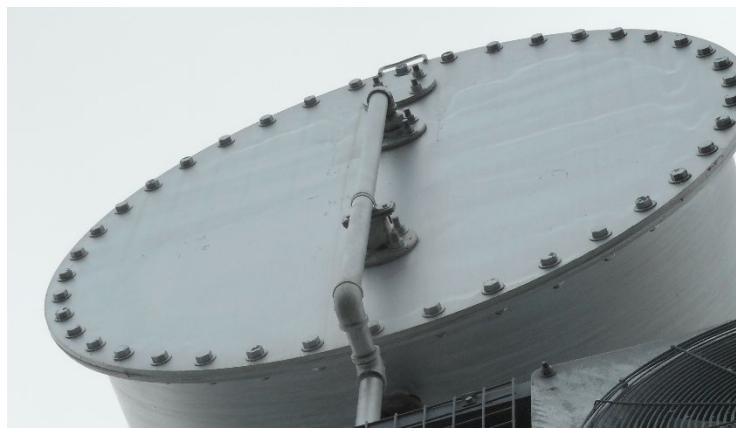
This transformer was originally designed and manufactured with a Drycol refrigeration type breather mounted on the end of the main oil conservator tank. The Drycol unit was later replaced after a number of years by a conventional desiccant breather. Hence the pipe work on the end of the conservator which now bridges the top and lower internal pipes used by the Drycol unit.

Figure 34: High and low Drycol mounting points on the end of the conservator now used for a conventional desiccant breather.

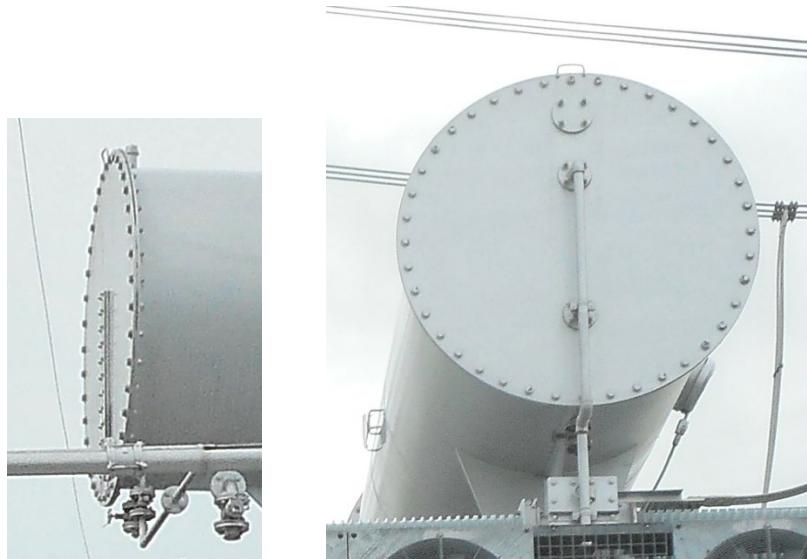
The main tank oil conservator design appears to have incorporated a tap changer (OLTC) conservator compartment at one end with the OLTC oil and main tank oil volumes sharing the head space in the conservator (eg; only a partial partition between the two oil volumes). This is confirmed because there is no separate breather for the OLTC oil volume.

Figure 36: (LHS) Shows OLTC conservator end of the main conservator tank. (RHS) Main tank and cooler bank end of the main conservator tank. Note the single desiccant breather pipe.
