Powerlink 2027-32 Revenue Proposal

CP.02631 Ross to Dan Gleeson 132kV Transmission Line Refit

Condition Assessment Report

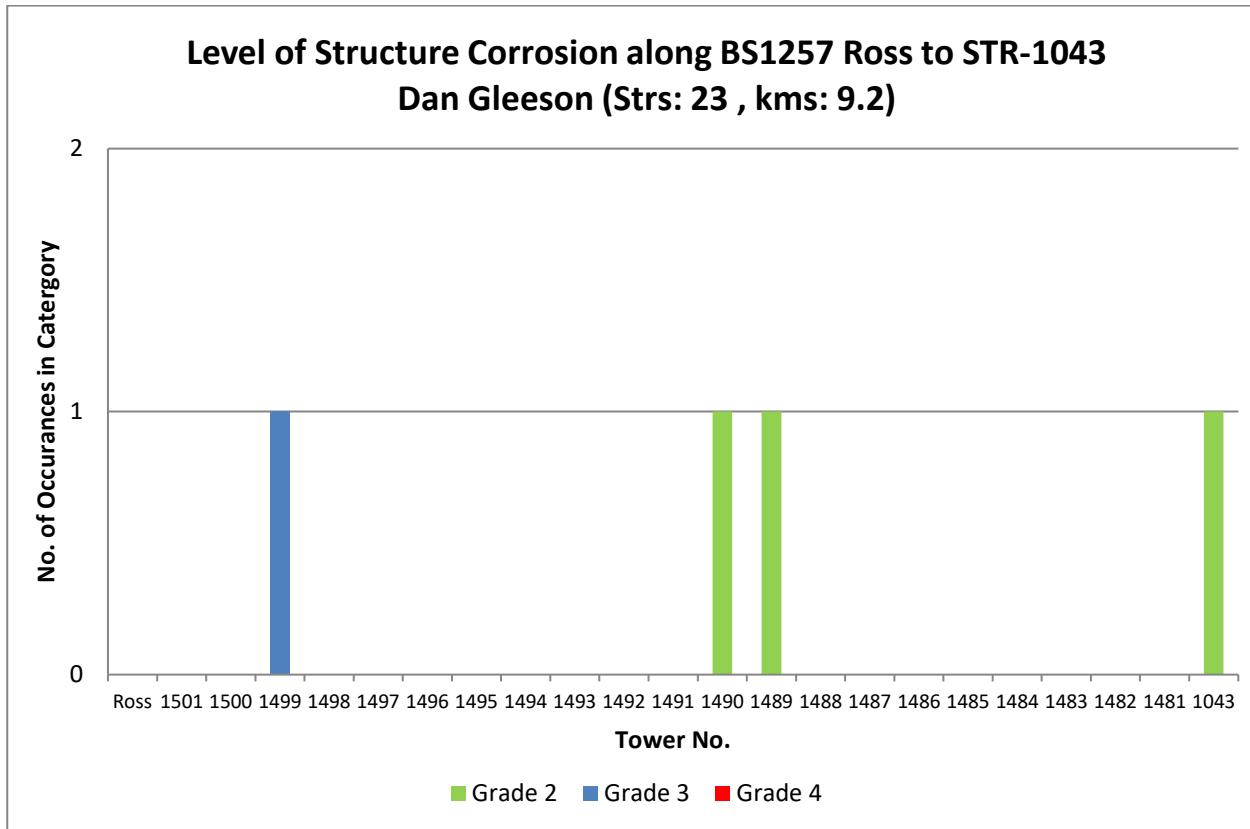
1.3 Notification Overview for Structures

The above graph shows the number of notifications relating to corrosion on each structure. It can be seen that have only been a small number of notifications raised throughout this built section and these will be addressed through maintenance procedures.

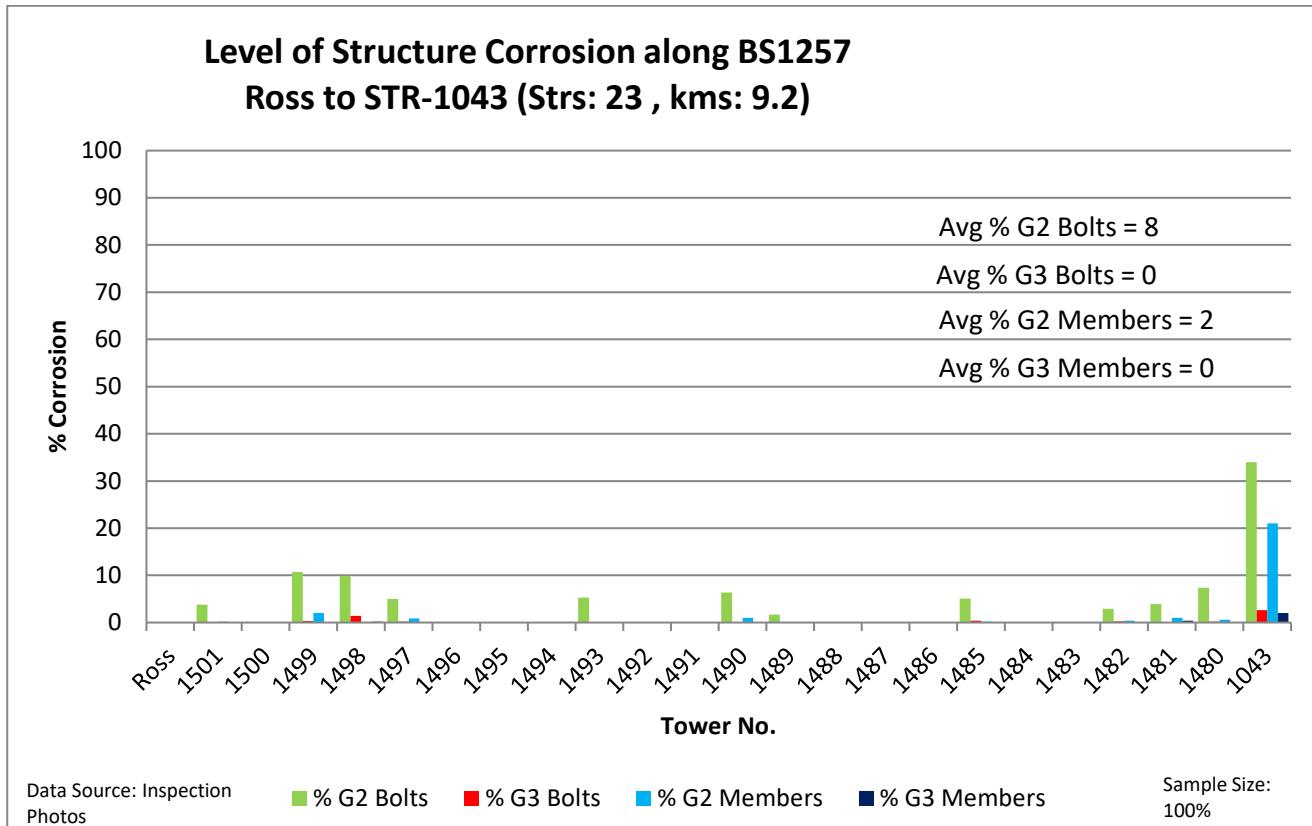
1.4 Structure Corrosion along Built Section

The graph below shows the percentage of corrosion on structures throughout the built section based on ground patrol photos taken between 2013 and 2015. Note that Grade 4 corrosion is not captured as part of this condition data as it is classed as a defect and recorded as a Notification.

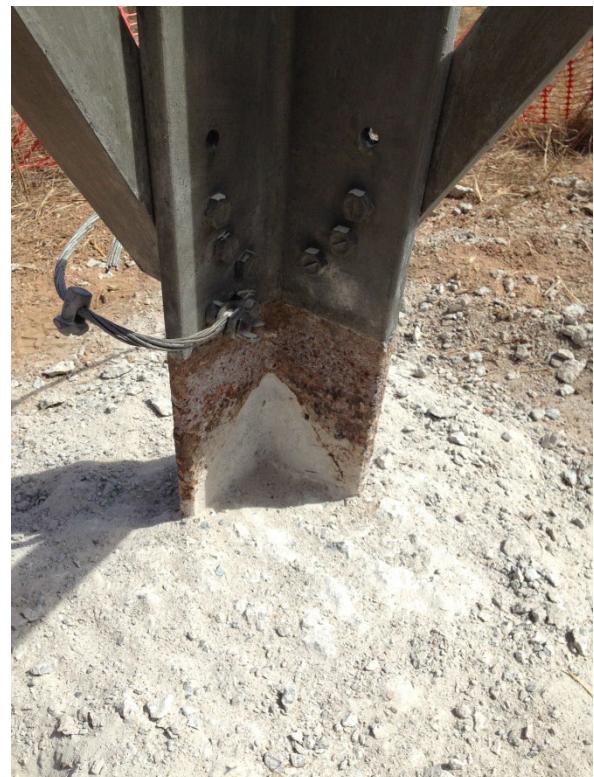
All steel lattice tower foundations in BS 1257 are of the reinforced concrete type and no visible corrosion is apparent, however the foundation caps have radial cracking which will allow moisture ingress and corrosion to develop.

Tower leg of STR-1498 showing large cracks radiating from the tower leg and the corrosion visible once the concrete cap has been removed

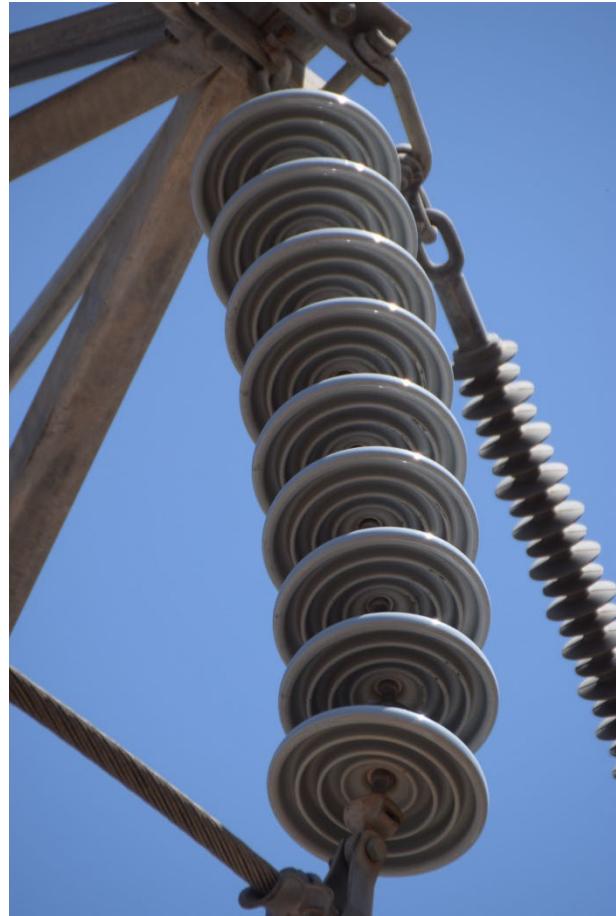
Bridging String STR-1043

Three structures contain bridging insulators which were changed under maintenance in 2001 and 2014 and are in good condition. All hardware associated with the bridging arrangements are the original hardware and Grade 2 corrosion is evident at all locations.
