Powerlink 2027-32 Revenue Proposal

CP.02750 Ross to Chalumbin Life Extension

Transmission Line Condition Assessment Report

**Transmission Line Condition Assessment – Report****Built Section 1220 – Ross to Chalumbin 275kV**

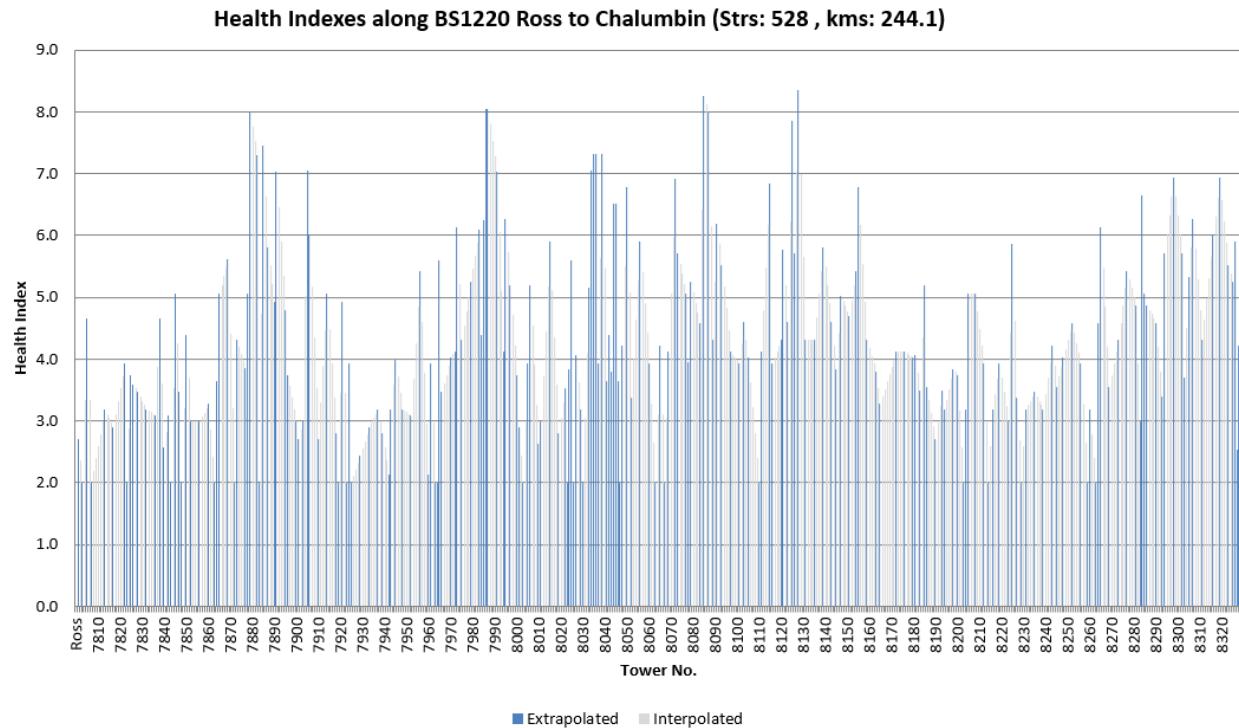
Below are the health indices of structures along the built section. While structures in average condition are not of concern, structures in the more elevated and exposed locations are currently at a health index of greater than 7 (representing a complete loss of galvanising on some members and bolts).

These values are based on the calculated health index data for the sample of structures that were inspected. The calculated values have been extrapolated from the date they were recorded to the current year. The values for towers between known (calculated) points have been interpolated to determine an estimated health index for those structures.

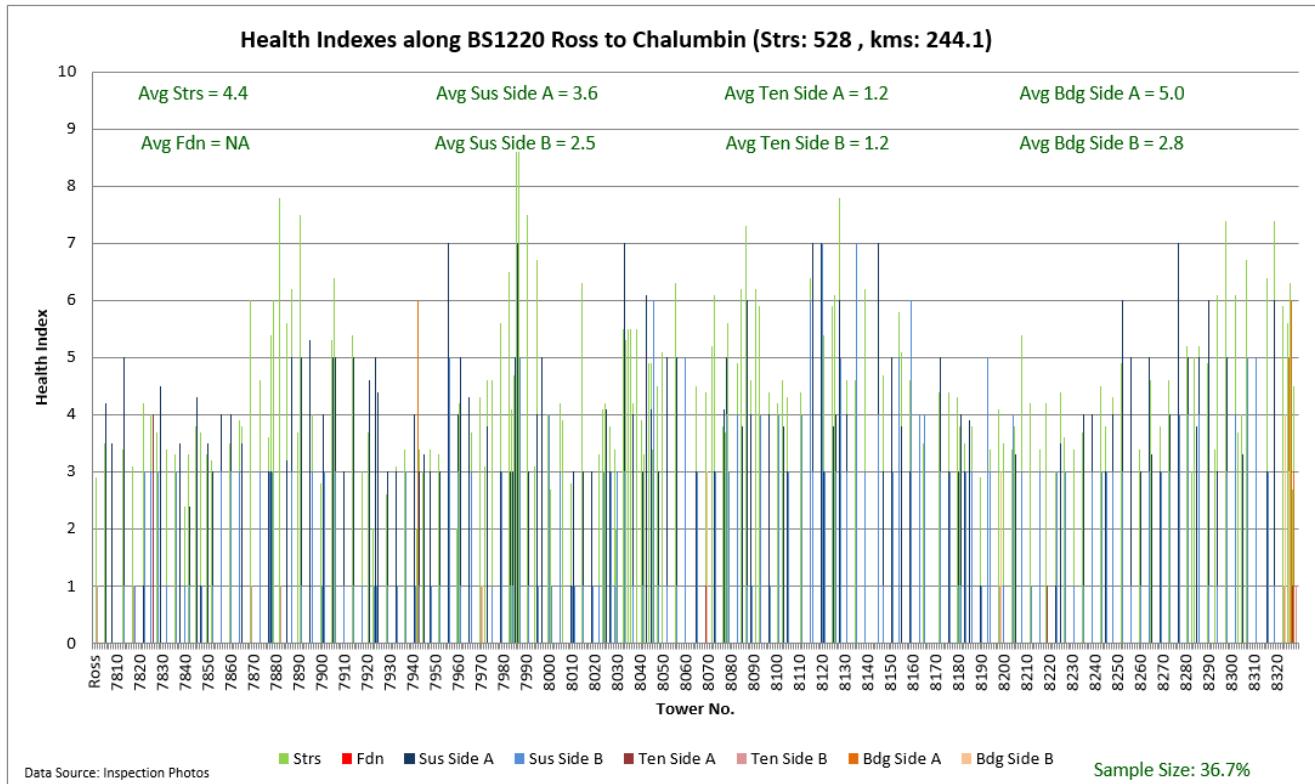
The condition data detailed in the below sections has been summarised in the following graph of available health indices for some major components.

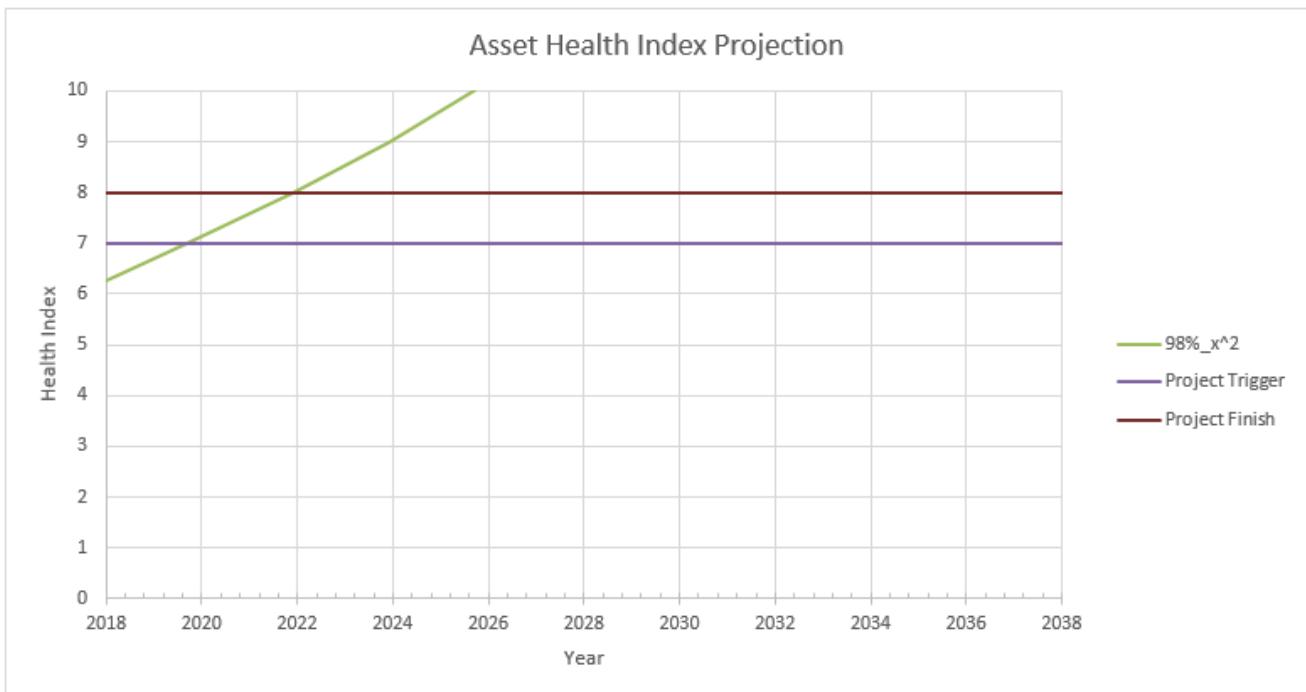
The percentages of corrosion are converted to a health index and based on statistical distribution of the results an Asset Health Index (AHI) is calculated. The following graph shows the AHI based on a threshold of 98% of towers which excludes the worst 2% of towers. The health index for the built section reflects the need to complete a project in the short term (2020-2022). However, since only a small percentage of bolts in a higher areas of towers is driving the need, a capital project could be deferred with increased maintenance or an operational refurbishment project.

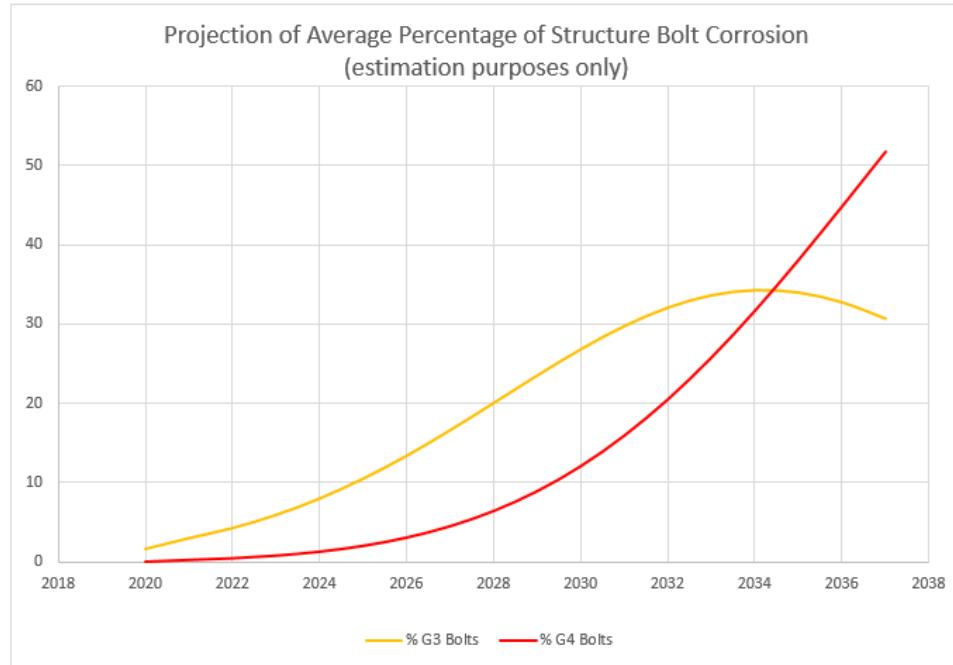
To aid with estimation, the average levels of corrosion calculated. Below is the projection of average level of corrosion on the entire built section based on the sample of data.

As shown in the below table, in 2024 it is estimated that on average across the built section 8% of bolts will have reached grade 3 if no maintenance is performed. This table can be used for high level estimating.

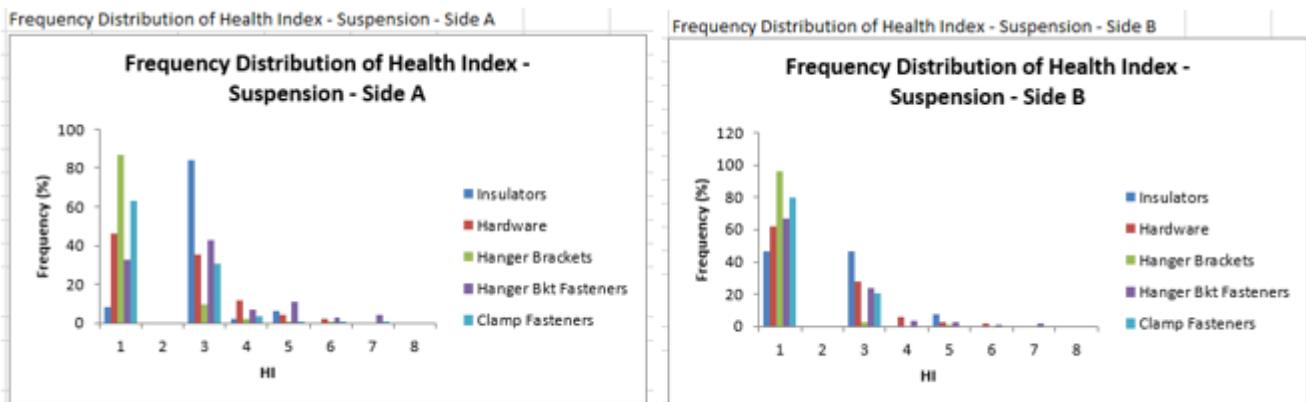
<p>1220-STR-8043-INSSUS_B</p> <p>Both projects were delivered utilizing live line techniques; leaving therefore original hardware on the line. Those components are now becoming deteriorated with suspension insulators health indices in the range 5.6 to 6.5.</p> <p>A failure of the insulator hardware, which attaches the insulator string to the structure or connecting a conductor to the insulators will result in a conductor drop.</p>
Tension	<p>Tension insulators and associated hardware were replaced in 2014 under project OR.01884.</p> <p>All components of tension insulation assemblies are in very good condition.</p>
Bridging	<p>The bridging insulators appear to be in similar condition as suspension insulators; due to the presence of the original hardware their health indices are being driven to moderately high levels (up to HI6).</p>

Below is the frequency distribution of suspension insulator health index based on the sample of data.
