Powerlink 2027-32 Revenue Proposal

CP.02919 Broadsound Primary Plant Replacement

H020 BroadSound Substation

Primary Plant Condition Assessment Report

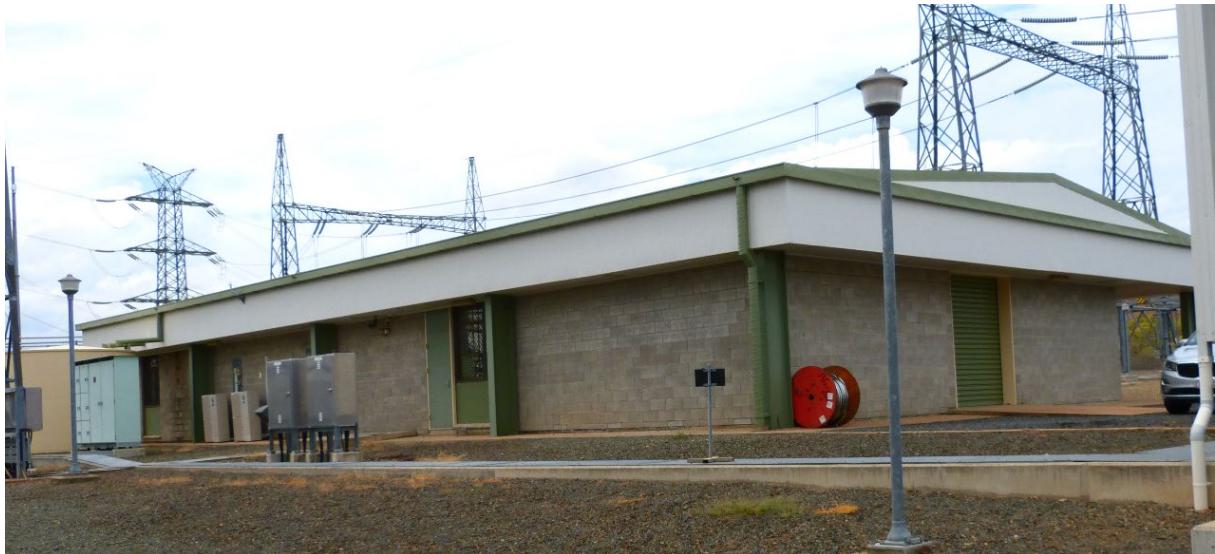
Figure 4 - Control Building +1

The control building +1 was established in 1984 and is 41 years old. The building was constructed on a concrete slab with concrete brick walls and a steel roof. The building is in good condition and if maintained it could provide an adequate service for a number of decades 275kV protection and control panels for Bay C051 and half of Bay C04 and telecommunication devices and their associated accessories are located in this building.

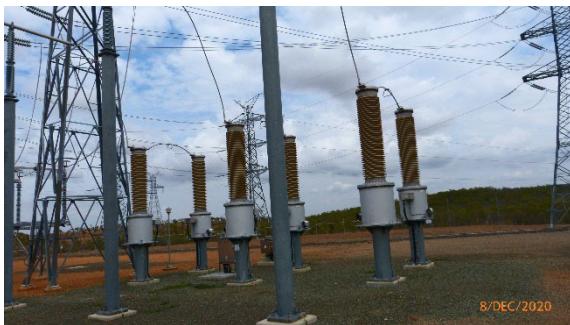
Figure 5 –PVT Bus-1

These two sets of PVTs are in “as new” condition as they were replaced in 2011.

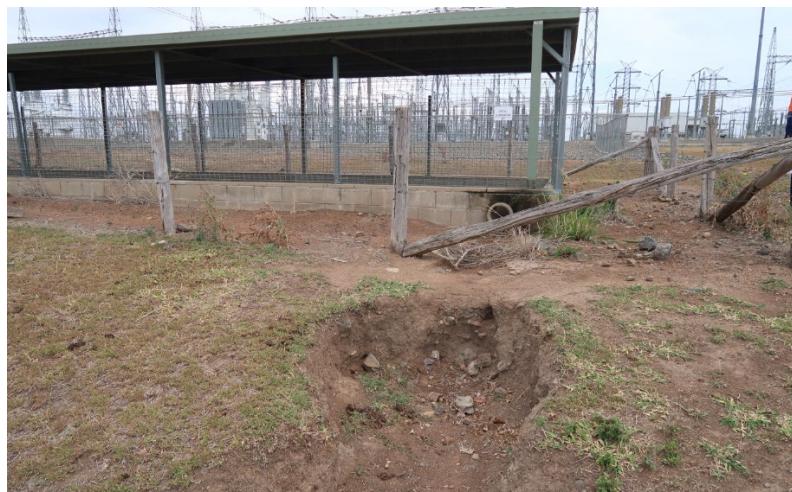
Figure 12: Oil Containment Tank Outlet

The oil separation tank for the line reactors is an old open type tank and in the event that oil enters the containment system the water discharge quality is unlikely to comply with Powerlink's requirements.

The tank should be replaced as early as possible and it is very unlikely that the water discharge quality would comply with Powerlink's requirements if there is a presence of oil in the oil containment system.
