# Powerlink 2027-32 Revenue Proposal

CP.02922 Calvale Selective Primary Plant Replacement

# SITE CONDITION ASSESSMENT REPORT

## H024 CALVALE

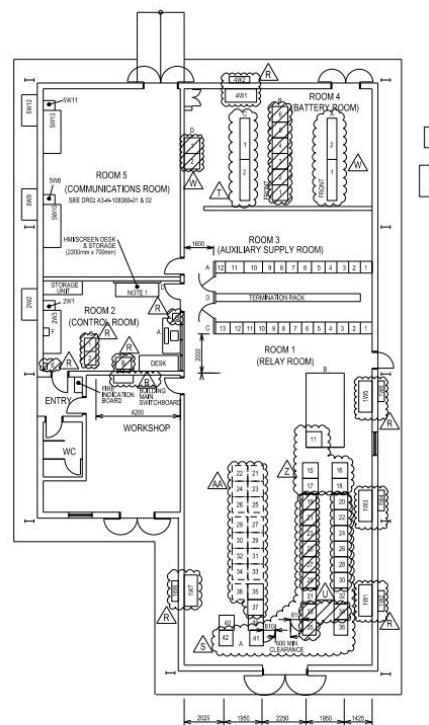
Figure 6 - Control building 1 layout

There is one control building and a work shed on this site. The original control building is brick construction with a steel metal roof and was commissioned in 1987. This building houses Powerlink 275/132kV control panels, the 125V and 50V DC supply systems and telecommunication equipment. It consists of a control/relay room, communications room, battery room, amenities room and toilet. The control, battery and comms rooms are all air conditioned. The majority of windows have bars installed. The building is reasonably well maintained, and no significant issues were noticed during site inspection in 2020.

**Recommendation:** Based on the condition it is recommended that this brick building is fit for purpose for another 40 years with regular maintenance.

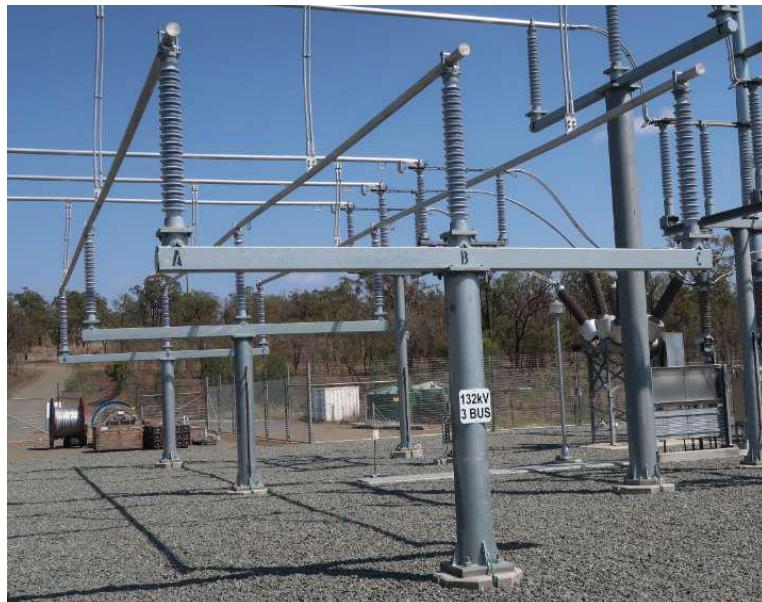
Figure 17: 132kV Bus Support Structure

The 132kV bus support structures were established in 2019 and are in as new condition. The structures support all three phases as shown in the figures below.

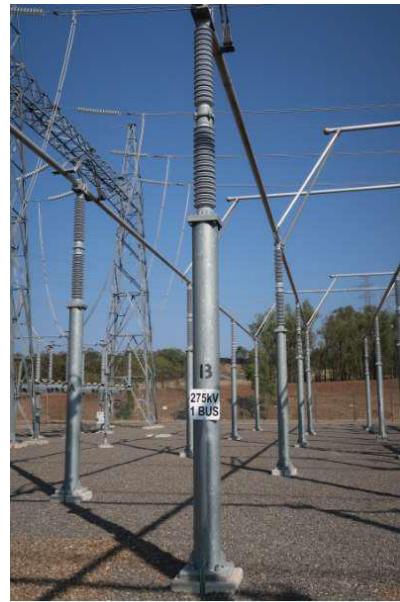
Figure 18: 275kV Tubular Bus Support Structure

In both 275kV & 132kV yards bus support structures have been built as lattice type structures and tubular poles. The bus support post insulators are in very good condition when inspected in 2020 and the associated structures and foundations in these buses are in good condition. However, a number of the structures were identified to have advanced corrosion of the bolts as shown in Figure 24. It is recommended to replace all corroded bolts.

**Recommendation:** The corroded bolts on all structures are recommended to be replaced immediately. The surge arrestors should also be replaced within 3 years. Apart from this, based on the above observations, the rest of the primary equipment in these bays is in good condition and no replacements are required in the next 10-15 year outlook.

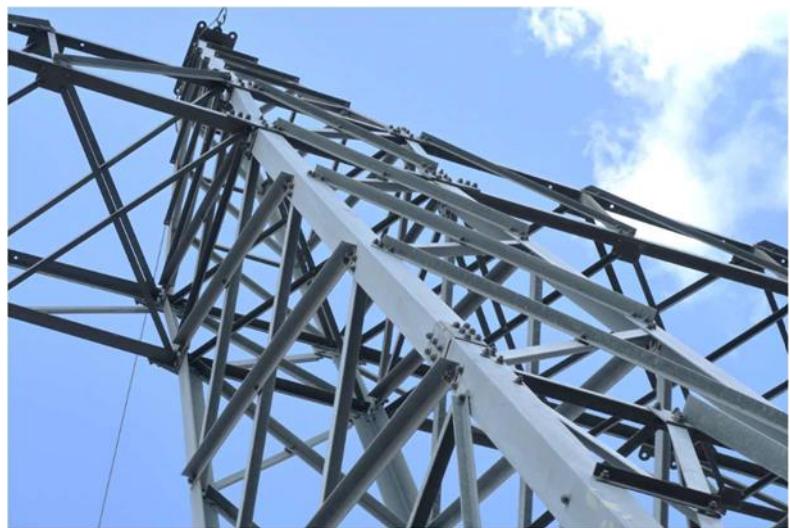
Figure 22: 275kV Structure Main Leg

The 275kV strain structures were established between 1984 and 2013. All 275 kV strain structures are the same lattice type as shown in the figures below. No issues related to the structures were found in 2020.

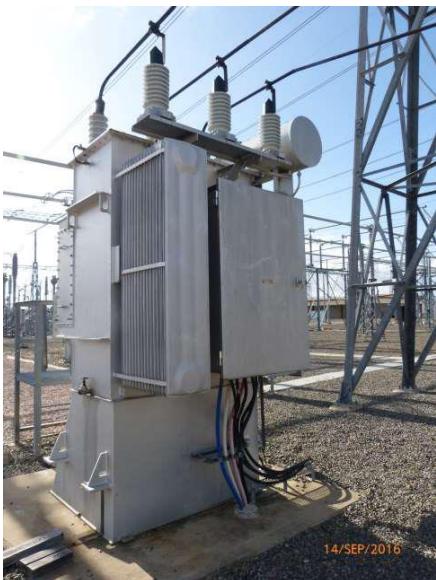
Figure 23: 3 Stn Transformer

These two station transformers are in good condition. However, the 4 station transformer is 50 year old and has approached the end of it's service life.

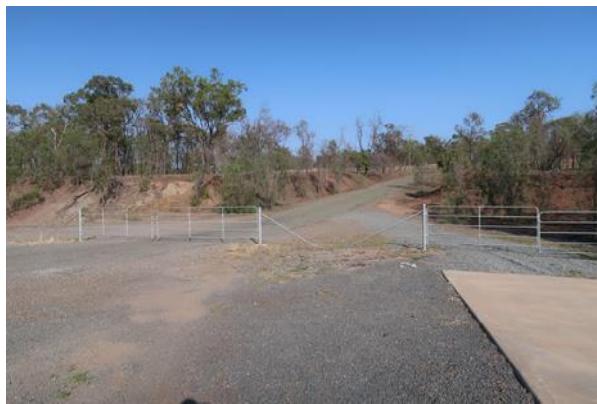
Figure 28: Substation access from Biloela Callide Rd

The Calvale Substation is accessed from Biloela Callide Rd, Biloela. This is a suburban road with good visibility of the entrance shown in Figure 28.

The access road through Powerlink's property between the road gate and the substation security gate is sealed and in good condition. The security gate and fence were not inspected due to the planned security fence upgrade project.

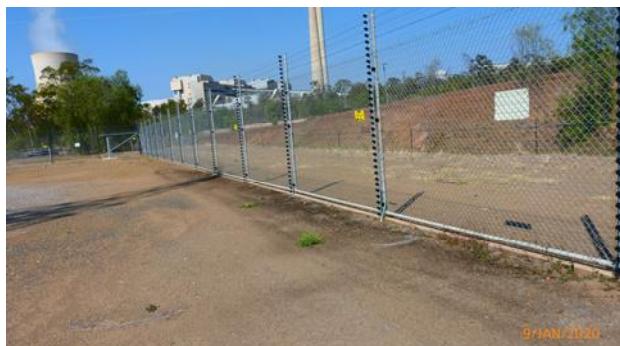
Figure 31: Gravel in the yard

A grid injection test was performed in August 2018 and the results were satisfactory. However the earth grid design report (objective ID A2984746) recommended that gravel surfacing be completed inside the northeastern fence and the southwestern gate and an asphalt strip placed outside these areas as a minimum and ideally gravel throughout and the asphalt around the entire yard. It appears that this recommendation was not implemented. The current gravel layer installed inside the substation appears to be of smaller thickness usually used to reduce requirements for vegetation maintenance inside substations.
