Powerlink 2027-32 Revenue Proposal

CP.02948 Chalumbin 275kV Substation Reinvestment

SITE CONDITION ASSESSMENT REPORT

H032 Chalumbin

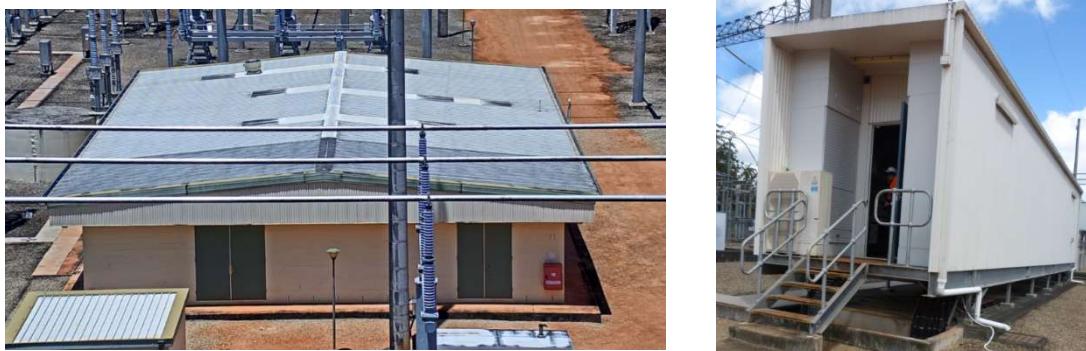
Figure 5 – Substation buildings

This site has two control buildings; a demountable 132kV control building and a brick built 275 kV control building. The Powerlink owned 275 kV control building is used to house Powerlink 275kV control panels, the 125V and 50V DC supply systems and telecommunication equipment. It consists of control/relay room, telecommunications room, battery room, amenities room and toilet. The control, battery and telecomms rooms are all air conditioned. The building is equipped with intruder alarm system, has sufficient lighting, access to protection and control panels and is maintained in good condition. There are some vacant spaces in this building and at high level it is assessed that only minor substation extensions to protection system can be done within the space available.

The demountable building is relatively new as it was installed in 2012 under the secondary system project upgrade. The building is in as new condition and no issues were detected.

Recommendation: Based on the condition it is recommended that the brick and demountable building have estimated remaining service lives of 40 years with maintenance.

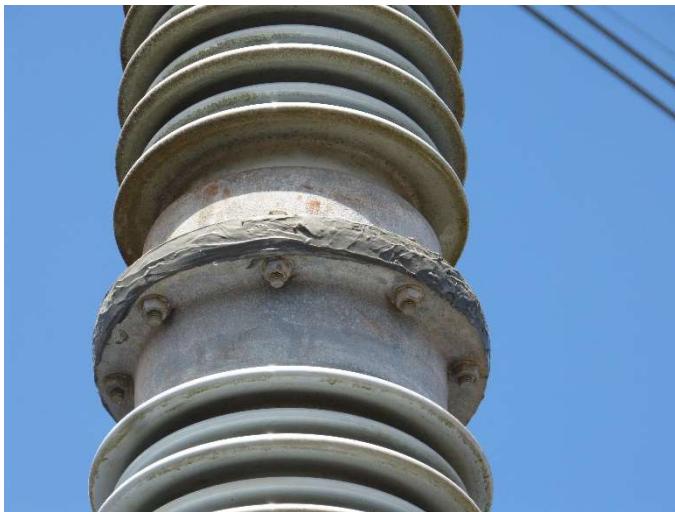
Figure 6 – 5032- Repair (Belzona) applied

ABB HPL300 circuit breaker 5032 is in service for 30 years and started to develop notable gas leaks in 2014 and has been topped up with gas at least once a year since then. There is no on line SF6 leak rate monitoring for this circuit breaker (CB). Powerpatch was applied to try to stop gas leak.

There are 44 circuit breakers of this type in service currently and 18 of these have developed gas leaks at various levels and at least four poles had to be replaced. There are only two spare poles available in stock and refurbishing/repairing these CBs has not proven to be cost effective. The recommended strategy for these ASEA CBs is to replace those that are already leaking and recover good poles of replaced CBs to increase spare holdings to assist in managing others in the fleet.

Considering that leaks are slow, but persistent and a number of times this CB has been topped up with SF6 gas, it is expected that condition of this CB will continue to deteriorate and will require high maintenance. Rectification works have been unsuccessful in stopping the leaks and multiple low SF6 alarms have occurred in the past 5 years. Two pole discrepancy trips have also occurred in the previous 5 years which have required rectification works both times. Although replacement is not considered urgent, it is considered to be eminent and therefore it is recommended to replace this CB 5032 in the next 5 years. Considering the fleet of this CBs, the fleet approach should be developed and when prioritisation of this CB replacement, the difficulty of obtaining prolonged outages and network consequence of such outages should be considered.

Recommendation: Based on the above observations, it is recommended that the CB and CTs incl. structures and foundations are replaced within the next 5 years preferably using dead tank CB.

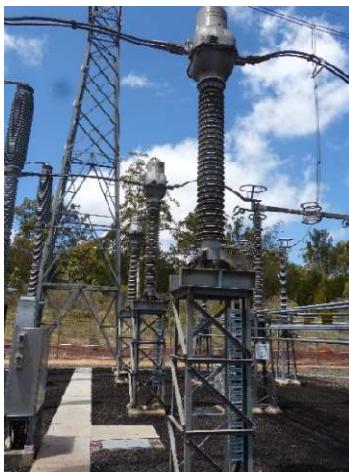
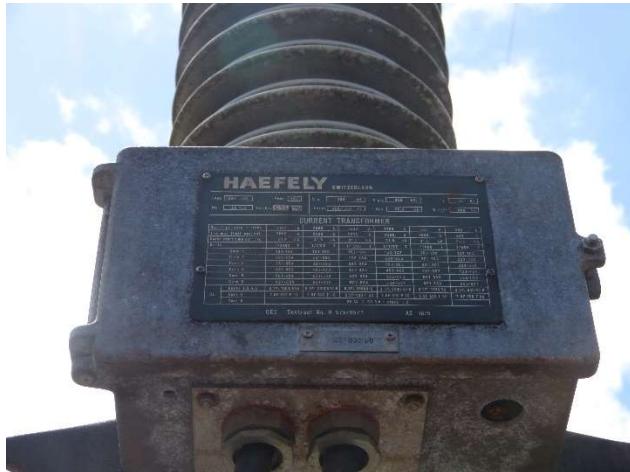
Figure 8 –CTs

The Haefely oil filled current transformers (CTs) are in reasonable condition considering they have been in service for 30 years and the DGA/moisture in oil analysis is satisfactory. There are no identified issues with oil seal integrity. Considering their age and the fact these have porcelain housing, leading to a high consequence in case of catastrophic failures, it is recommended to replace these in 5 years. This way the replacement of CTs can be combined with replacement of circuit breaker in this bay, reducing the impact of outage on the network.

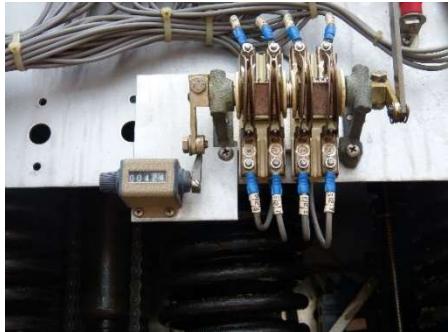
Figure 10– CB71662

This bay was established in 1989, so majority of the high voltage equipment in this bay have been in service for just over 30 years. In 2015, the small oil leak was noticed from circuit breaker and few smaller parts of it had to be replaced, indicating that aging process has started. In addition there is a well-developed corrosion of various parts of earth switches and disconnectors. In 2016 all three CVTs failed in service (high moisture content in base box) and were replaced using CVTs manufactured in 2008. As obvious from Figure 11 A phase has bottom of base tank heavily corroded. It is presumed that tank is made of aluminium so the source of corrosion could be hold down bolts.

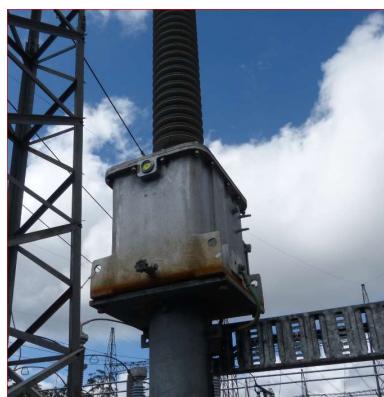
Figure 11 - CVT corrosion

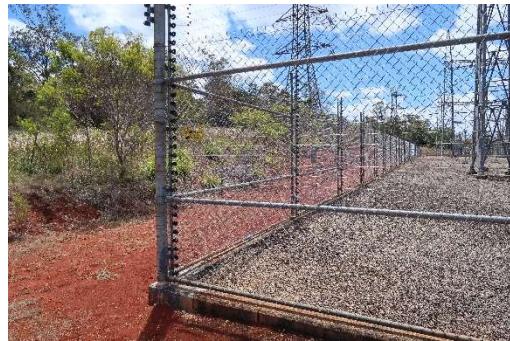
Figure 15 –Substation security fence

The substation security fence consists of a standard chain wire fence and an electric fence mounted on the inside of the chain wire fence, installed in 2017. The chain wire fence is approximately 2.4m tall and has a bottom rail and an additional rail at approximately one metre above the ground. It is estimated that both chain wire and electric fence should last until 2032. Then it should be replaced to suit new substation security standard.

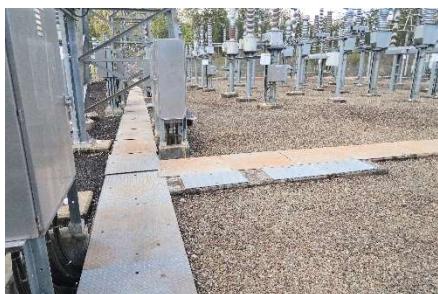
Figure 17 – Cable trenches

There is no indication in the maintenance records of any issues related to the cable trench covers. The cable ducts and the associated cable covers were in good condition and the covers were neatly placed without significant gaps that could present a tripping hazard.

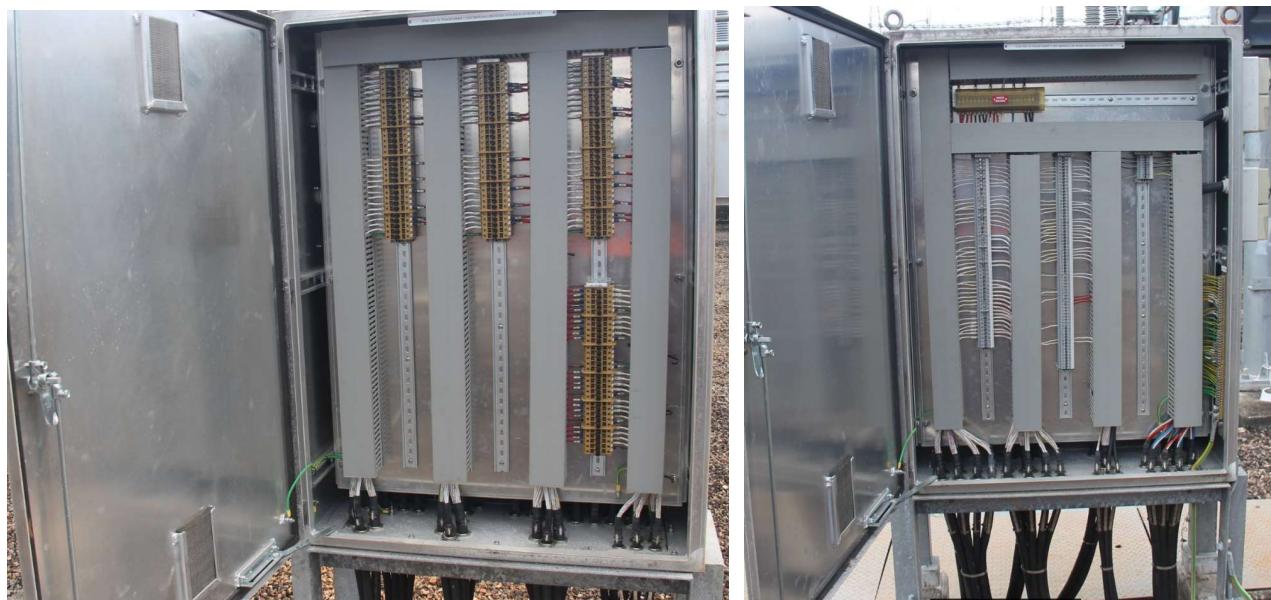
275kV 1T bay marshalling kiosk

Marshalling kiosks and VT boxes for 275kV 1 and 2 Transformer were replaced under CP.01566 Chalumbin secondary system replacement between 2011 and 2012. Marshalling kiosks and associated control cables are in good condition. There are no condition driven replacements required until 2051.

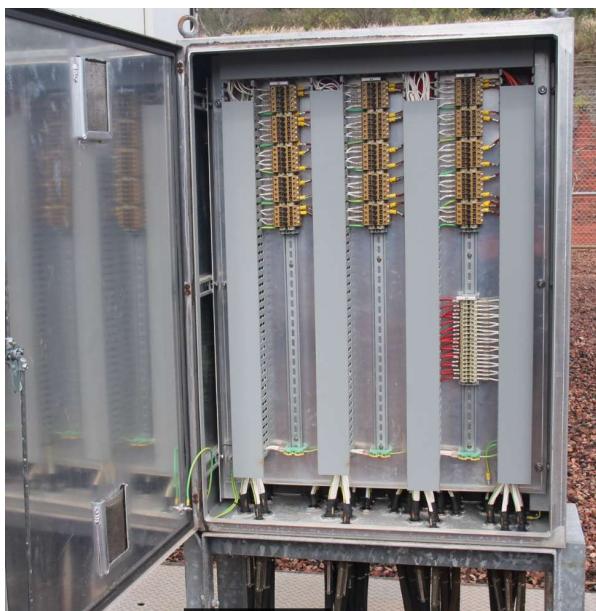
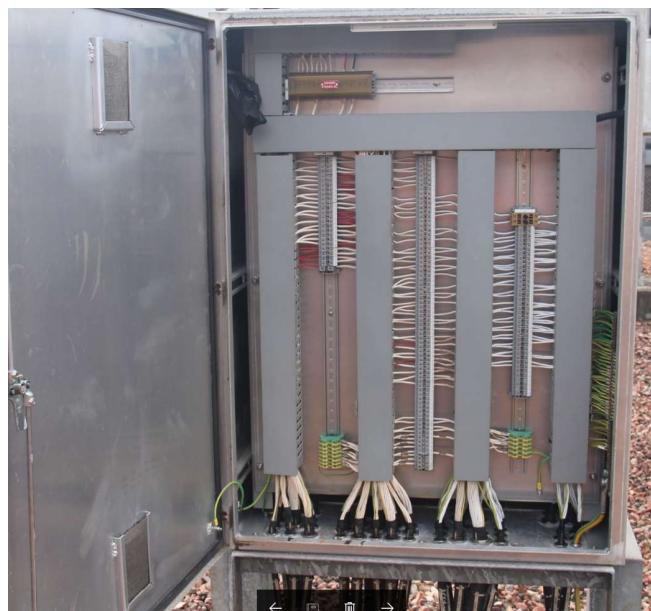
275kV Feeder 876 bay marshalling kiosk

Marshalling kiosks and VT boxes for 275kV feeder 876 were installed in 2007 and are in good condition. There are no condition-driven required replacement until 2047.

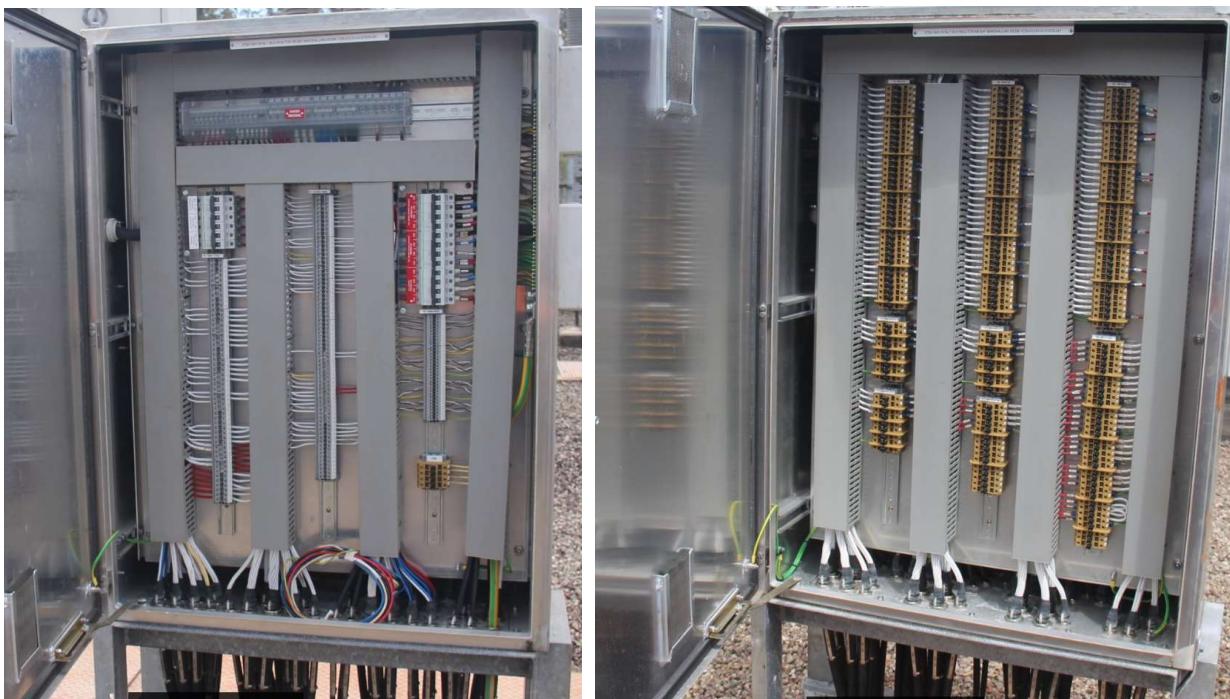
275kV bus reactor 5 bay marshalling kiosk

Marshalling kiosks for 275kV bus reactor 5 were installed in 2012/2013 and are in good condition. There are no condition-driven required replacement until 2052.

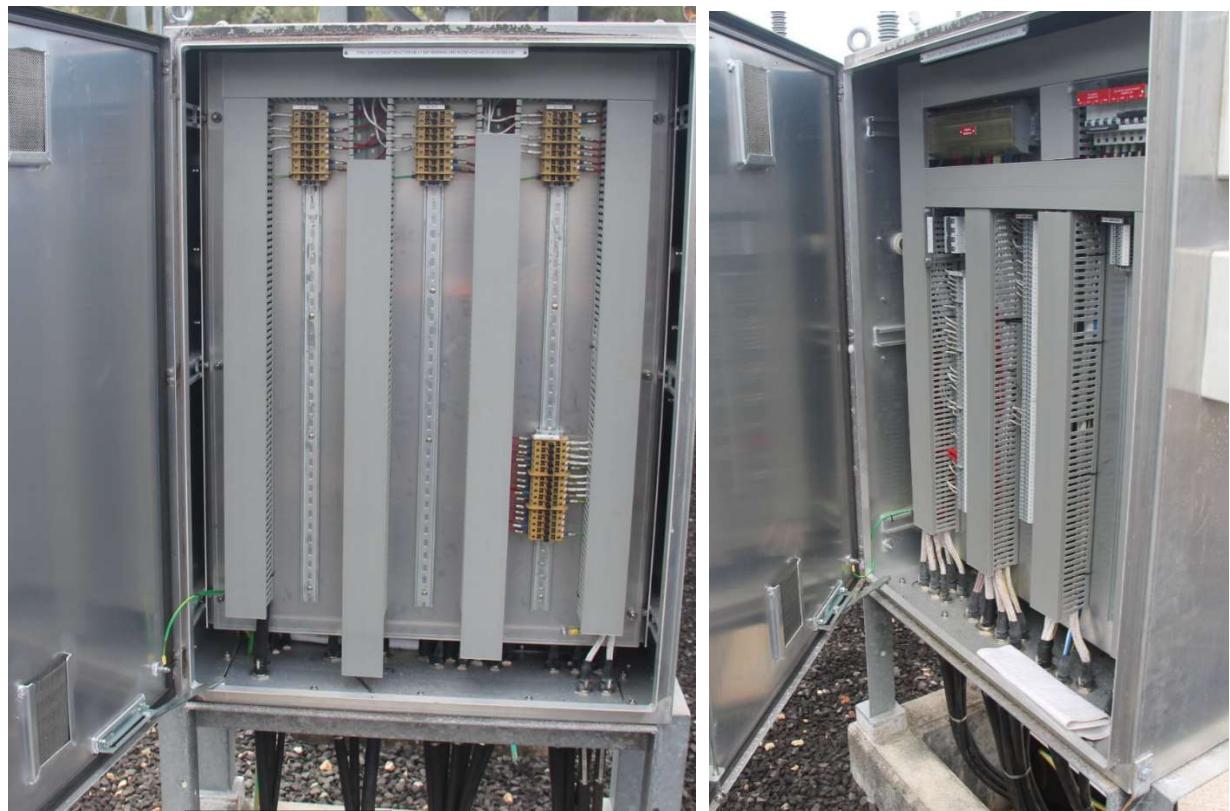
275kV Feeder 857 reactor marshalling kiosk

Marshalling kiosks for 275kV Feeder 857 and 858 reactor were replaced in 2011/2012 and are in good condition. There are no condition-driven required replacement until 2051.

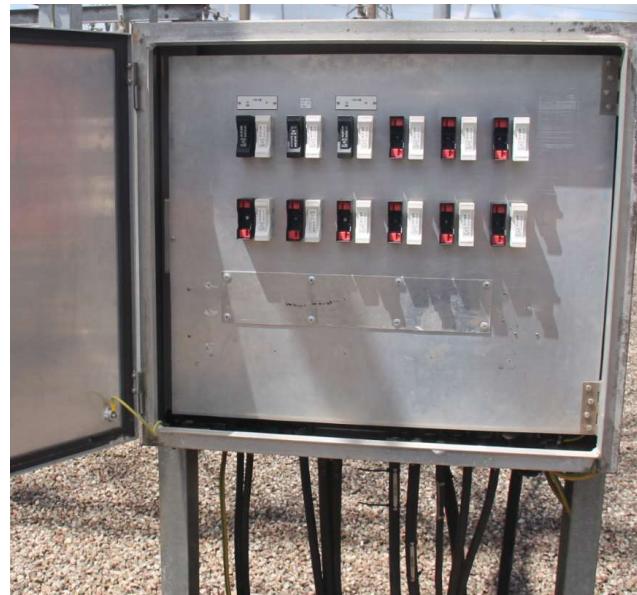
275kV =C06 AC and DC marshalling kiosk

AC marshalling kiosk for 275kV diameter =C06 was commissioned in 2007. Marshalling kiosks and associated cables are in fair condition. There are no condition driven replacement required until 2041. The DC marshalling kiosk for diameter =C06 was installed in 2003. Associated fuses do not provide safety and monitoring features and make the event investigation more difficult. Maintenance on these fuses is expensive. These fuses should be replaced with MCBs to improve the performance of circuitries according to current design standard with major secondary system replacement.

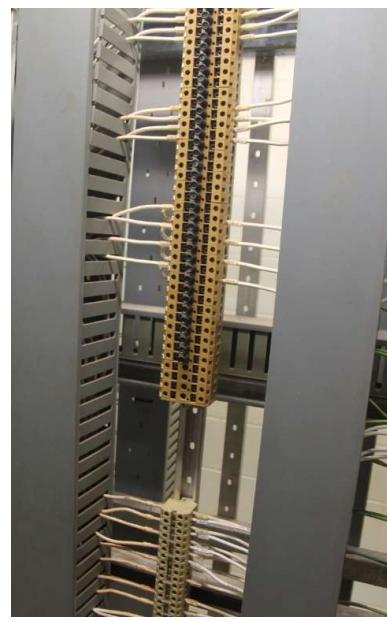
It is a cable termination rack arrangement in Building +1 at H032 Chalumbin. But majority of control cables up to the marshalling kiosks have been wired directly to the protection and control panels and haven't been terminated via the terminal racks. The floor and support structure are intact. Termination racks were built in 1988 and old terminals need to be replaced if these rack are utilised for future secondary system replacement.

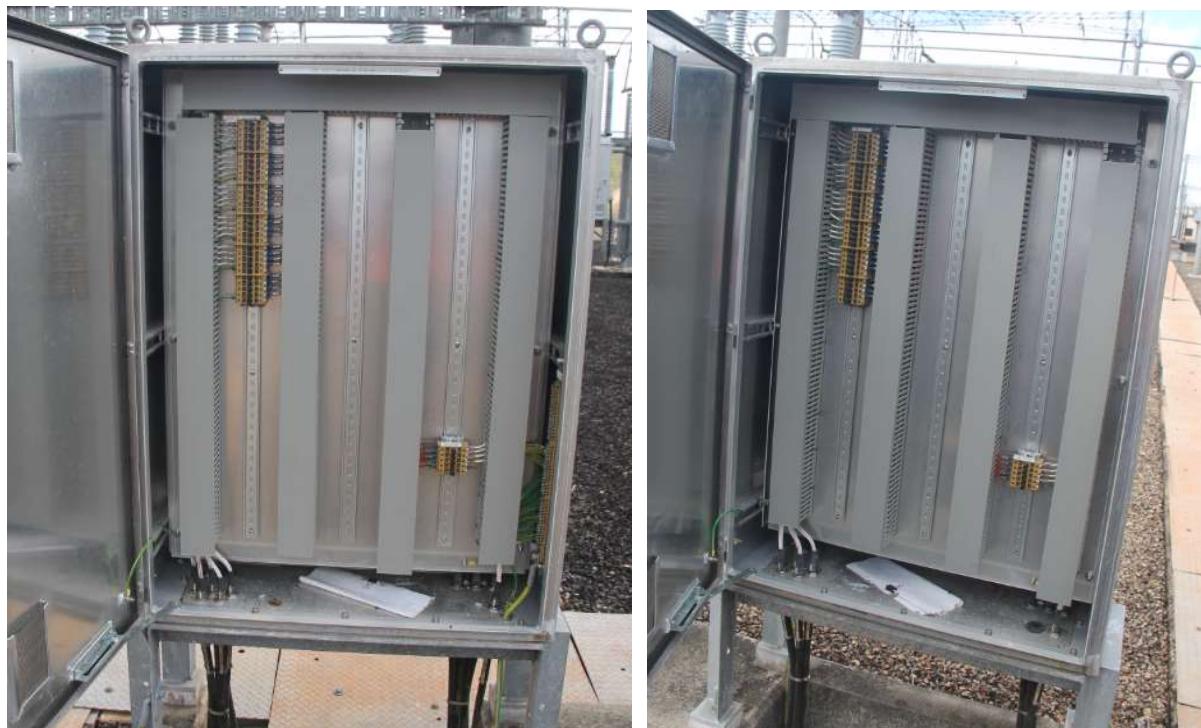
132kV 1 Bus CT marshalling kiosk

132kV bus and bus coupler marshalling kiosks (including VT boxes) were replaced under CP.01566 Chalumbin secondary system replacement in 2011. These kiosks and associated

control cables are in good condition and there are no condition-driven replacements required until 2051.

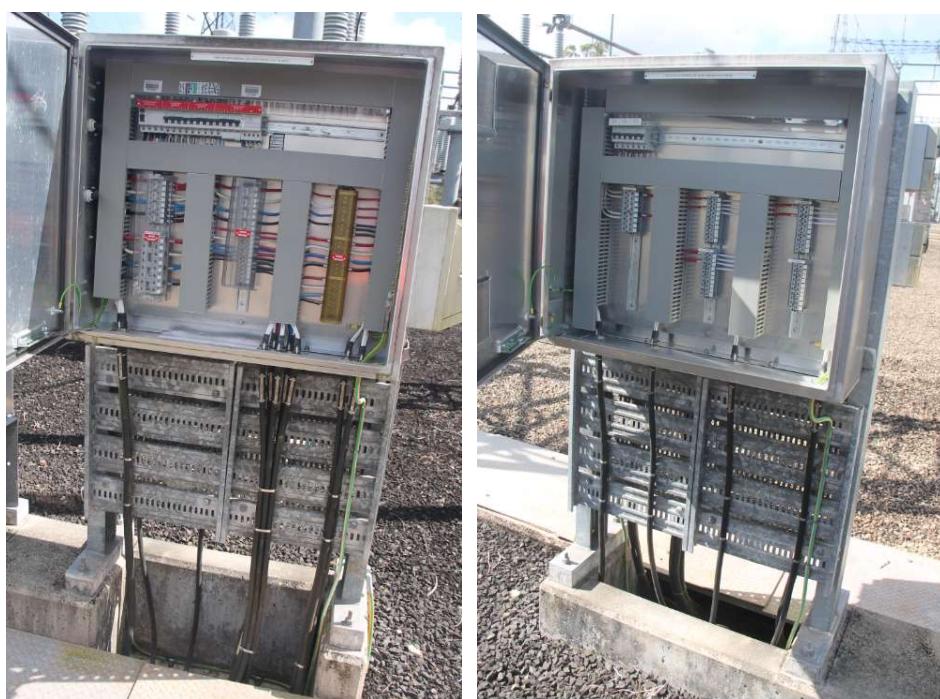
132kV Bay =D04 AC and DC marshalling kiosks

AC/DC marshalling kiosks for 132kV bay =D04, =D06 and =D08 and marshalling kiosks for 1 CAP and 1T shunt reactor were replaced under CP.01566 Chalumbin secondary system replacement in 2011. These kiosks and associated control cables are in good condition and there are no condition-driven replacements required until 2051.

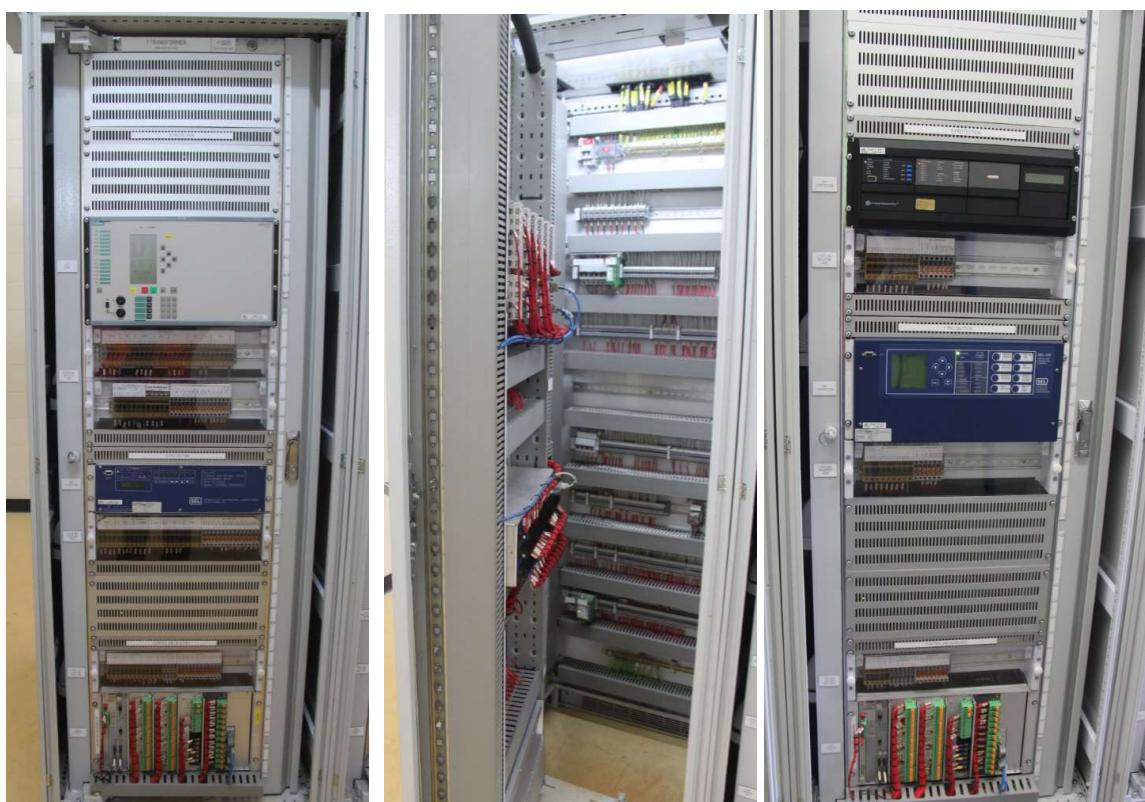
1 Transformer 275/132kV protection and control panel

Protection and control equipment including the panel for 1& 2 275/132kV transformer were replacement under CP.01566 Chalumbin secondary system replacement in 2013. These secondary systems are in good condition. Health index indicate that there are no condition-driven replacements required until 2033.

- Replace all secondary systems for 275kV coupler 503 and 504
- Replace all secondary systems for 275/132kV 1T and 2T
- Replace all secondary systems for 275kV bus reactor
- Replace all secondary systems for 275kV Feeder 857 reactor
- Replace all secondary systems for 275kV Feeder 858 reactor
- Replace all secondary systems for 132kV 1 and 2 Bus
- Replace all secondary systems for 132kV bus coupler
- Replace all secondary systems for 132kV feeder 7165
- Replace all secondary systems for 132kV feeder 7166
- Replace all secondary systems for 132kV feeder 7191
- Replace all secondary systems for 132kV feeder 7192
- Replace all secondary systems for 132kV 1 Cap
- Replace all secondary systems for 1T 19kV Reactor
- Replace SCADA RTU C50 and common RTUs C50 in building +1 and +4
- Replace the TWS fault locator
- Replace Tekron GPS clock in building +4

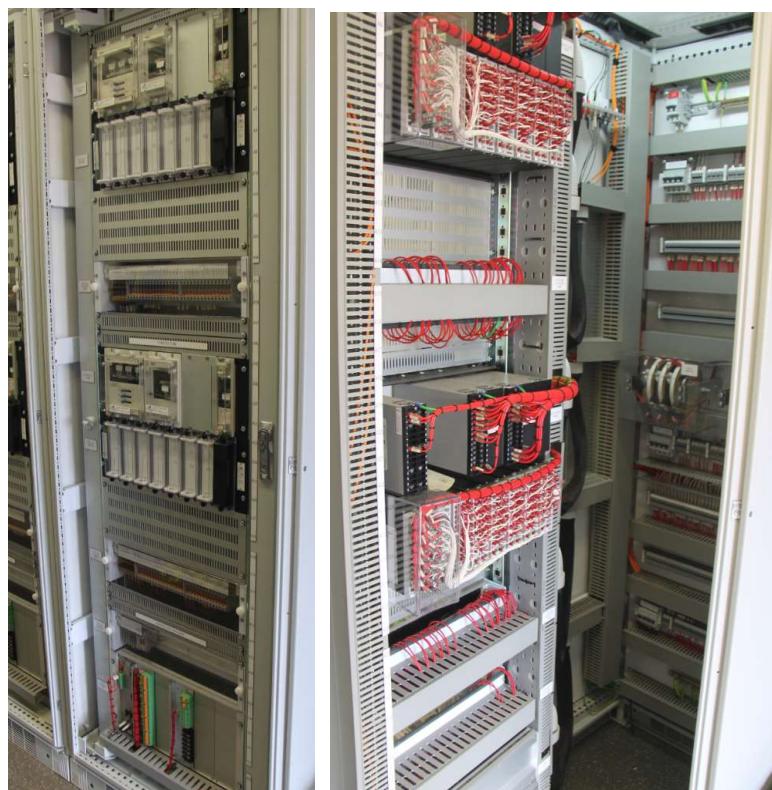
132kV 1 Bus zone protection and control panel

Secondary systems for 132kV bus zones and the bus coupler were replaced under CP.01566 Chalumbin secondary system replacement between 2012 and 2013. They are in good condition. There are no condition-driven replacements required until 2032.

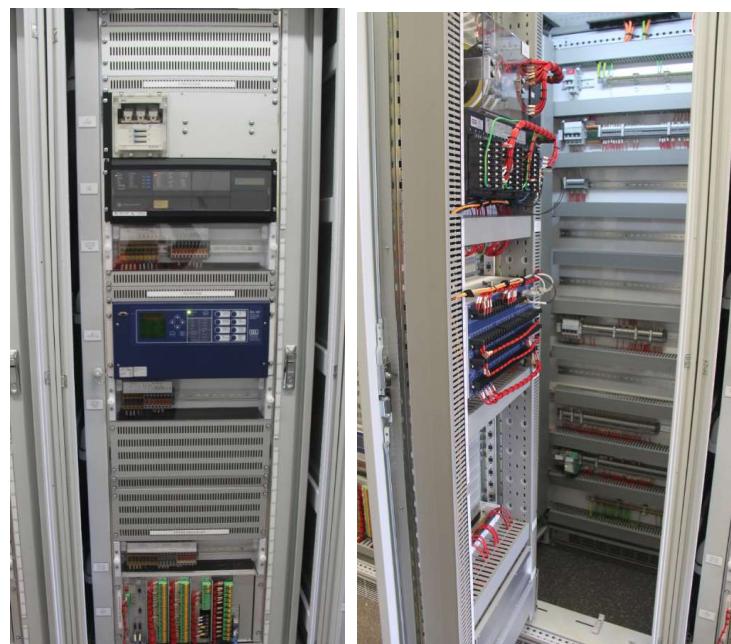
19kV Reactor protection and control panel

Secondary systems for 19kV reactor were replaced under CP.01566 Chalumbin secondary system replacement 2013. There are no condition-driven replacements required until 2033.

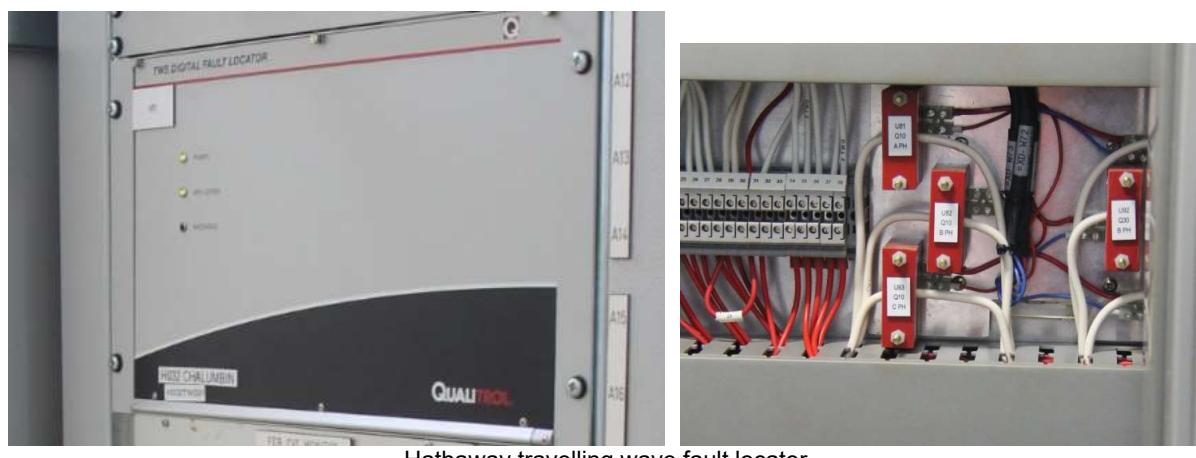
Hathaway travelling wave fault locator

Travelling wave based fault locator was installed in 2010 and is in fair condition. Health index indicates that there is no condition-driven replacement required within 10 years.

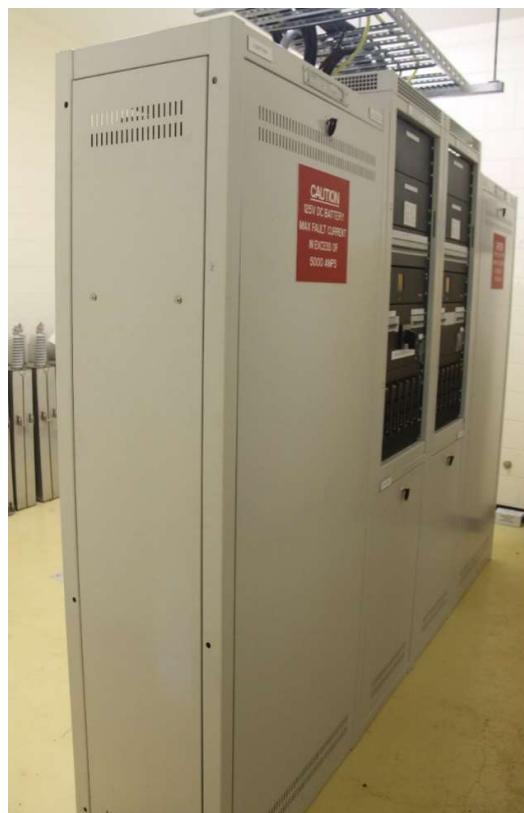
125VDC Batteries and charger

The dual 125VDC and dual 48VDC systems and associated distribution board were replaced in 2014 and 2012 respectively. There are no condition driven replacements required until 2026 and 2024.

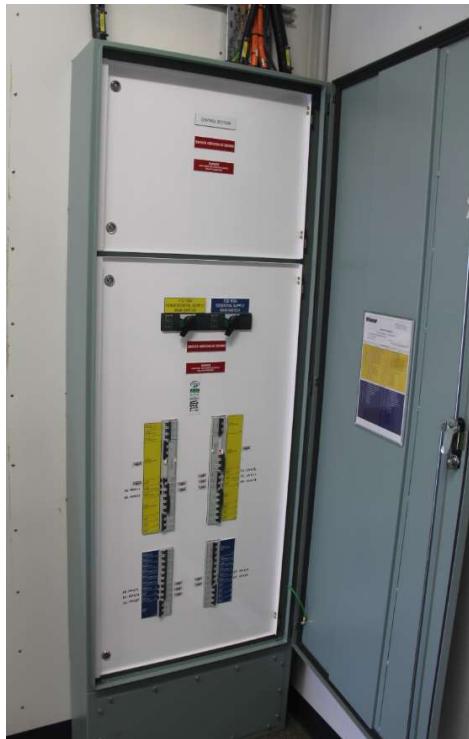
AC distribution boards in building +4

AC distribution boards and associated DC distribution boards in Building +4 were installed in 2012 and are in good condition. There are no condition driven replacements required within 10 years. Dual 125VDC will reach the end of technical asset life and need to be replaced by 2024.
