# Powerlink 2027-32 Revenue Proposal

Project Pack

CP.03005 T142 Tennyson T3 Replacement

## Transformer Condition Assessment T142 Tennyson Substation

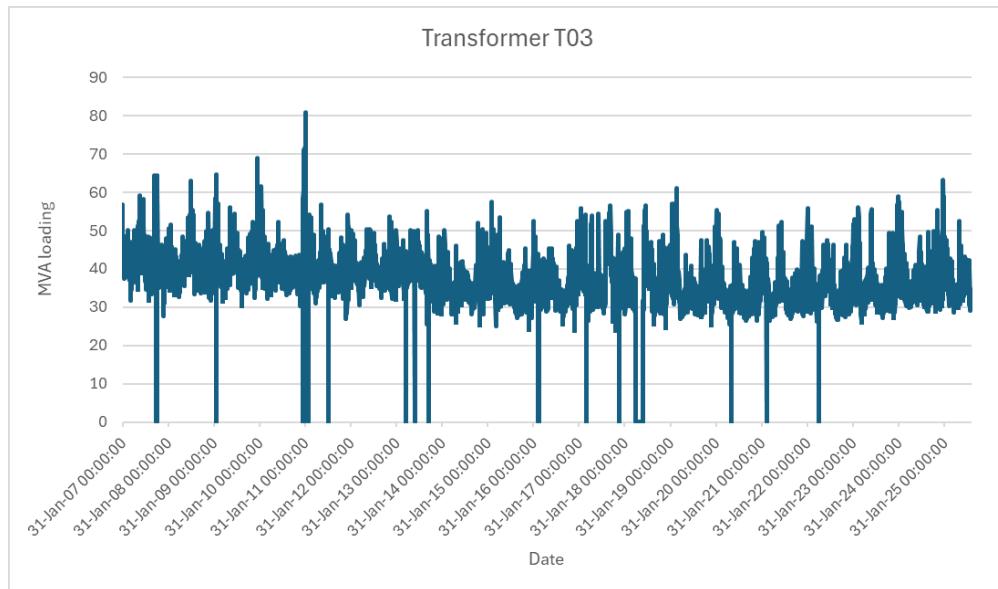
**Figure 5:** T142 Tennyson transformer T03 loading in MVA.

The graph in the previous figure 5 shows the average transformer T03 MVA loading over the past 5 years was around 26MVA, well below its 48MVA ONAN nameplate rating (48/60/80MVA ONAN/ODAN/ODAF). Under normal circumstances, this relatively light loading should allow for slow internal HV cellulose insulation ageing, especially if this loading characteristic is representative of the 25 years of service.

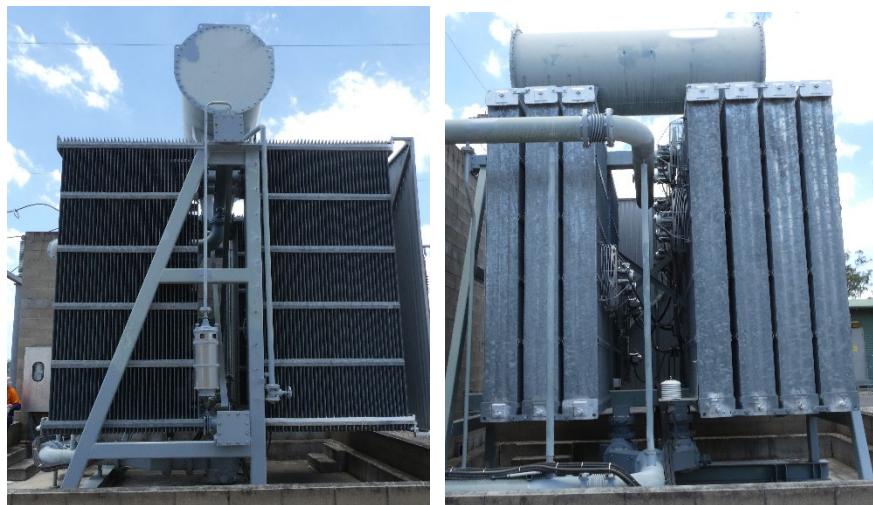
**Figure 15:** (LHS) View of the outer Cooler Bank 'A'-frame support structure.

The main 'A'-frame support structures for the cooler bank are in good physical condition but the surface paint is oxidised. The surfaces of these structures show signs of paint touch-ups.

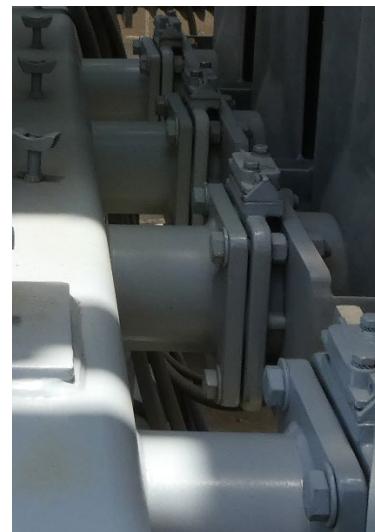
The cooler bank has butterfly valves for isolating each of the radiator panels from the top and bottom main oil headers as can be seen in the figure below. They are not leaking oil and due to some maintenance, they do not show local corrosion.

**Figure 20:** Butterfly valves are installed for isolating each of the radiator panels from the top and bottom main oil headers.

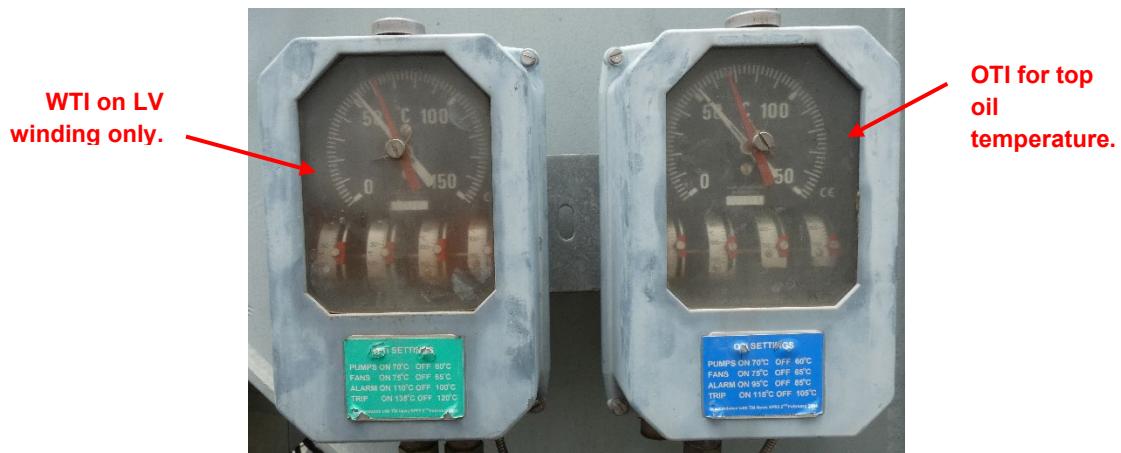
This transformer is designed with one winding hot spot temperature (WTI) instrument for the LV winding and one top oil temperature (OTI) monitoring instrument as shown in the figure below. In addition to this, the transformer also has a programmable logic controller that controls the on board cooling system and telemetry of transformer operating variables, alarms and trip signals. As such, the WTI instrument is not normally required for indicating the transformer winding hot spot temperatures since the PLC calculates this based on the transformer top oil temperature. Hence, no replacement of these instruments is necessary.

**Figure 26:** One WTI and one OTI are installed.

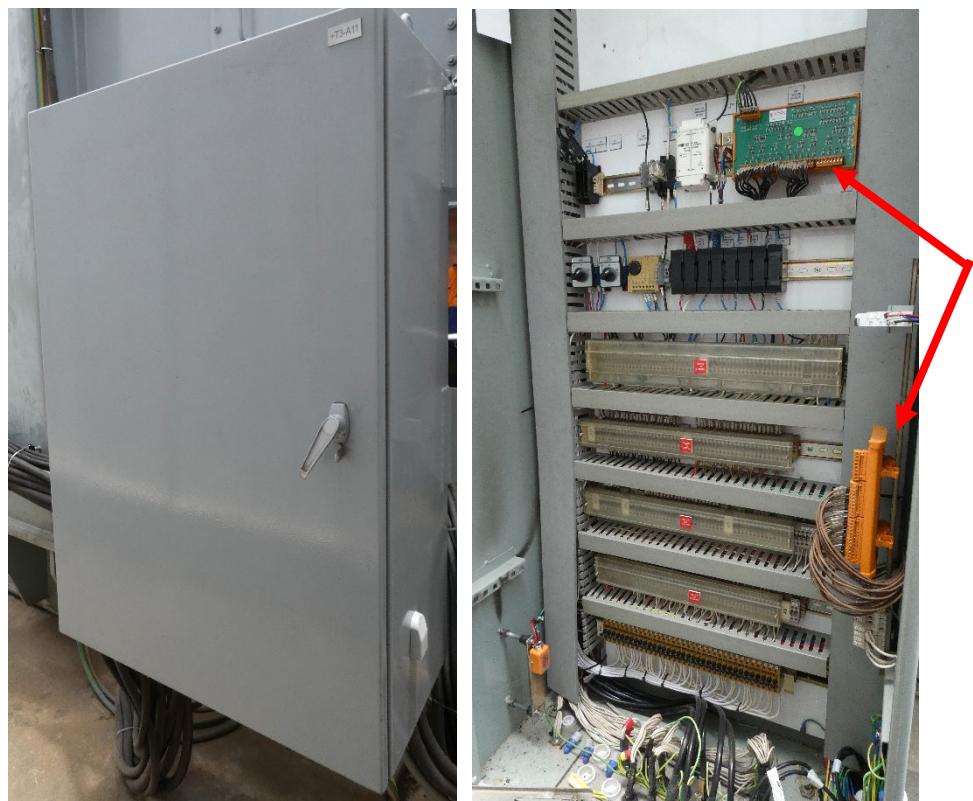
Safety barriers are installed over terminal strips where there are live terminals that could pose a safety risk if the outer cubicle door is opened. These barriers are shown in the figure below.

**Figure 27:** Main Control Cubicle view with the outer door open. Note dual OLTC TPI cards, one for PLQ and one for Energy Queensland.

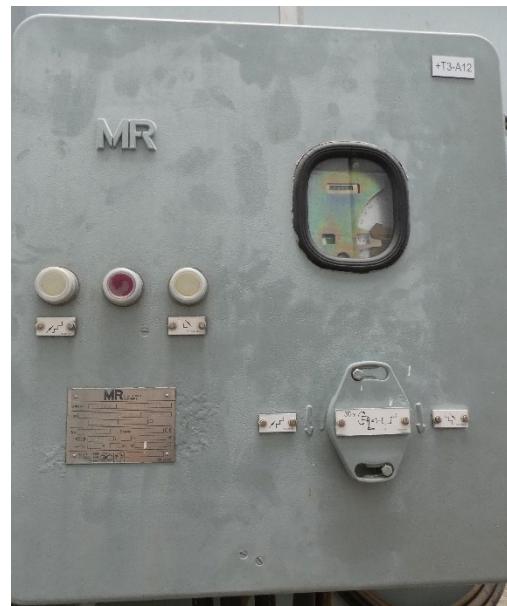
**Figure 30:** OLTC Control Cubicle.

The tap changer was last serviced in August 2022 and has 77,677 operations on the counter. There were significant issues reported with the OLTC and multiple trips occurred due to the OLTC motor in 2022. As such the motor was replaced in the same year, with these works being considered successful as no further defects have been noticed operationally.

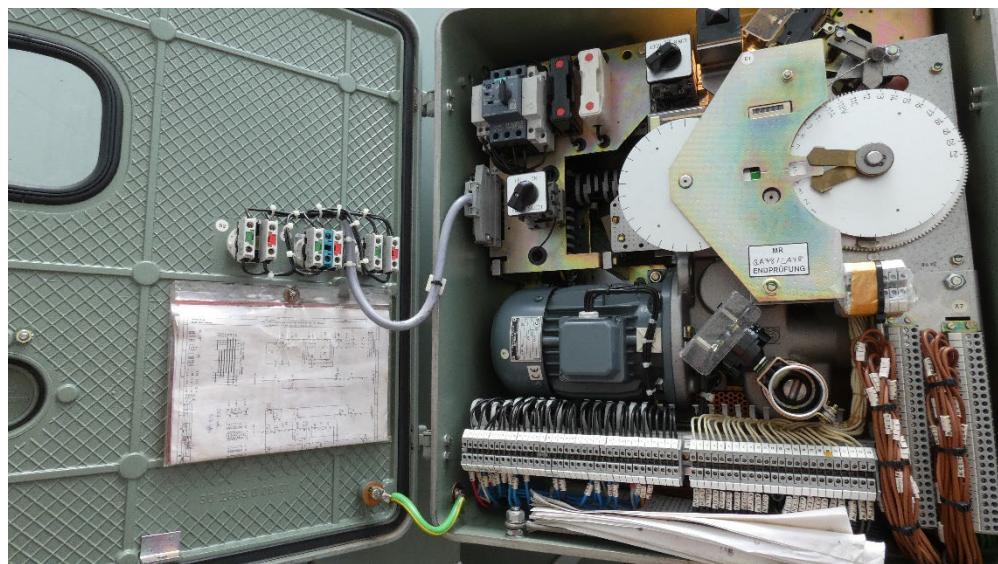
**Figure 31:** Inside the Tap Changer Control Cubicle.

Electrical safety barriers are not installed over live terminals in the tap changer Control Cubicle but PQ have been advised that such barriers are available if specified when the tap changer is purchased. Retrofitting of the barriers may also be possible during routine tap changer maintenance.

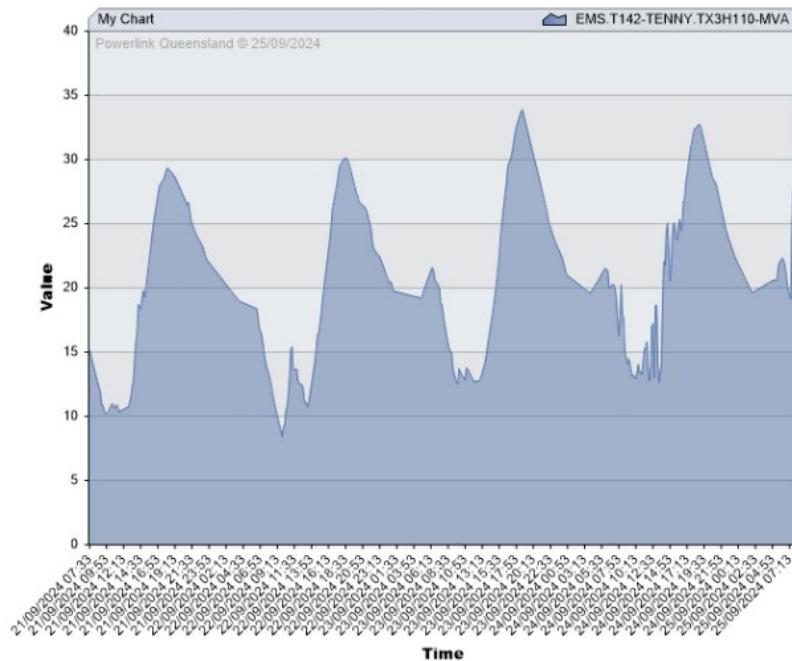
Figure 35: Transformer T03 loading over 4 days in September 2024.

The above figure shows typical repetitive load cycling over 4 days with adequate cooling intervals in between each loading. Over the years of service, this load fluctuation even though small can impact the windings and clamping due to thermal / mechanical working of internal load carrying conductors / joints. There is a phenomena called "**Thermal Softening**" and "**Hydroscopic Softening**" of the cellulose insulation which load cycling contributes to and which will negatively impact the mechanical clamping of the windings over time.

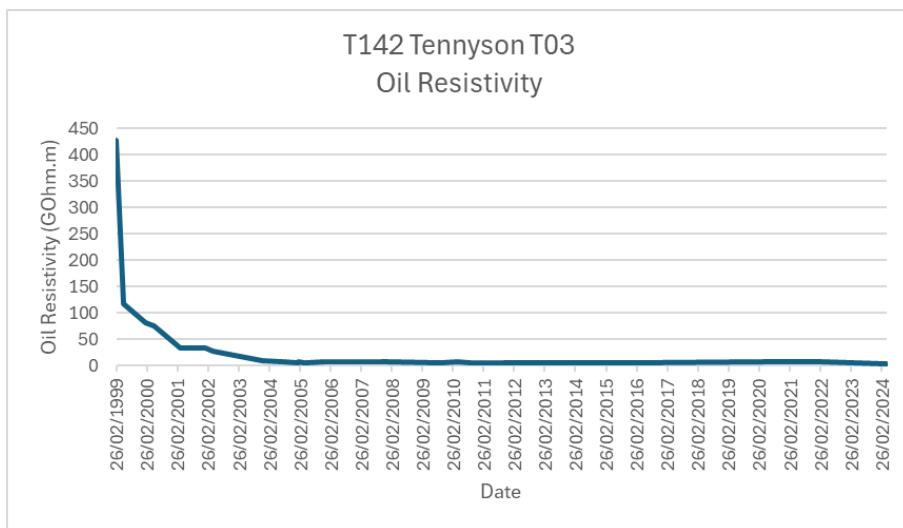
Transformer oil resistivity (Gohm.m) value normally decreases fairly quickly in service. The scaling of the resistivity axis in the figure below creates an illusion that the oil resistivity is very poor. Based on the resistivity characteristic shown in the figure below for this transformer oil and using assessment categories of "Good", "Fair" and "Poor", this oil's resistivity of 4Gohm.m (at 90C) would fall into the category of "Poor" for its age from a conductivity point of view. No action is required due to oil resistivity alone.

**Figure 38:** Transformer T03 oil Resistivity characteristics over its service life.

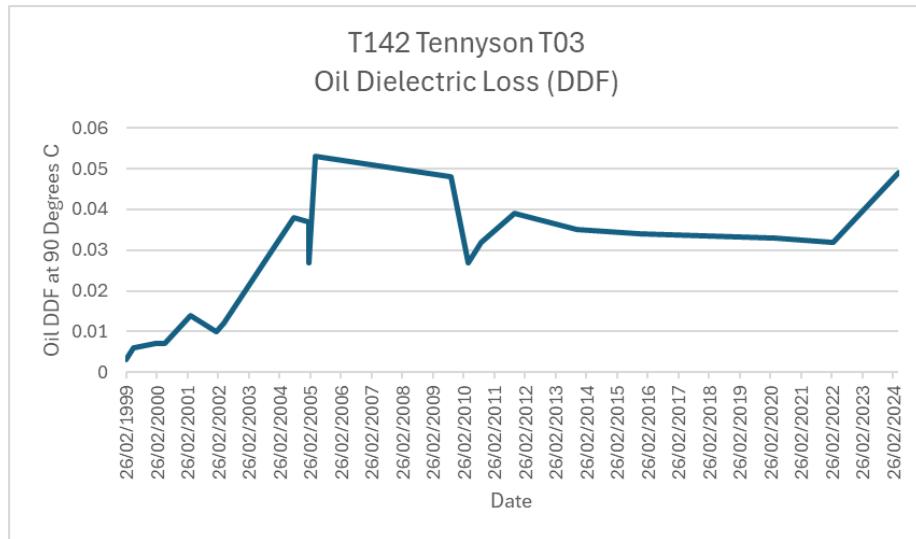
**Figure 40:** Transformer oil Dielectric Dissipation Factor (DDF) characteristics over its service life.

The Tennyson T03 transformer oil DDF rose steadily up to 0.05mgKOH/gm (mgKOH/gm is an “acidity” unit. The DDF rose steadily up to approximately 0.035 and peaked in 2024 at 0.049 where the limit for DDF = 0.10). This is well below the alarm level.

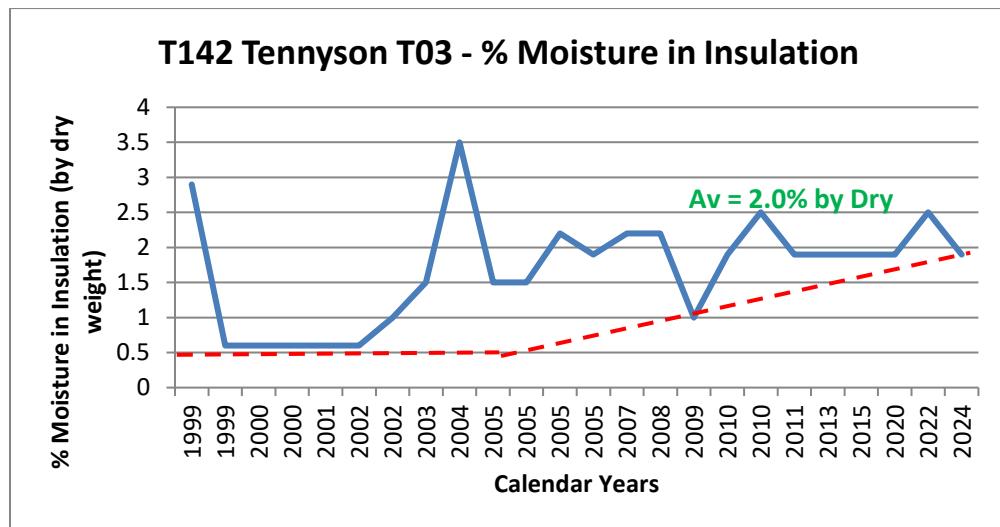
Analysis of Powerlink’s Oil and Insulation Testing Laboratory test data by using internally developed diagnostic software suggested an average moisture in the cellulose insulation figure of about 2.0% by dry weight.

With a gradual increase up to 2.0% by dry weight moisture in the cellulose insulation combined with daily load cycling, it would be reasonable to expect some cyclic physical growth in the winding clamping structure, all be it small. The load cycling on the transformer and changing direction of moisture migration in response to the changing temperature gradients across the paper / oil interface would also induce some loss in mechanical clamping pressure on the windings. This is in addition to the previously mentioned thermal and hydroscopic softening of the cellulose insulation.

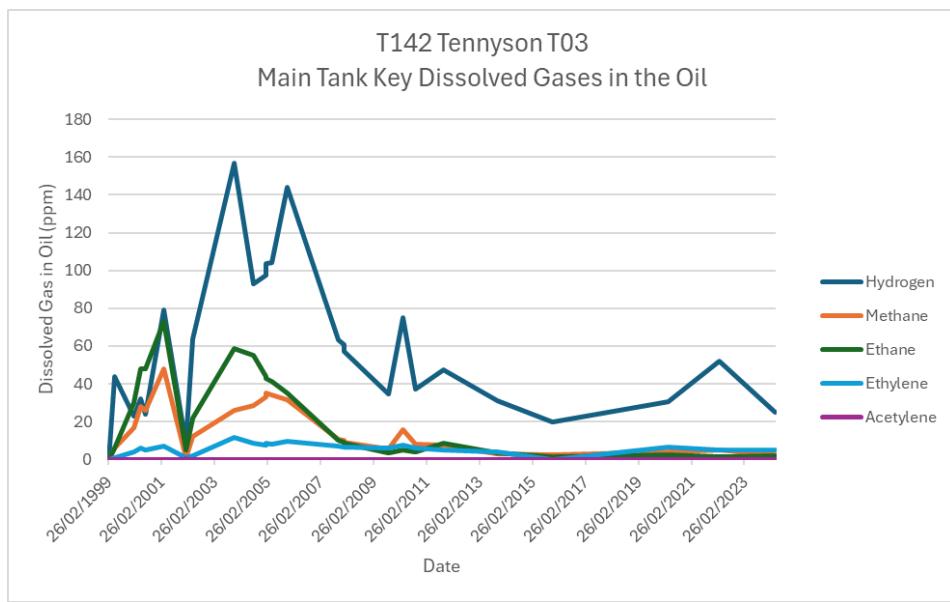
A review of Powerlink's Oil and Insulation Testing Laboratory DGA (dissolved gas in oil analysis) test data for this transformer revealed periodic signs of localised hot spot(s). This heating occurred over an extended period from around 2005 through to 2010 and then again from 2020 to 2022 before stabilising in 2024. The individual peaks shown in the dissolved gas-in-oil trends in the figure below have occurred due to changes in transformer loading for those periods of time.

**Figure 42:** “Key” dissolved gases in oil over the transformer’s service life.

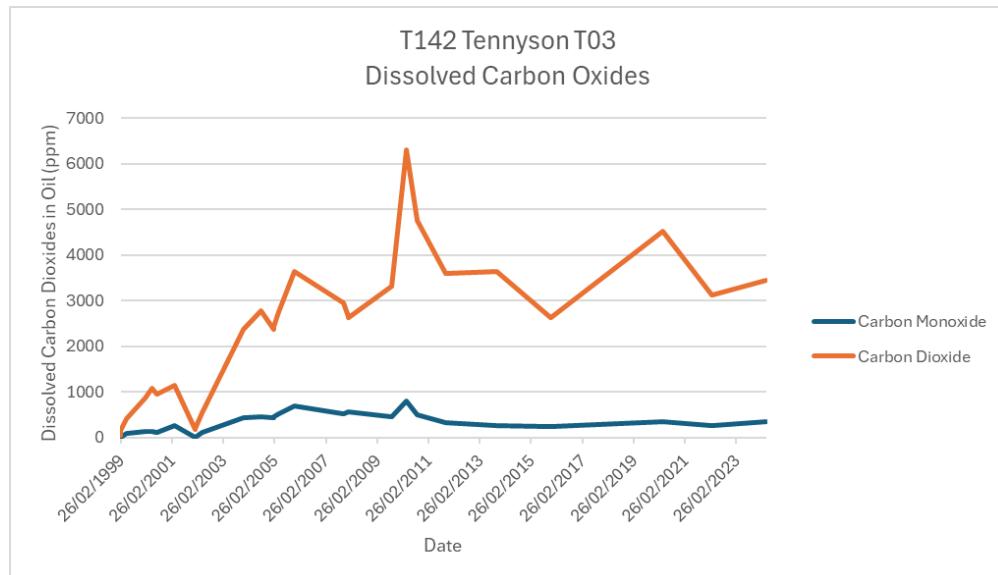
The dissolved carbon oxide gases shown in the figure below also confirm the localised heating discussed above for the key dissolved thermal gases for 2005 through to 2010 and then again in 2020 to 2022.

**Figure 43:** Carbon Monoxide and Carbon Dioxide dissolved gasses over the transformer’s service life.

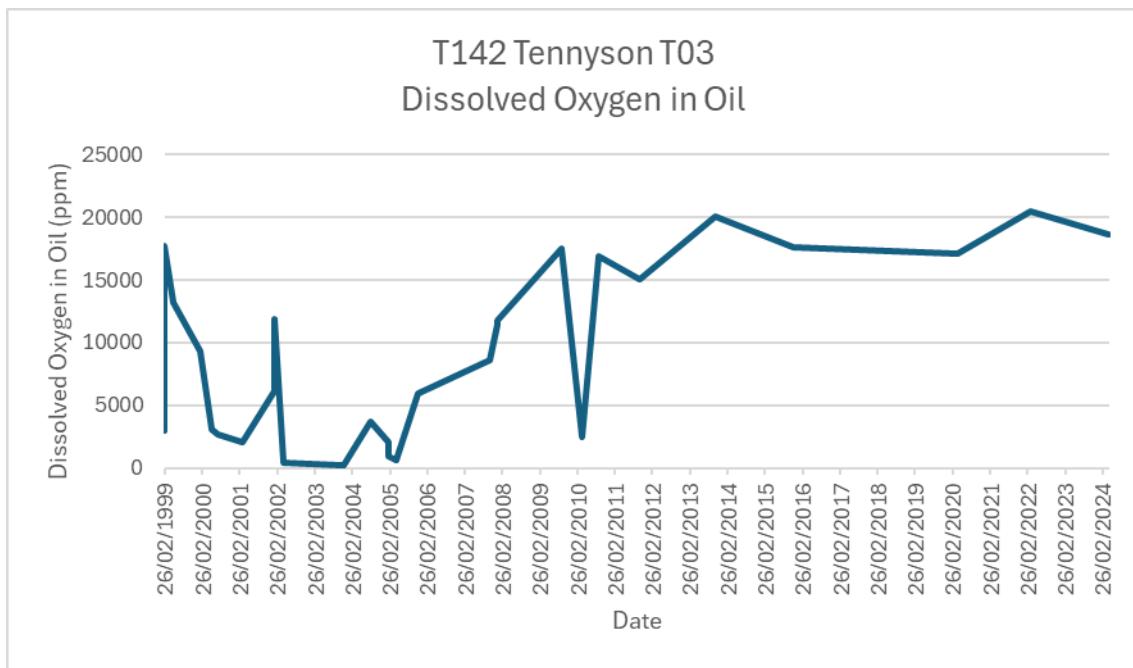
We are expecting more dissolved oxygen consumption for the above mentioned periods of time when other oil parameters indicated that the transformer had localised hot spots for several years and this is what has been displayed in the figure below for the dissolved oxygen in oil.

**Figure 44:** Dissolved oxygen in oil activity over the transformer's life.

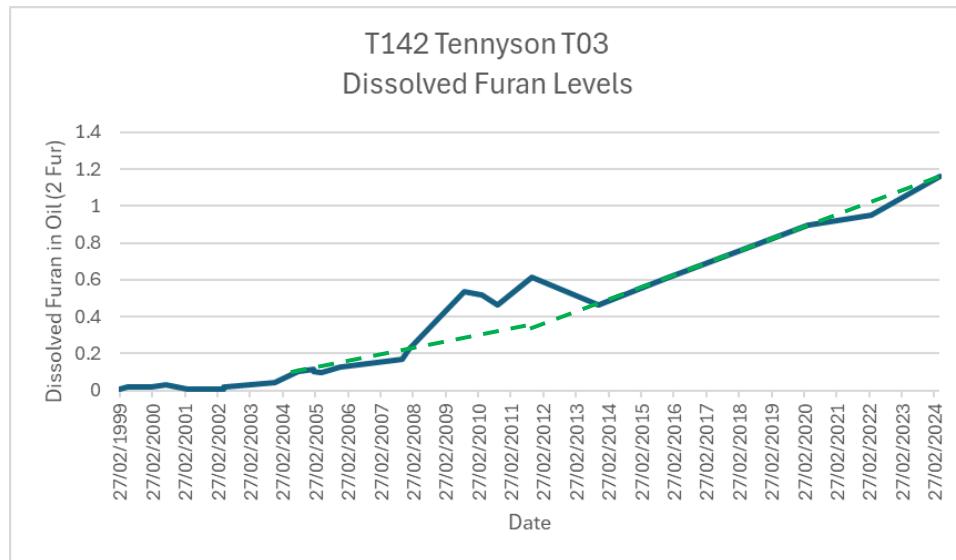
**Figure 45:** Dissolved Furan (2 Furfur) in oil over the transformer's life.

By using the dissolved Furan (2FurFur) in oil test data from Powerlink's Oil & Insulation Scientific Testing Laboratory, the average trend in dissolved

Furan level gives an average value at present of 1.1 ppm (parts per million) in oil. Because of the more localised nature of the winding hot spots, when the dissolved Furan generation from these higher temperature locations is averaged out in the total transformer oil volume, the hot spot contribution of Furans is not easily distinguishable from that generated by the bulk insulation mass. The dissolved Furan in oil characteristic in the figure below certainly adds further confirmation of the more severe cellulose insulation heating from around the 2005 through to 2024.

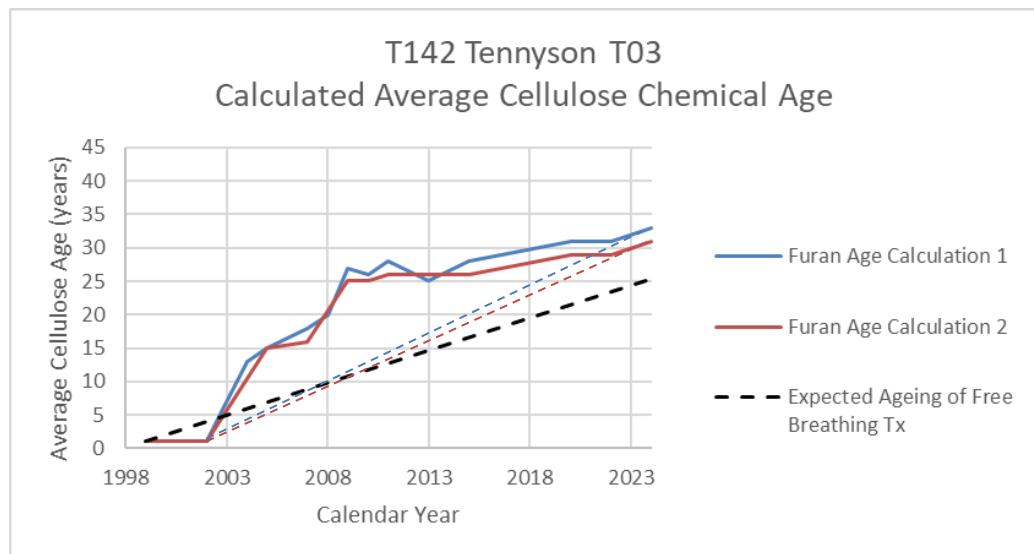
**Figure 48:** Calculated bulk insulation chemical age over the transformer's life.

Now that the average cellulose insulation *Degree of Polymerisation* (DPv) has been calculated to be between a DPv of between 415 to 280, the **average insulation chemical age** is calculated to be between **31 years to 33 years** as shown in the figure below. This is poor for a 25 year old transformer, representing accelerated insulation ageing of about 1.32 times. The reason for this accelerated ageing cannot be known for fact, however aside from the possible PLC issues indicated in this section, it should be noted that the Power Transformer was purchased from another utilities specification and as such may be of different quality to that expected by Powerlink Queensland specifications. Poor manufacturing quality of this specific transformer may be to blame for the accelerated ageing, however it is worth stating that the factory tests all tested acceptably.

There will obviously be a lower DPv in more critical, localised areas of the **winding hot spots** and this value is estimated to be below 200. This calculated DPv for the localised winding hot spot insulation represents a **calculated winding hot spot insulation chemical age of 40 years** which is well above unity insulation ageing for a 25 year old transformer.

This transformer's internal HV insulation system is in poor condition, reaching statistical end of reliable service life. If the functionality of this transformer is required into the future at Tennyson substation, the transformer will need to be replaced within 2-4 years. Its external physical condition is acceptable for its age.

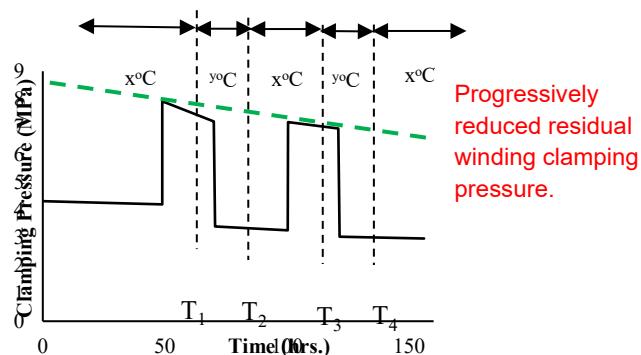
**Figure 50:** Example of the effect of cyclic compression on a clamped insulation structure.

- (f) Cyclic loading will also mechanically work the winding clamping structure. It is realised that the load (temperature) changes are not normally as sharp as shown in the diagram below but the diagram demonstrates the result of cyclic compressive forces on the clamping structure of the windings.

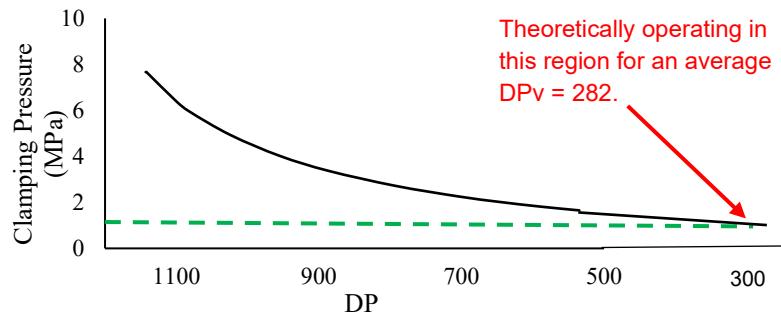
**Figure 51:** Example of the effect of loss of DPv on Clamping Pressure.

- (g) Softening due to cellulose ageing (loss of cellulose mass) indicated by the decrease from  $DP_v = 1150$  when new to a lowest average now of  $DP_v = 282$  will lower the winding residual clamping pressure significantly but as to exactly how much would require transformer internal access.

Considering all of the above aspects, the mechanical stability and through fault withstand capability of the winding structure is considered to be in a weakened state. Provided no significant through faults occur, the transformer should be able to continue to operate under normal service conditions until it is either replaced or scrapped within 2-4 years.

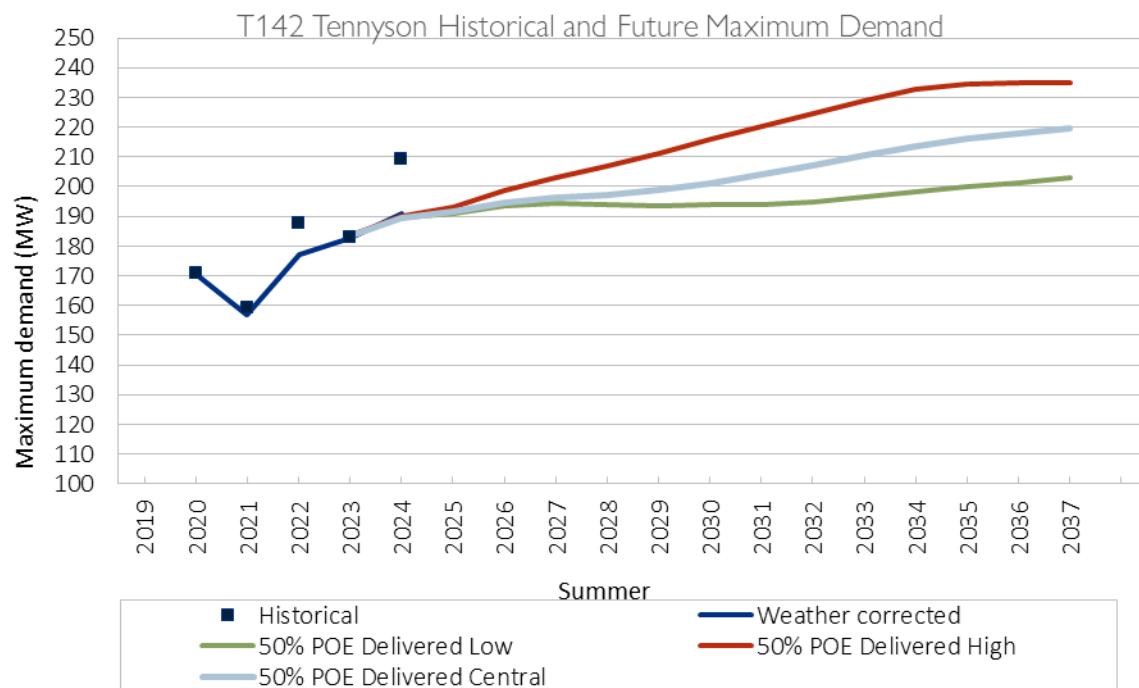
Figure 3. T142 Tennyson Substation Historical and Future Load Forecast

The peak delivered demand at Tennyson Substation already exceeds the N-1 capacity of the 3 transformers. This is operational managed using short term ratings and EQL load transfers.

For the network to be in a “secure” state, then a contingency of T3, must not overload the remaining T1 and T2 i.e. combined capacity =  $2 \times \sim 115\text{MW} = \sim 230\text{MW}$ . Alternatively, an automated scheme is required. Based on the 10PoE load forecast of Figure 3, a scheme is required for the 2033/34 summer period.

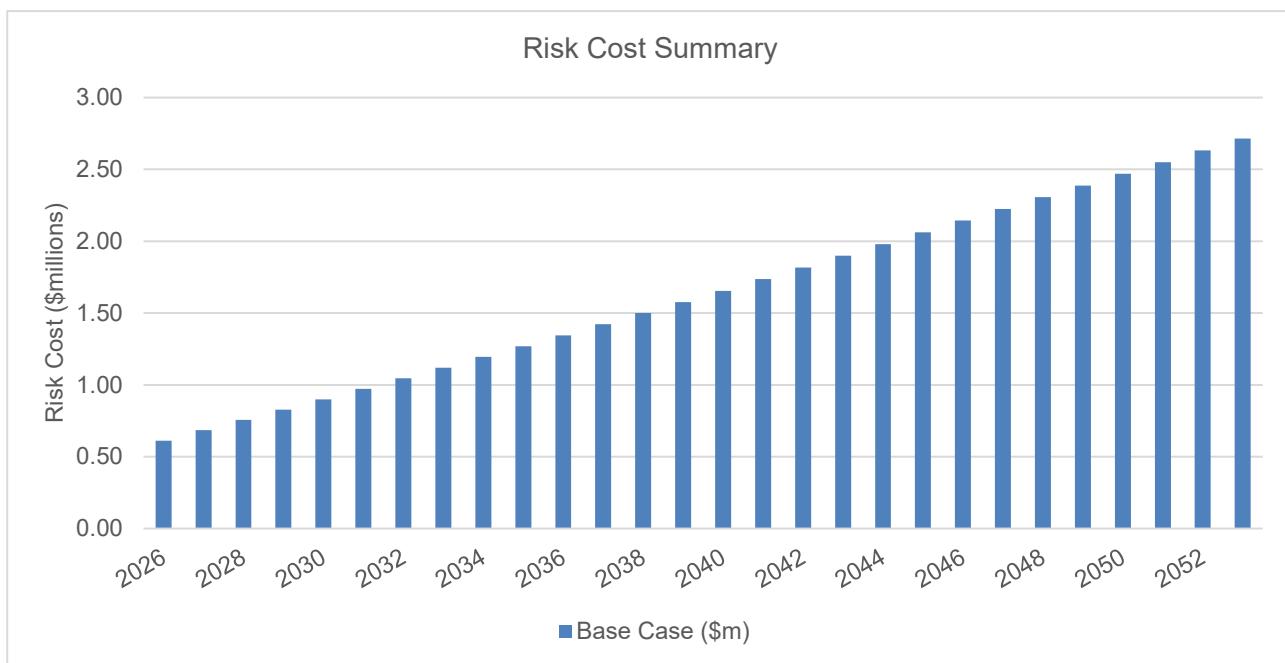
Figure 1: Total risk cost

Risk costs associated with the equipment in scope are expected to increase from \$0.61 million in 2026 to \$1.35 million in 2036 and \$2.15 million by 2046. Key highlights of the analysis include:

- Financial risks forms approximately 96% of the base case risk. Of this, the majority is a result of peaceful failures modes.
- Network risk and safety risk accounts for approximately 2% and 2% of the total risk, and environmental risk is zero for this project.

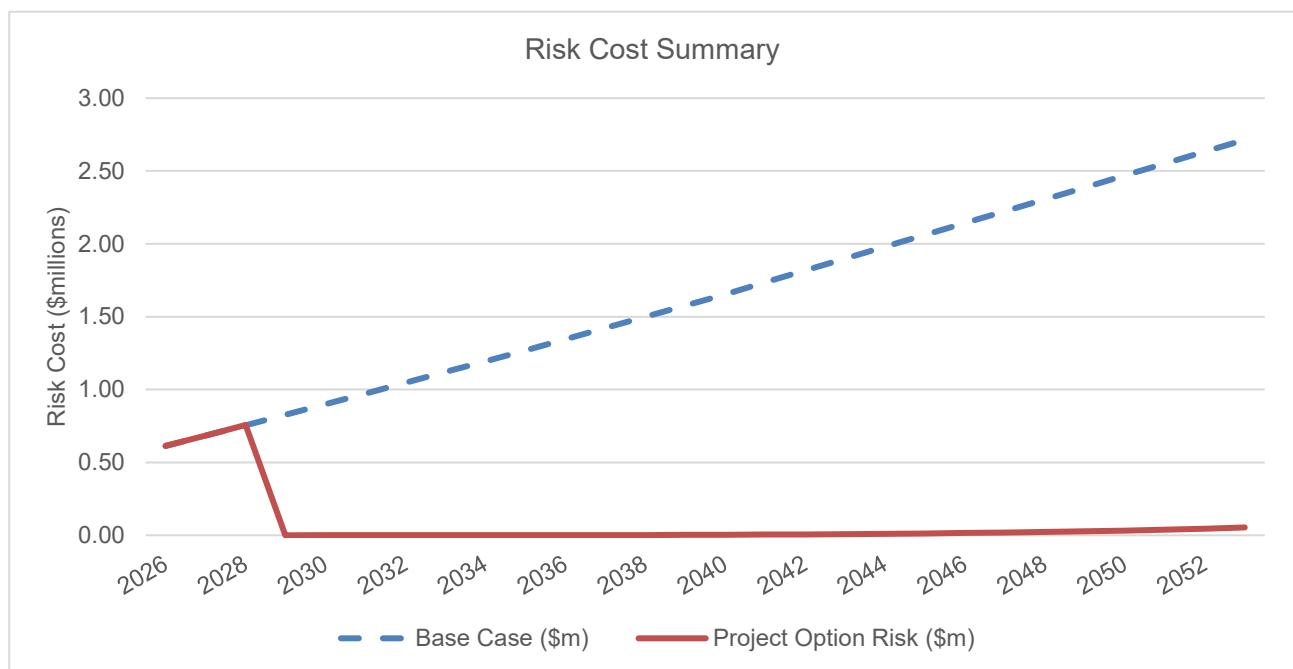
Figure 3: Project Option Risk Cost (compared to base case)

Following the year of investment (2028) the risk cost associated with the equipment in scope reduces close to \$0. By 2041, the risk cost of the project option is approximately \$.01 million, compared with the base case risk cost of \$1.74 million.
