Powerlink 2027-32 Revenue Proposal

CP.03144 Chalumbin 132kV Substation Reinvestment

SITE CONDITION ASSESSMENT REPORT

H032 Chalumbin

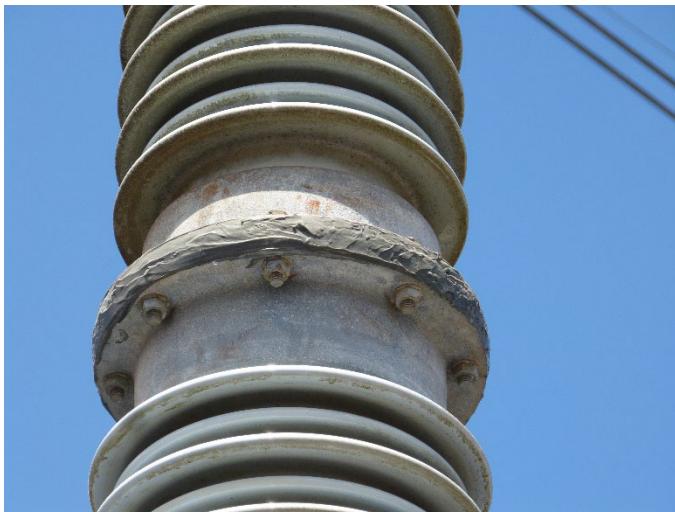
ABB HPL300 circuit breaker 5032 is in service for 30 years and started to develop notable gas leaks in 2014 and has been topped up with gas at least once a year since then. There is no on line SF6 leak rate monitoring for this circuit breaker (CB). Powerpatch was applied to try to stop gas leak.

Figure 6 – 5032- Repair (Belzona) applied

Considering that leaks are slow, but persistent and a number of times this CB has been topped up with SF6 gas, it is expected that condition of this CB will continue to deteriorate and will require high maintenance. Rectification works have been unsuccessful in stopping the leaks and multiple low SF6 alarms have occurred in the past 5 years. Two pole discrepancy trips have also occurred in the previous 5 years which have required rectification works both times. Although replacement is not considered urgent, it is considered to be eminent and therefore it is recommended to replace this CB 5032 in the next 5 years. Considering the fleet of this CBs, the fleet approach should be developed and when prioritisation of this CB replacement, the difficulty of obtaining prolonged outages and network consequence of such outages should be considered.

There are 44 circuit breakers of this type in service currently and 18 of these have developed gas leaks at various levels and at least four poles had to be replaced. There are only two spare poles available in stock and refurbishing/repairing these CBs has not proven to be cost effective. The recommended strategy for these ASEA CBs is to replace those that are already leaking and recover good poles of replaced CBs to increase spare holdings to assist in managing others in the fleet.

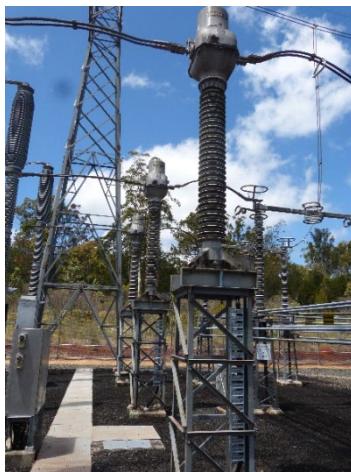
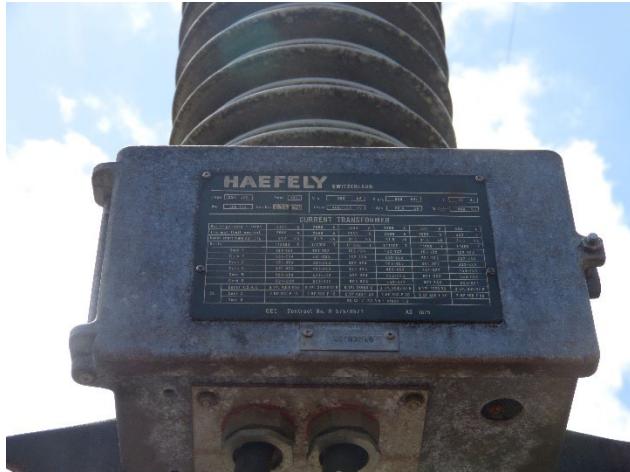
Figure 8 –CTs

The Haefely oil filled current transformers (CTs) are in reasonable condition considering they have been in service for 30 years and the DGA/moisture in oil analysis is satisfactory. There are no identified issues with oil seal integrity. Considering their age and the fact these have porcelain housing, leading to a high consequence in case of catastrophic failures, it is recommended to replace these in 5 years. This way the replacement of CTs can be combined with replacement of circuit breaker in this bay, reducing the impact of outage on the network.

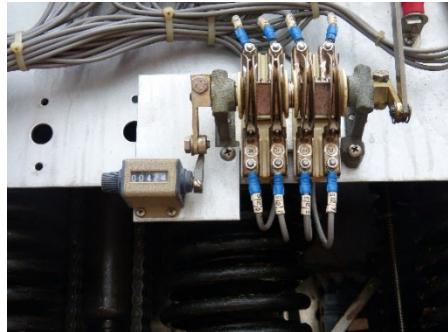
Figure 10– CB71662

This bay was established in 1989, so majority of the high voltage equipment in this bay have been in service for just over 30 years. In 2015, the small oil leak was noticed from circuit breaker and few smaller parts of it had to be replaced, indicating that aging process has started. In addition there is a well-developed corrosion of various parts of earth switches and disconnectors. In 2016 all three CVTs failed in service (high moisture content in base box) and were replaced using CVTs manufactured in 2008. As obvious from Figure 11 A phase has bottom of base tank heavily corroded. It is presumed that tank is made of aluminium so the source of corrosion could be hold down bolts.

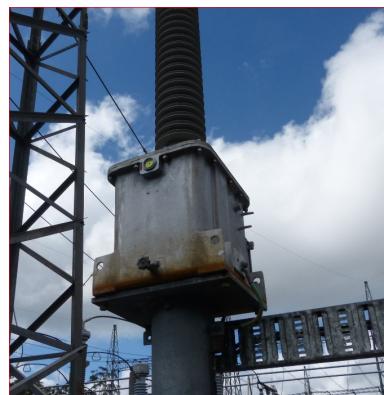
Figure 11 - CVT corrosion

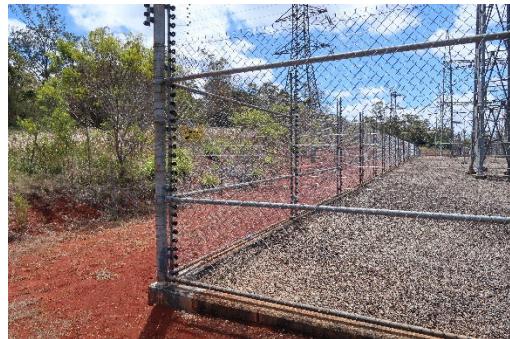
Figure 15 –Substation security fence

The substation security fence consists of a standard chain wire fence and an electric fence mounted on the inside of the chain wire fence, installed in 2017. The chain wire fence is approximately 2.4m tall and has a bottom rail and an additional rail at approximately one metre above the ground. It is estimated that both chain wire and electric fence should last until 2032. Then it should be replaced to suit new substation security standard.

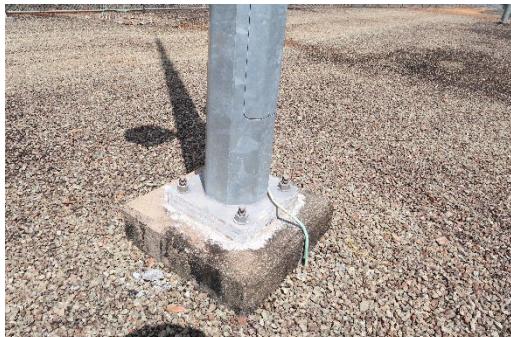
Figure 16 – Gravel and unmarked internal roadways

The substation platform is covered in gravel and is generally well maintained. No surface water pooling was observed on the platform. However, identifying any drainage issues was unlikely as the inspection occurred in dry weather.

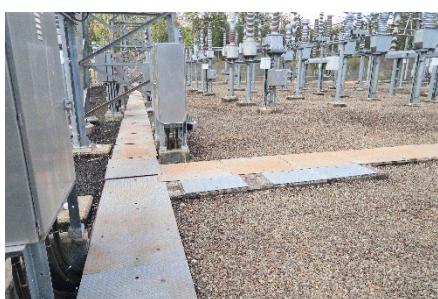
Figure 17 – Cable trenches

There is no indication in the maintenance records of any issues related to the cable trench covers. The cable ducts and the associated cable covers were in good condition and the covers were neatly placed without significant gaps that could present a tripping hazard.

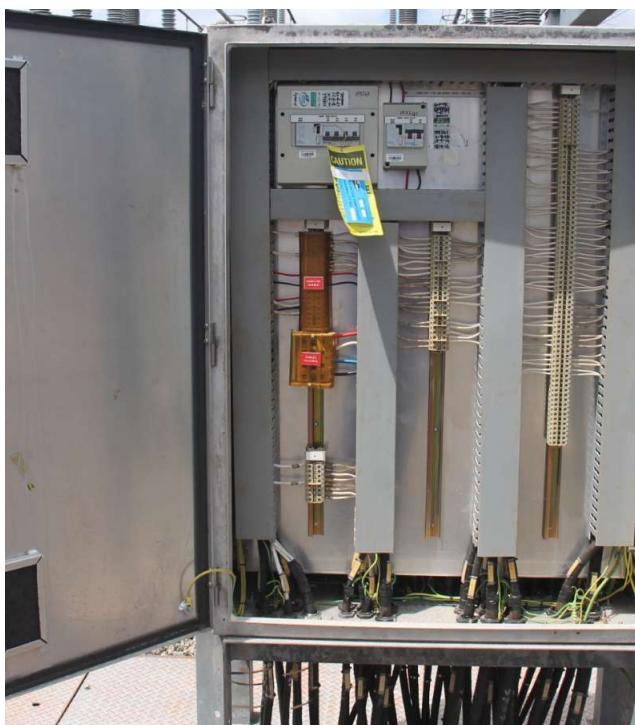
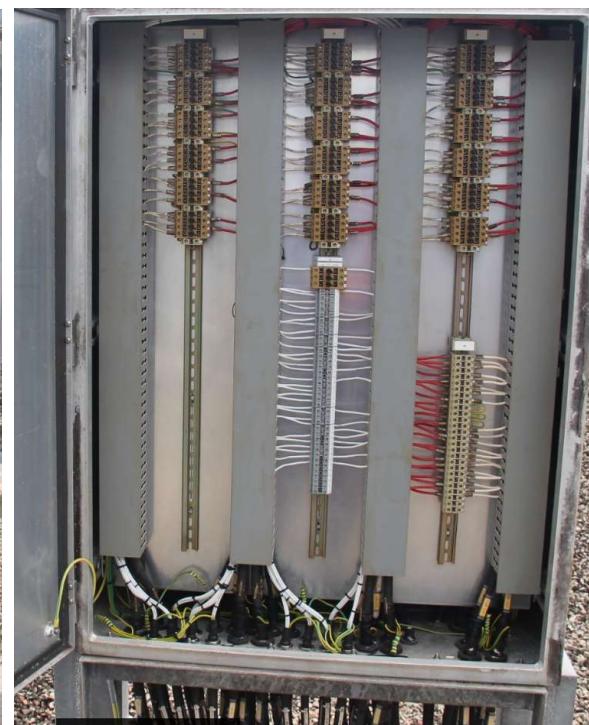
275kV Feeder 857 bay marshalling kiosk

Marshalling kiosks and VT boxes for 275kV feeder 857, 858 and 877 were installed between 2003 and 2004. Marshalling kiosks are in fair condition and there is no condition driven replacement until 2043/2044. VT boxes utilise fuses to protect the circuitry. Fuses do not provide safety and monitoring features and make the event investigation more difficult. Maintenance on these fuses is expensive. These fuses should be replaced with MCBs to improve the performance of circuitries according to current design standard with major secondary system replacement.

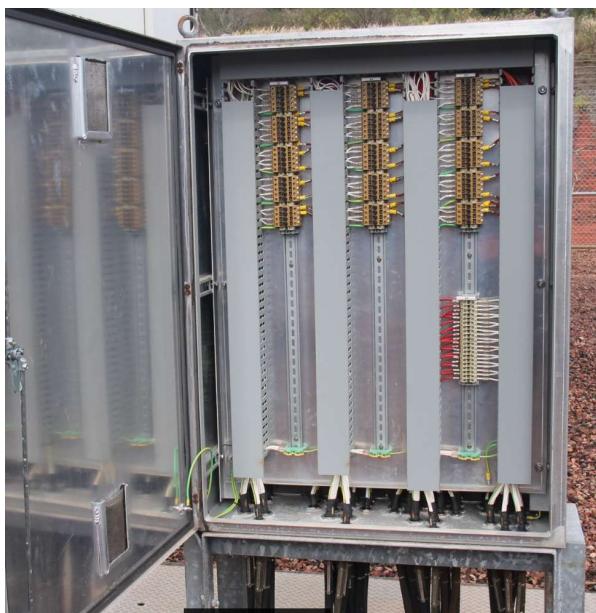
275kV Feeder 876 bay marshalling kiosk

Marshalling kiosks and VT boxes for 275kV feeder 876 were installed in 2007 and are in good condition. There are no condition-driven required replacement until 2047.

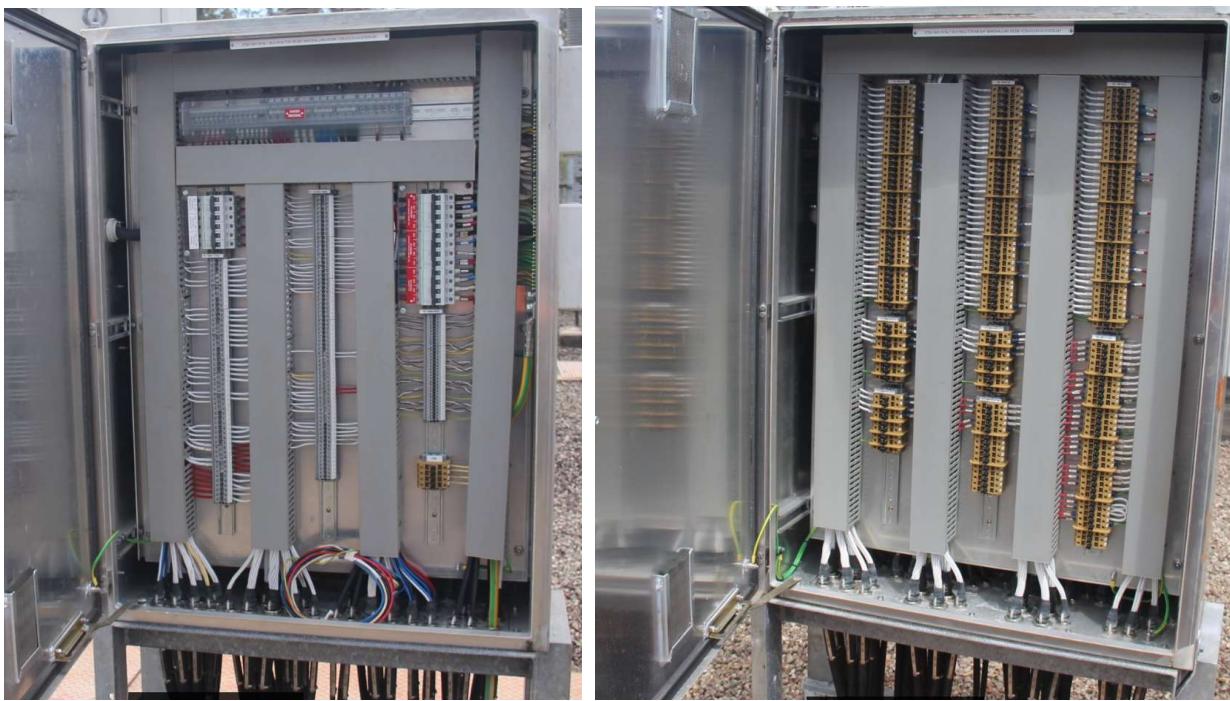
275kV bus reactor 5 bay marshalling kiosk

Marshalling kiosks for 275kV bus reactor 5 were installed in 2012/2013 and are in good condition. There are no condition-driven required replacement until 2052.

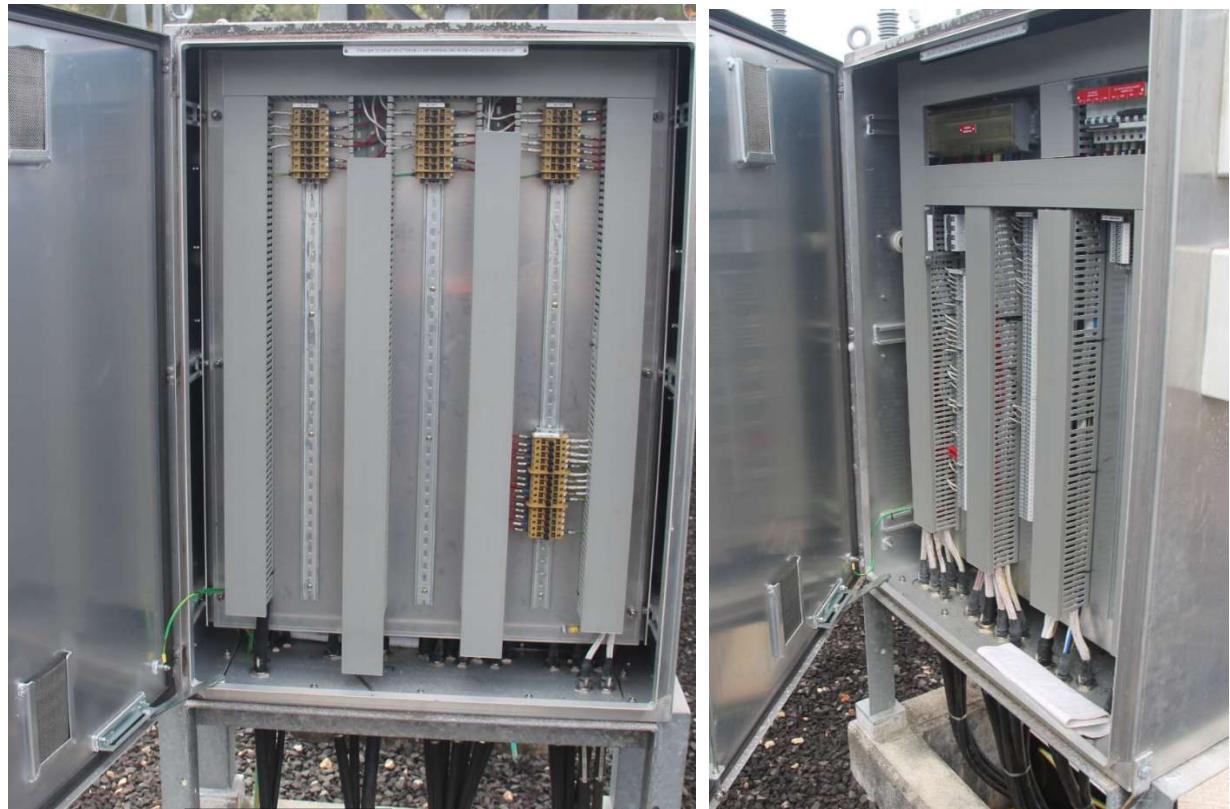
275kV Feeder 857 reactor marshalling kiosk

Marshalling kiosks for 275kV Feeder 857 and 858 reactor were replaced in 2011/2012 and are in good condition. There are no condition-driven required replacement until 2051.

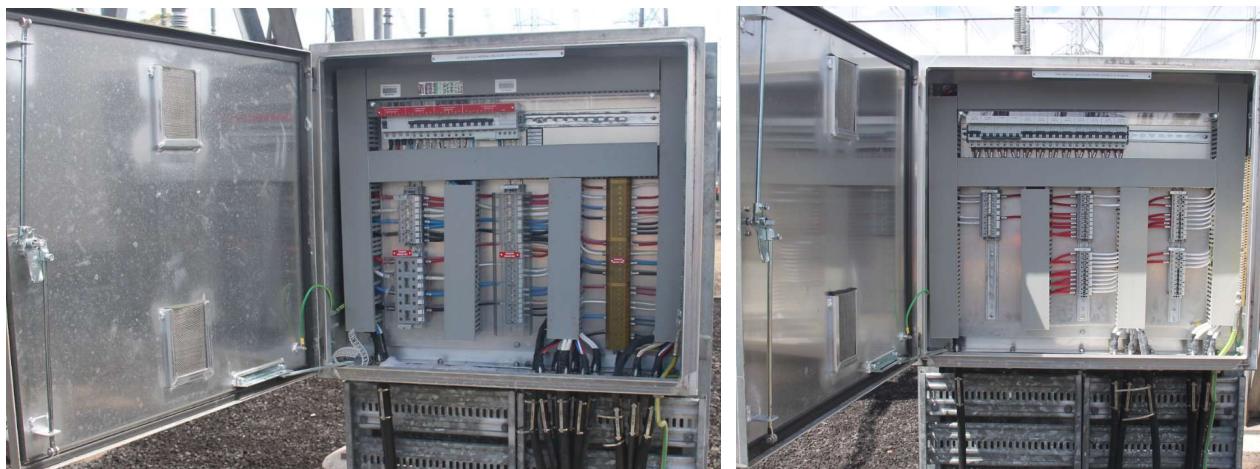
275kV =C03 AC and DC marshalling kiosk

Auxiliary kiosks for 275kV diameter =C03, =C04 and =C05 were commissioned/replaced between 2011/2012. Marshalling kiosks and associated cables are in good condition. There are no condition driven replacement required until 2051.

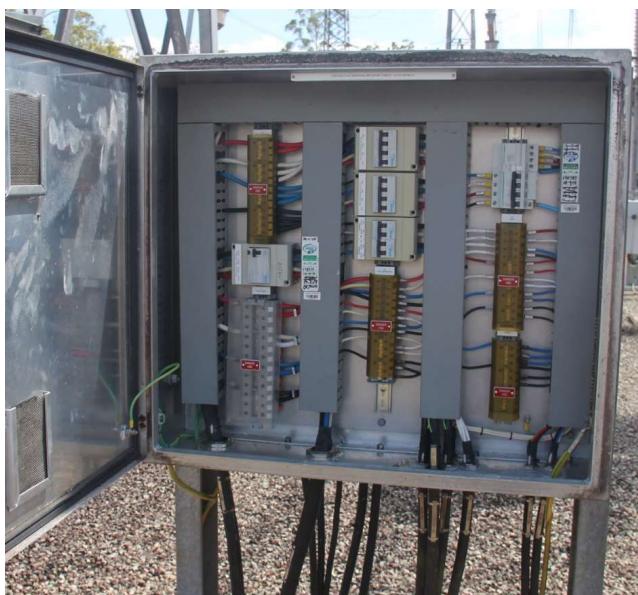
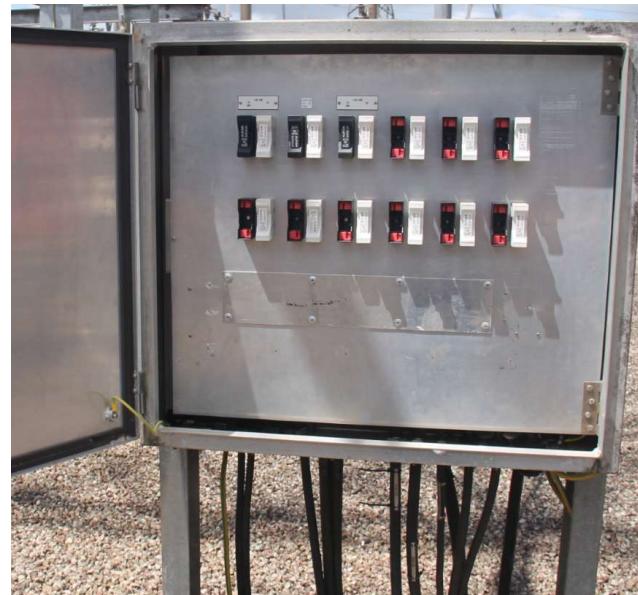
275kV =C06 AC and DC marshalling kiosk

AC marshalling kiosk for 275kV diameter =C06 was commissioned in 2007. Marshalling kiosks and associated cables are in fair condition. There are no condition driven replacement required until 2041. The DC marshalling kiosk for diameter =C06 was installed in 2003. Associated fuses do not provide safety and monitoring features and make the event investigation more difficult.

Maintenance on these fuses is expensive. These fuses should be replaced with MCBs to improve the performance of circuitries according to current design standard with major secondary system replacement.

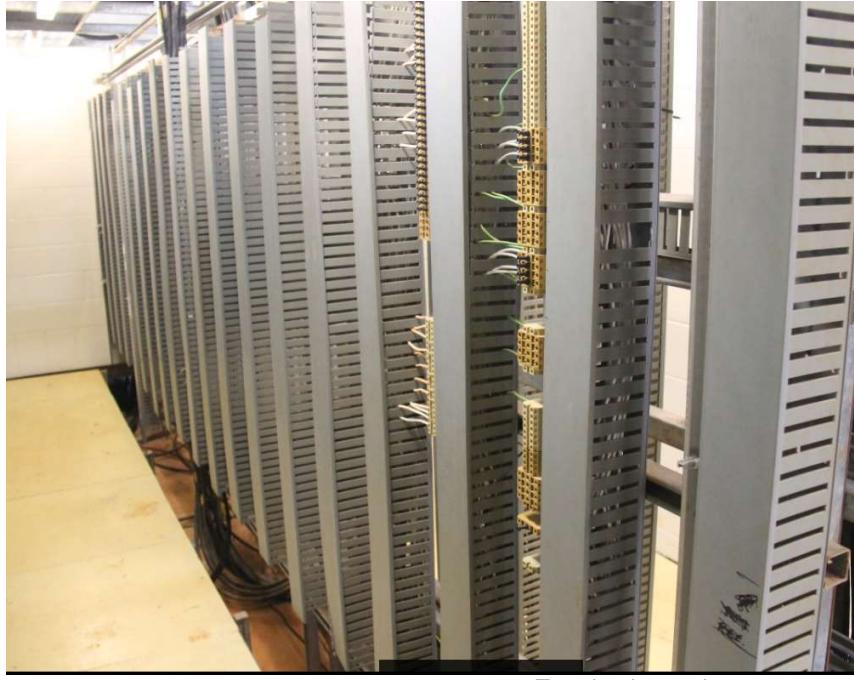
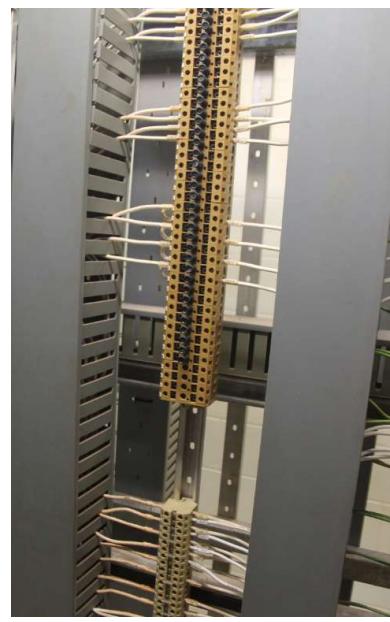
It is a cable termination rack arrangement in Building +1 at H032 Chalumbin. But majority of control cables up to the marshalling kiosks have been wired directly to the protection and control panels and haven't been terminated via the terminal racks. The floor and support structure are intact. Termination racks were built in 1988 and old terminals need to be replaced if these rack are utilised for future secondary system replacement.

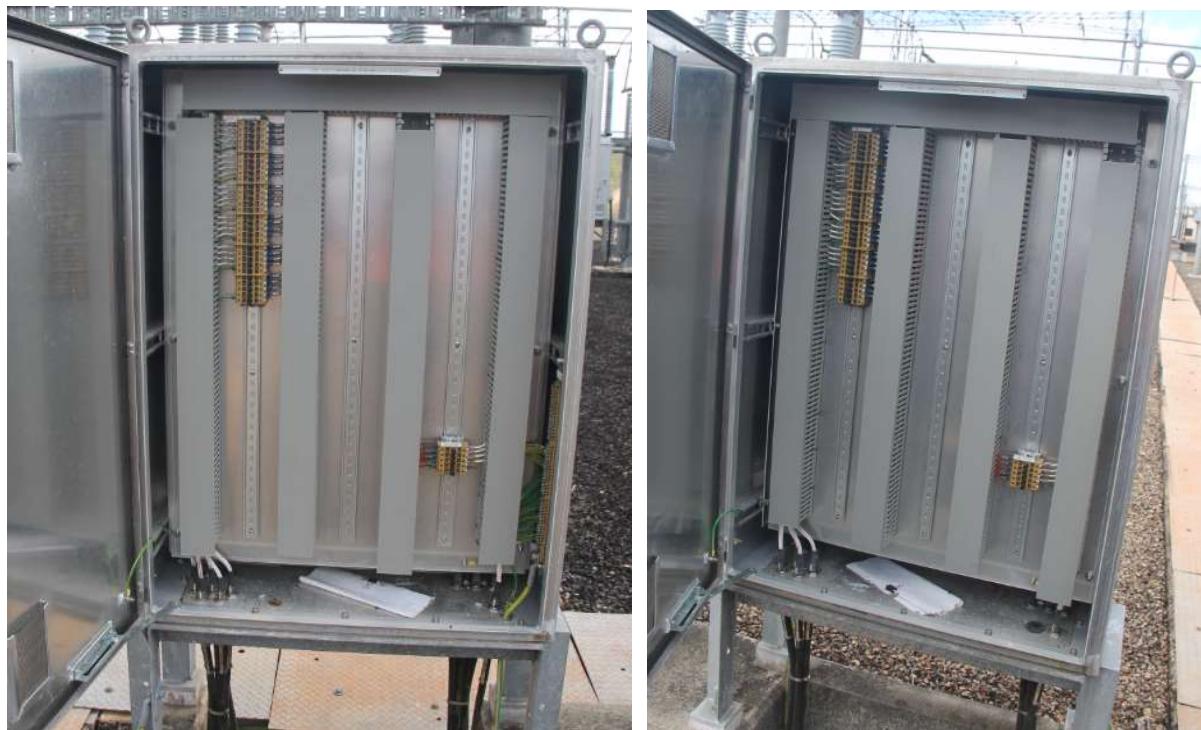
132kV 1 Bus CT marshalling kiosk

132kV bus and bus coupler marshalling kiosks (including VT boxes) were replaced under CP.01566 Chalumbin secondary system replacement in 2011. These kiosks and associated

control cables are in good condition and there are no condition-driven replacements required until 2051.

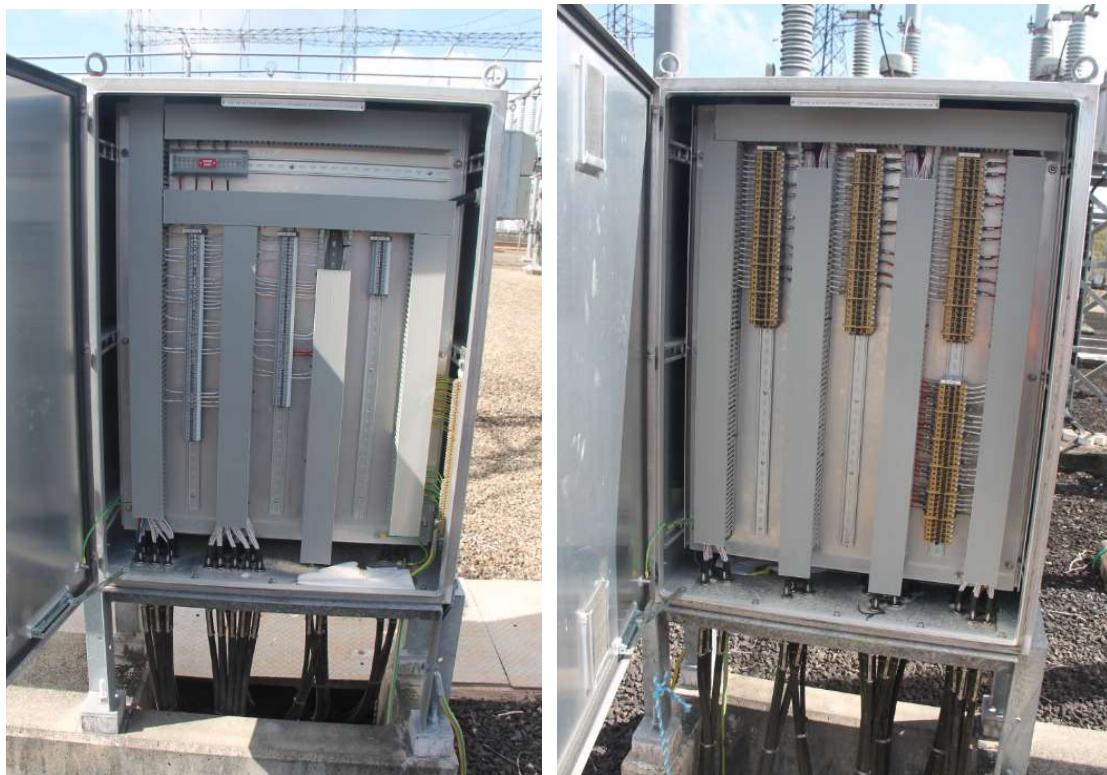
132kV Bay =D04 1 Transformer LV bay marshalling kiosk

Marshalling kiosks and VT boxes of 1 and 2 Transformer LV were replaced under CP.01566 Chalumbin secondary system replacement in 2011. These kiosks and associated control cables are in good condition and there are no condition-driven replacements required until 2051.

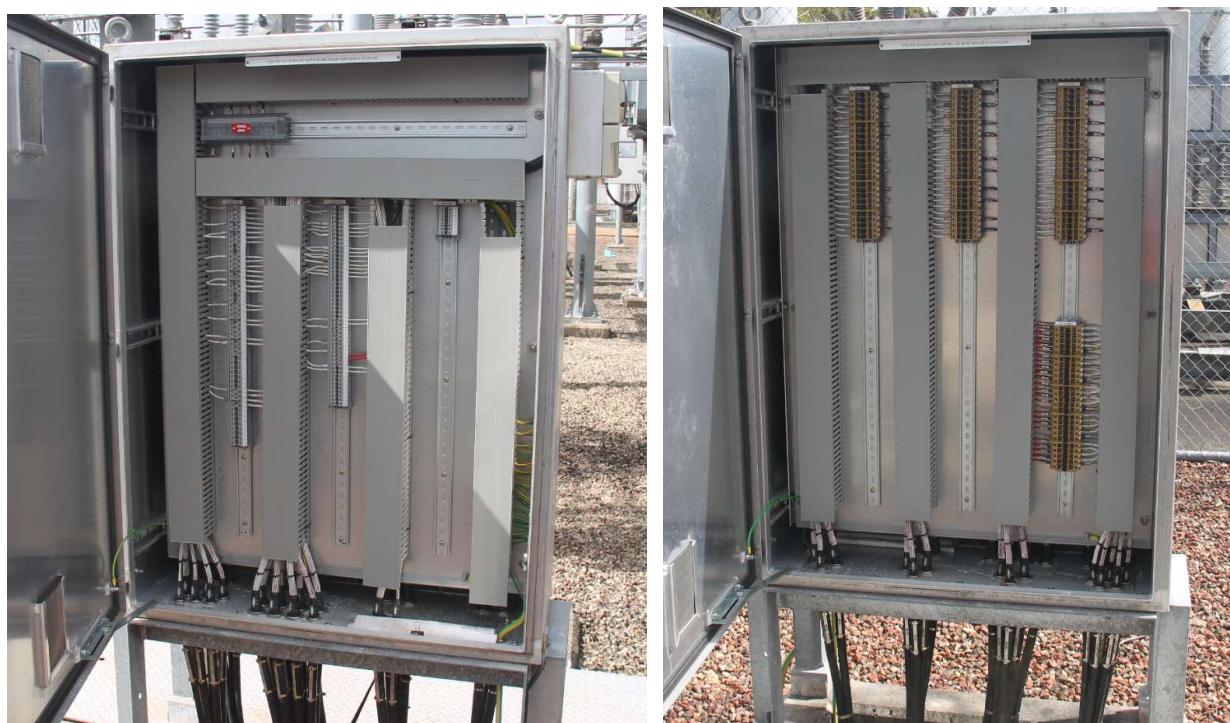
132kV Bay =D08 Feeder 7165 bay marshalling kiosk

Marshalling kiosks and VT boxes for feeder bay =D08, =D07, =D05 and =D06 were replaced under CP.01566 Chalumbin secondary system replacement in 2011. These kiosks and associated control cables are in good condition and there are no condition-driven replacements required until 2051.

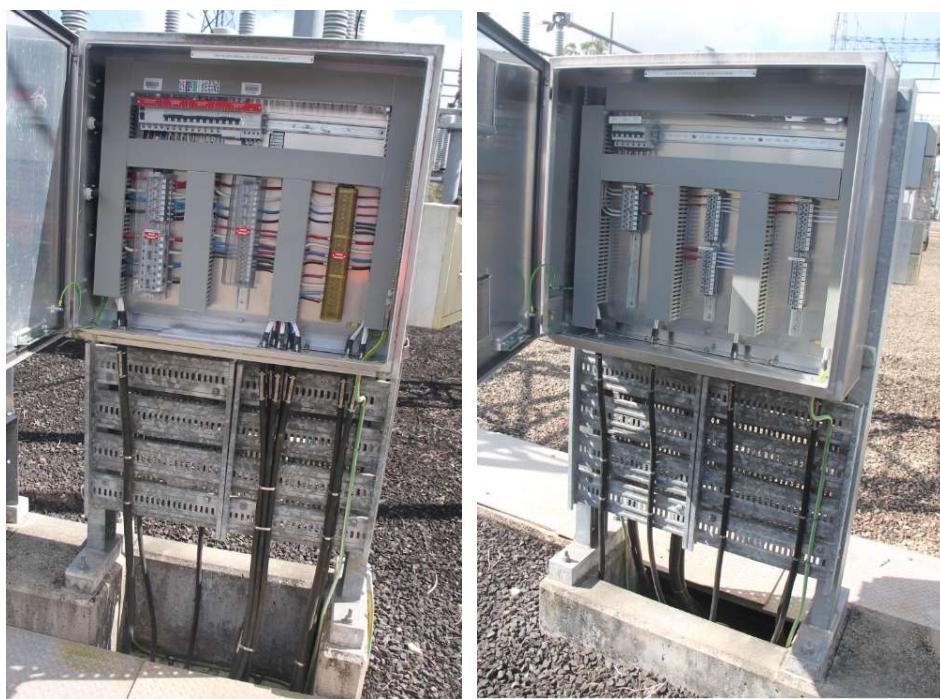
132kV Bay =D04 AC and DC marshalling kiosks

AC/DC marshalling kiosks for 132kV bay =D04, =D06 and =D08 and marshalling kiosks for 1 CAP and 1T shunt reactor were replaced under CP.01566 Chalumbin secondary system replacement in 2011. These kiosks and associated control cables are in good condition and there are no condition-driven replacements required until 2051.

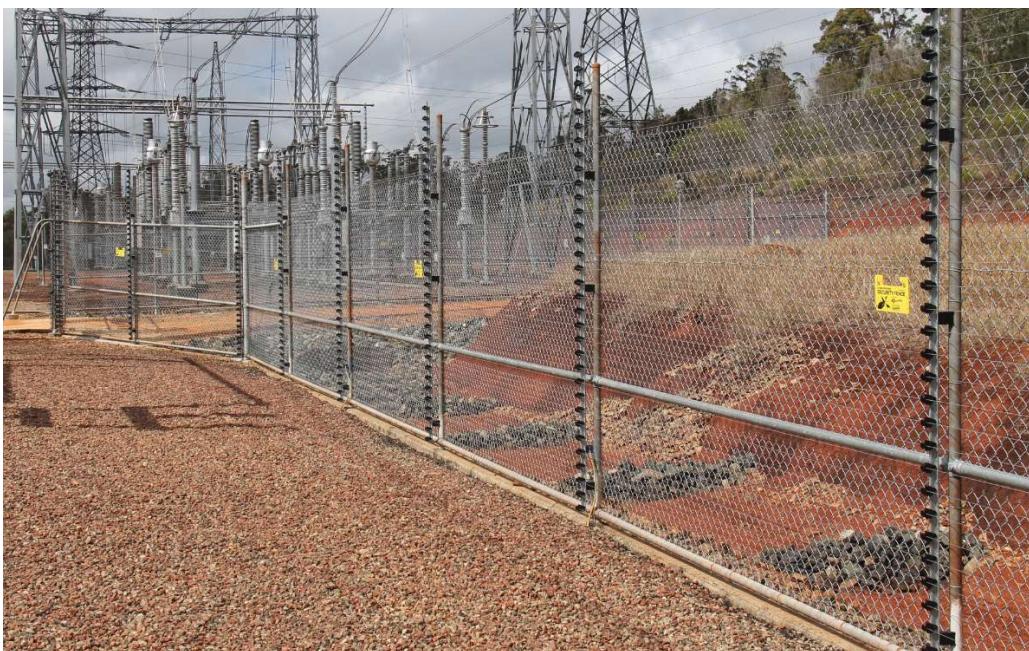
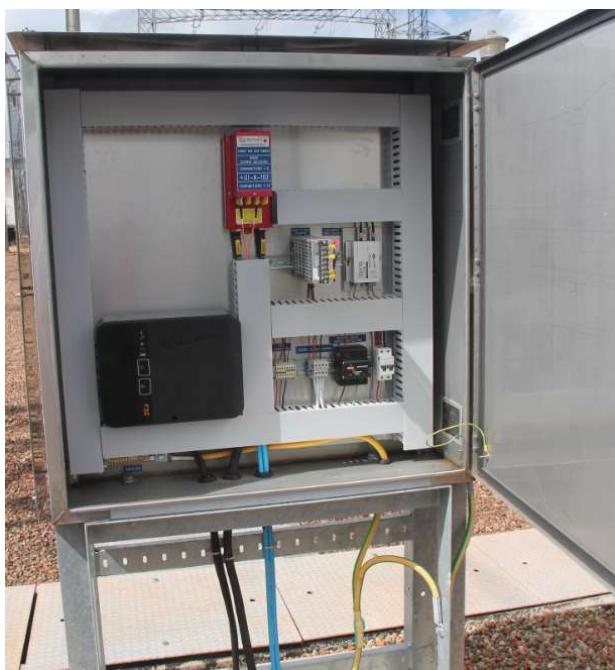
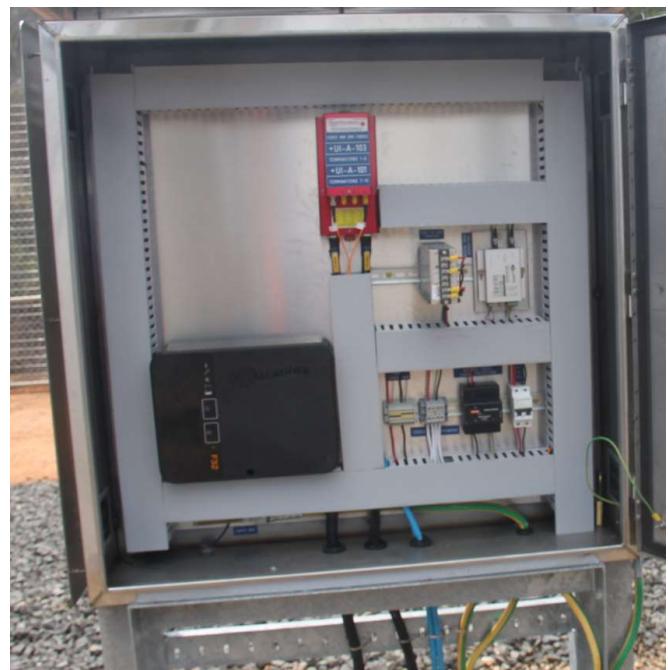
Electric fence and associated control cubicle

Electrical fence was installed at H032 Chalumbin in 2017 and associated control cubicles are in good condition.

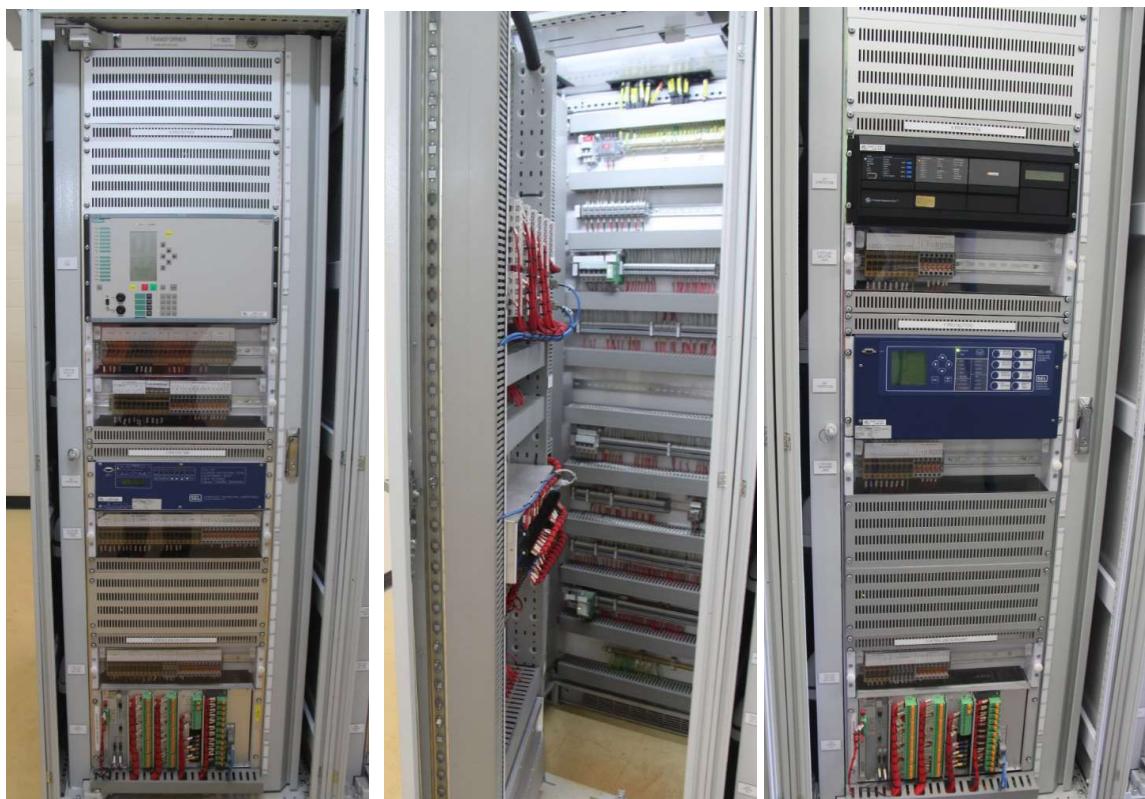
1 Transformer 275/132kV protection and control panel

Protection and control equipment including the panel for 1& 2 275/132kV transformer were replacement under CP.01566 Chalumbin secondary system replacement in 2013. These secondary systems are in good condition. Health index indicate that there are no condition-driven replacements required until 2033.

- Replace all secondary systems for 275kV coupler 503 and 504
- Replace all secondary systems for 275/132kV 1T and 2T
- Replace all secondary systems for 275kV bus reactor
- Replace all secondary systems for 275kV Feeder 857 reactor
- Replace all secondary systems for 275kV Feeder 858 reactor
- Replace all secondary systems for 132kV 1 and 2 Bus
- Replace all secondary systems for 132kV bus coupler
- Replace all secondary systems for 132kV feeder 7165
- Replace all secondary systems for 132kV feeder 7166
- Replace all secondary systems for 132kV feeder 7191
- Replace all secondary systems for 132kV feeder 7192
- Replace all secondary systems for 132kV 1 Cap
- Replace all secondary systems for 1T 19kV Reactor
- Replace SCADA RTU [REDACTED] and common RTUs [REDACTED] in building +1 and +4
- Replace the TWS fault locator
- Replace [REDACTED] GPS clock in building +4

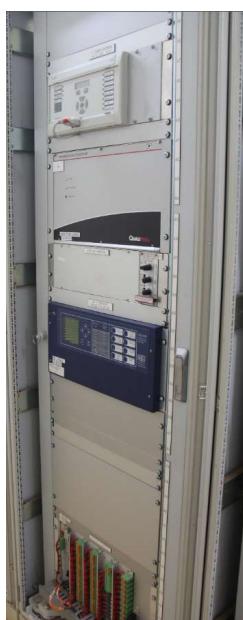
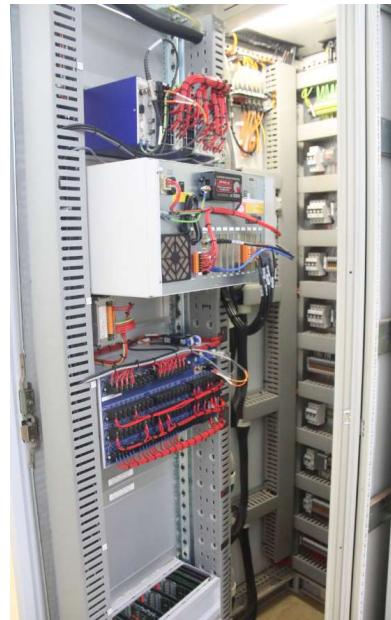
Feeder 857 protection and control panel

Majority of protection and control equipment (except [REDACTED] for feeders 857 and 858 were commissioned between 2005 and 2006. These devices have become obsolete and manufacturers have ceased the support. Health index shows that they will reach the end of technical asset life and need to be replaced between 2025 and 2026.

- Replace all fuses with MCBs for Feeder 857 and 858 VT boxes
- Replace protection and control equipment for Feeder 857 and update the protection and control panel according to SU0020
- Replace protection and control equipment for Feeder 858 and update the protection and control panel according to SU0020
- Replace protection and control equipment for Feeder 876 and update the protection and control panel according to SU0020
- Replace dual 48VDC battery and associated chargers in Building +1

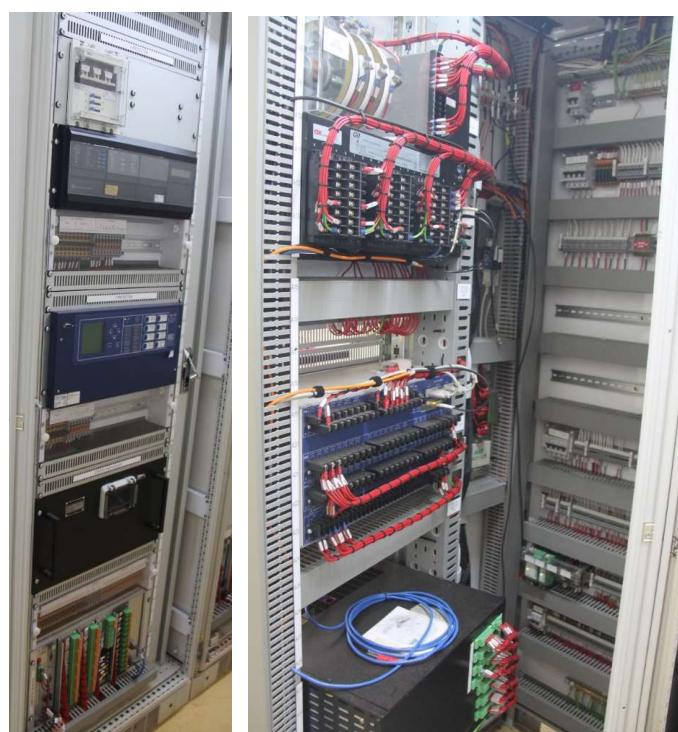
275kV Bus reactor protection and control panel

High Impedance [REDACTED] and CB management relay [REDACTED] and [REDACTED] are used to protect 275kV bus reactor, Feeder 857 and 858 reactor and mounted on a swing frame panel. These relays have been providing reliable services. There are no condition-driven replacements required until 2034.

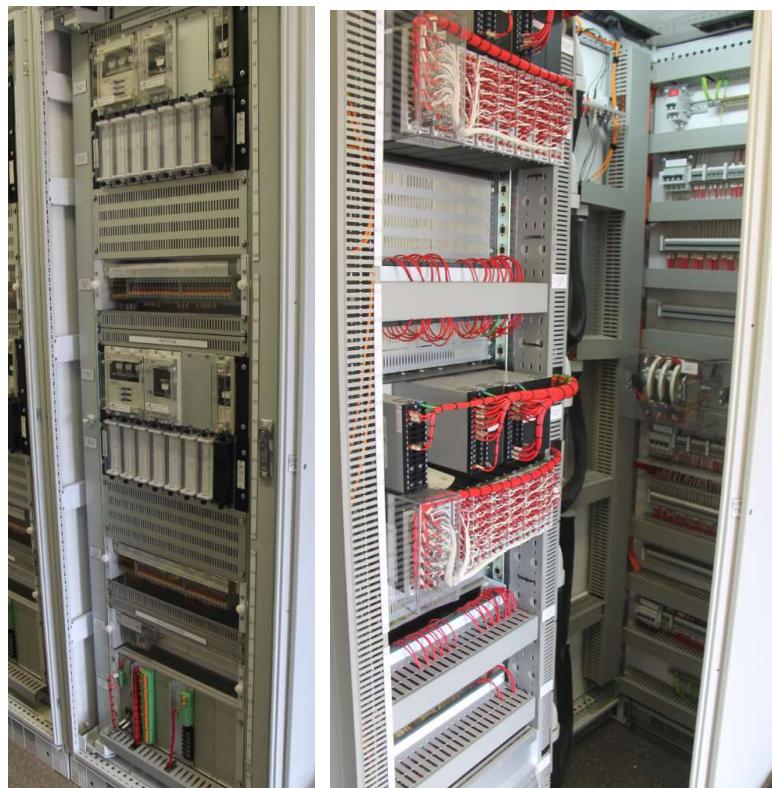
132kV 1 Bus zone protection and control panel

Secondary systems for 132kV bus zones and the bus coupler were replaced under CP.01566 Chalumbin secondary system replacement between 2012 and 2013. They are in good condition. There are no condition-driven replacements required until 2032.

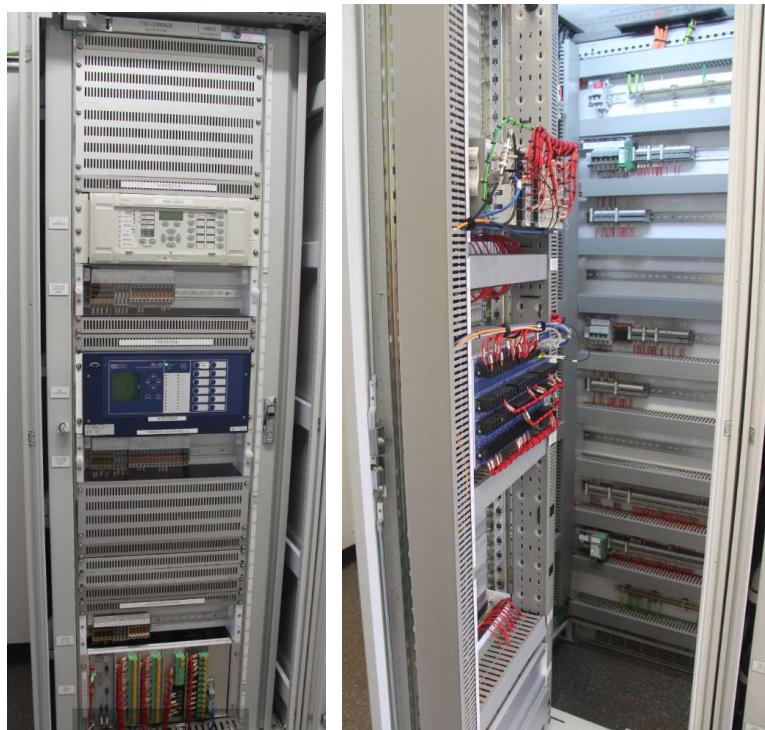
Feeder 7165 protection and control panel

Secondary systems for 132kV Feeder 7165, 7166, 7191 and 7192 were replaced under CP.01566 Chalumbin secondary system replacement between 2012 and 2013. They are in good condition. There are no condition-driven replacements required until 2032-2033.

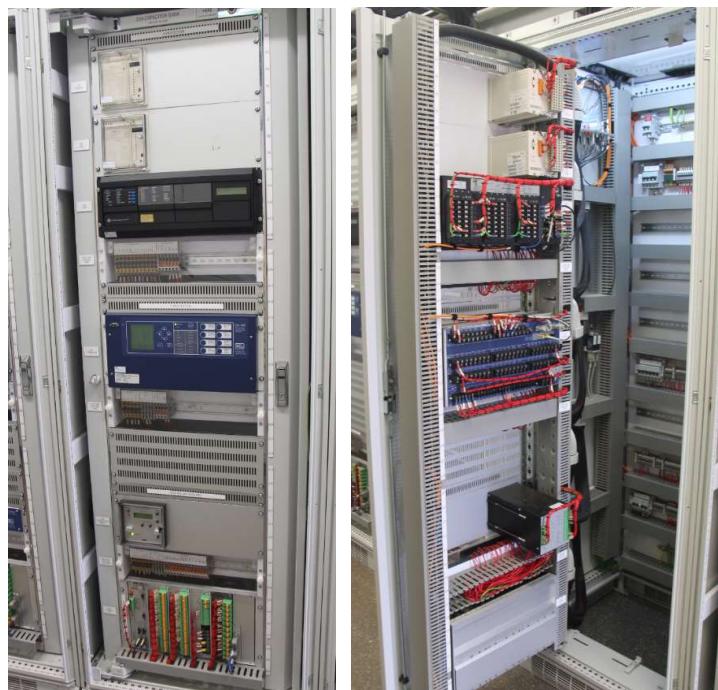
1 CAP protection and control panel

Secondary systems on 132kV 1 Capacitor bank were replaced in 2013. There are no condition-driven replacements required (except [REDACTED] O/C relay) until 2033. The O/C relay, [REDACTED] needs to be replaced in 2024 based on associated health index.

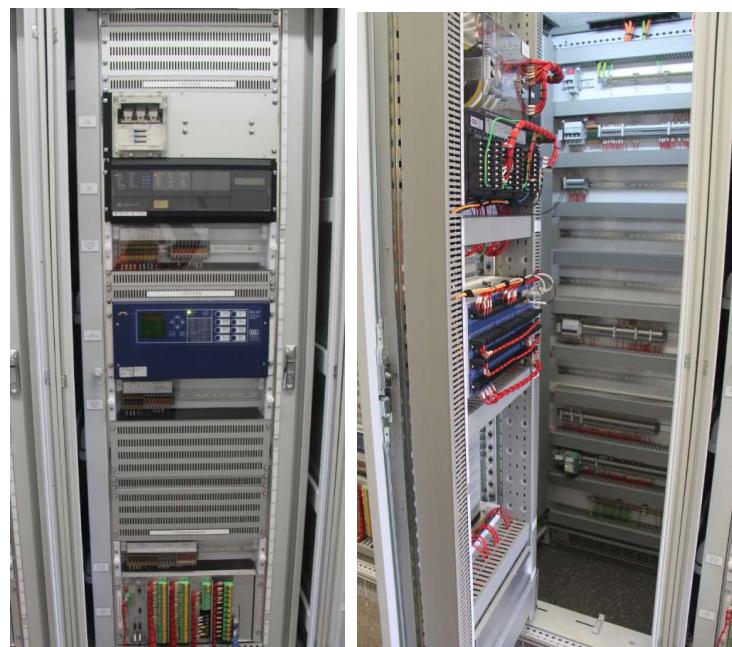
19kV Reactor protection and control panel

Secondary systems for 19kV reactor were replaced under CP.01566 Chalumbin secondary system replacement 2013. There are no condition-driven replacements required until 2033.

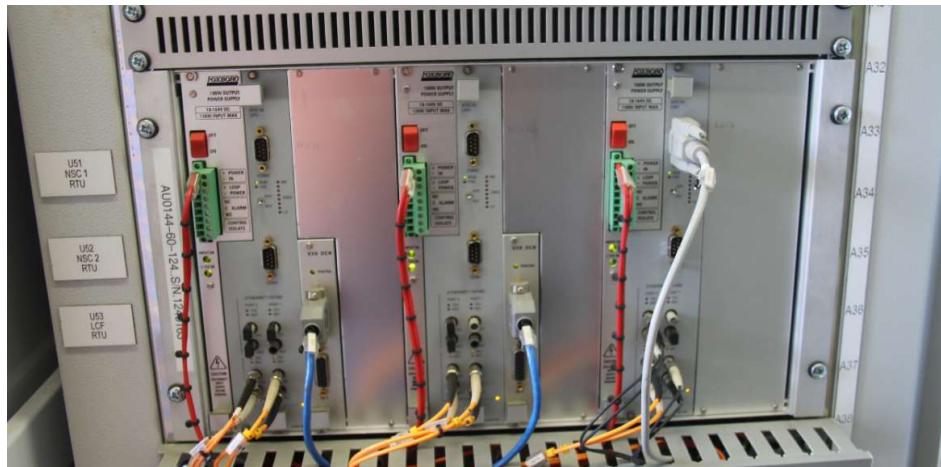
SCADA NSC1/NSC2 RTU and LCF RTU

Dedicated SCADA paths have been implemented for 275/132kV secondary systems at H032 Chalumbin. The SCADA system has independent NSC1 and NSC2 RTU to implement 2 x dual SCADA paths based on DNP serial protocol. The serial SCADA is being phased out because of expensive serial infrastructures and will be migrated to DNP over IP under major secondary system replacement.

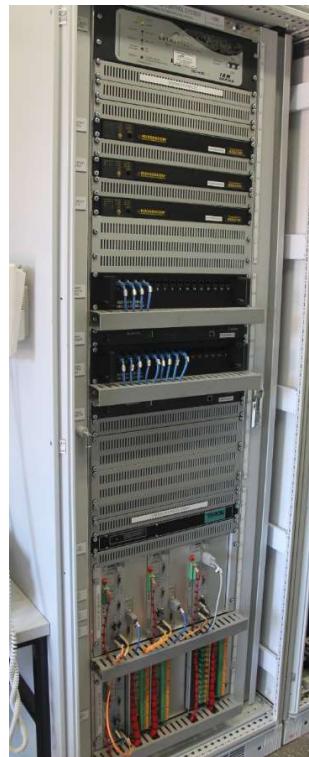
Station OpsWAN panel in Building +4

OpsWAN equipment in Building +4 was installed in 2012 and are in fair condition. Health index indicates that these equipment will reach the end of technical asset life and need to be replaced between 2024 and 2025.

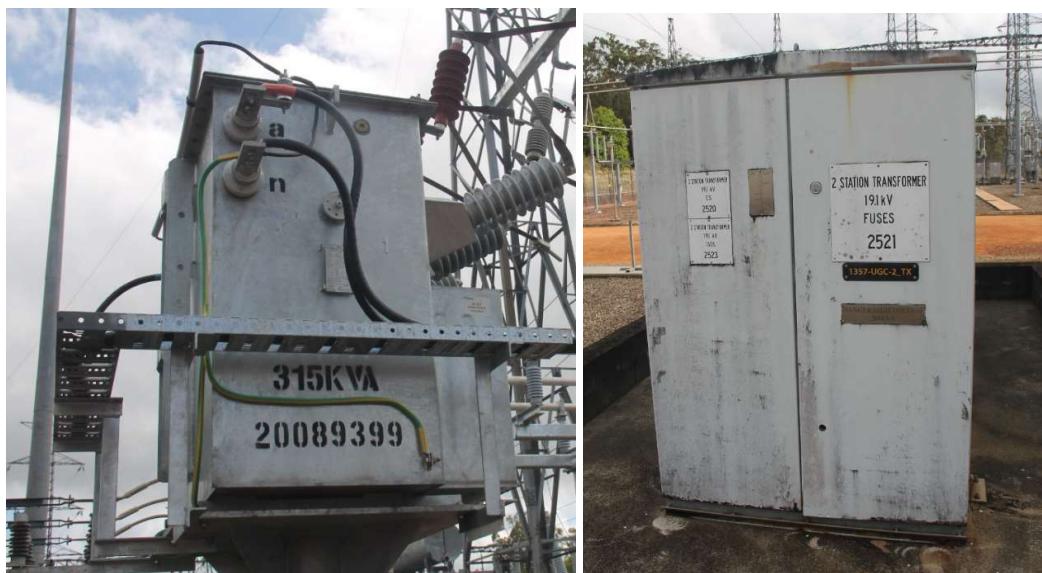
Station transformer 1 and 2

The 415VAC auxiliary supplies are derived from two Powerlink 19.1/433V 315kVA and 200kVA station transformers. Standby AC supply is from an on-site 150kVA diesel generator. Suitable monitoring and changeover arrangement are available for the site. The arrangement is considered acceptable for the situation.

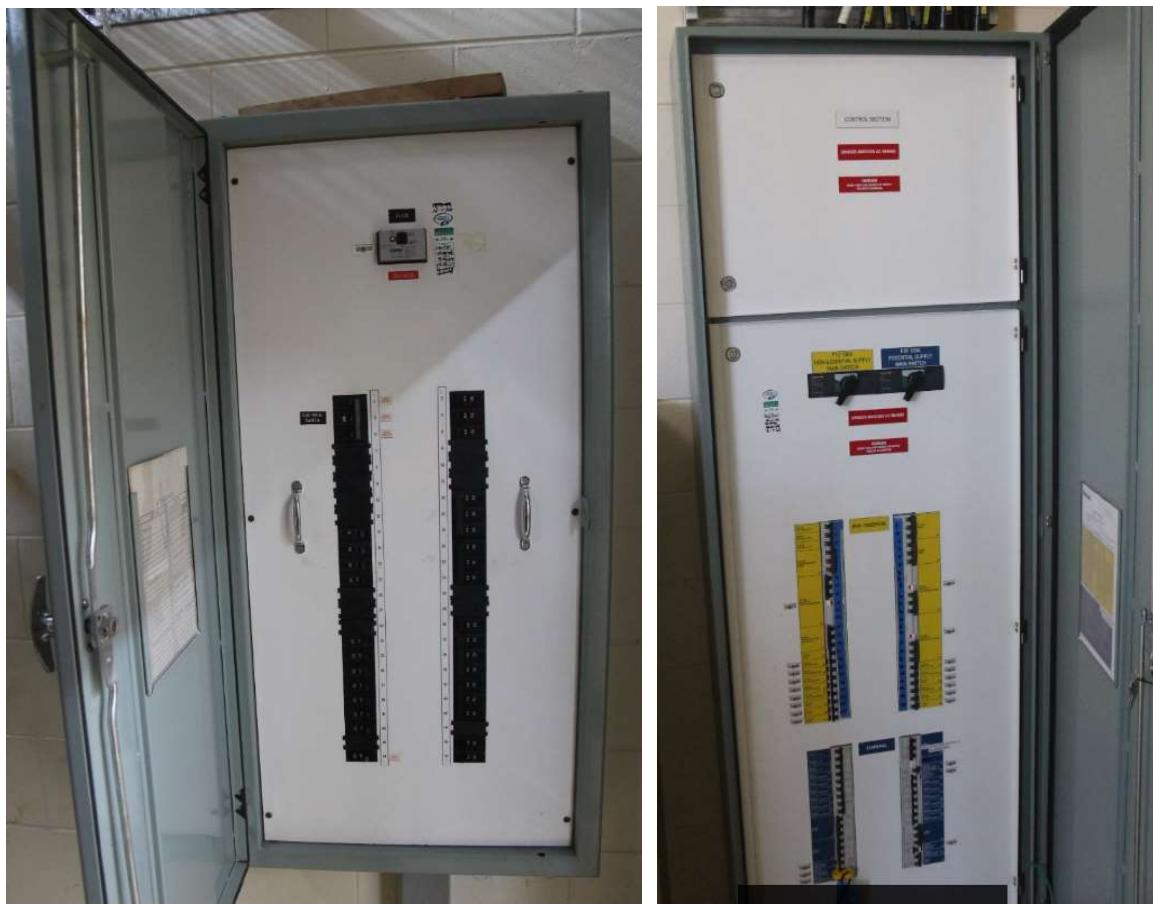
AC distribution board in Building +1

The AC distribution boards in building +1 were installed in 2012 and are in good condition.

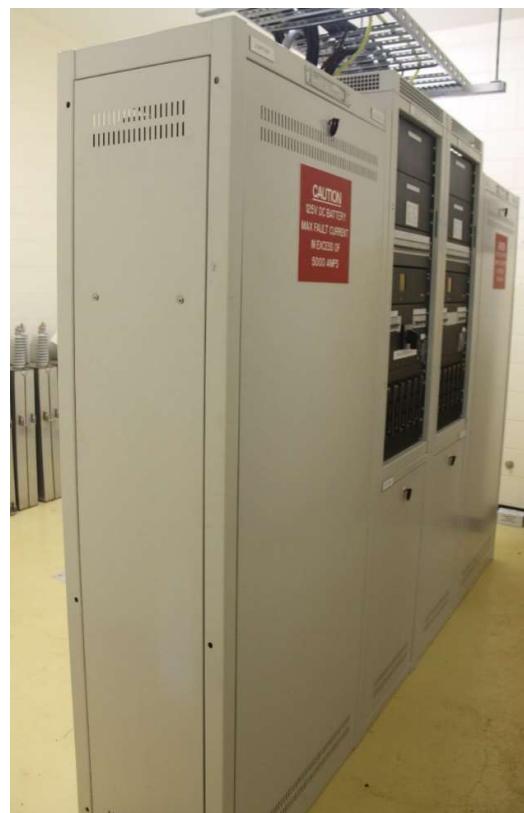
125VDC Batteries and charger

The dual 125VDC and dual 48VDC systems and associated distribution board were replaced in 2014 and 2012 respectively. There are no condition driven replacements required until 2026 and 2024.

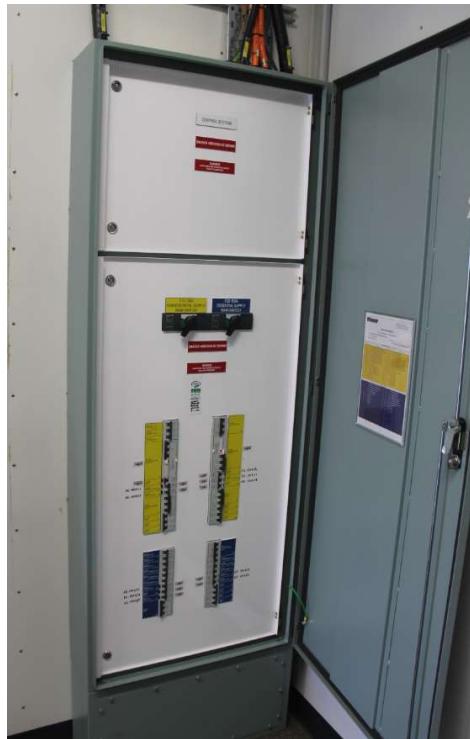
AC distribution boards in building +4

AC distribution boards and associated DC distribution boards in Building +4 were installed in 2012 and are in good condition. There are no condition driven replacements required within 10 years. Dual 125VDC will reach the end of technical asset life and need to be replaced by 2024.

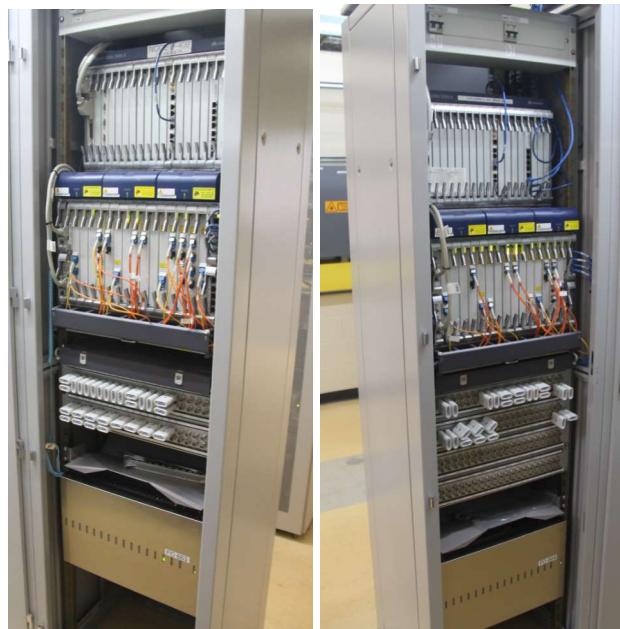
SDH and PDH at Building +1

Communication systems at H032 Chalumbin consist of fibre optic technology with Nokia PDH and Huawei SDH MUX equipment. They have been providing reliable services for protection and control systems. Nokia no longer manufacturers the PDH equipment, and support for hardware replacement is provided by AVARA.
