Powerlink 2027-32 Revenue Proposal

CP.03144 Chalumbin 132kV Substation Reinvestment

SITE CONDITION ASSESSMENT REPORT

H032 Chalumbin

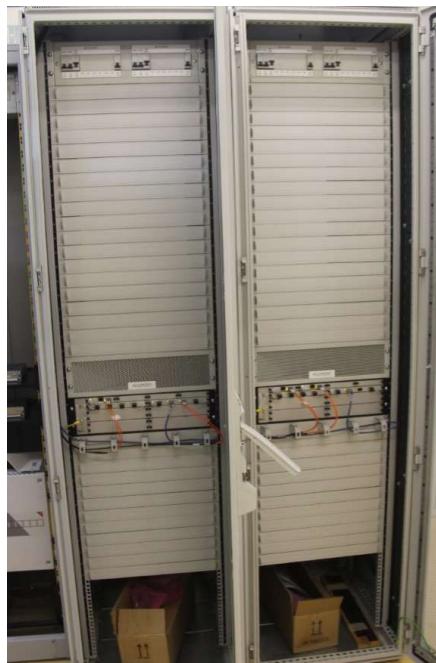
MPLS network panel

MPLS network has been installed at H032 Chalumbin substation. It can be used by future secondary systems such as SCADA and metering implementation.
