Powerlink 2027-32 Revenue Proposal

CP.03149 Newlands Transformer 1 Life Extension

T1 Transformer Condition Assessment

T069 Newlands Substation

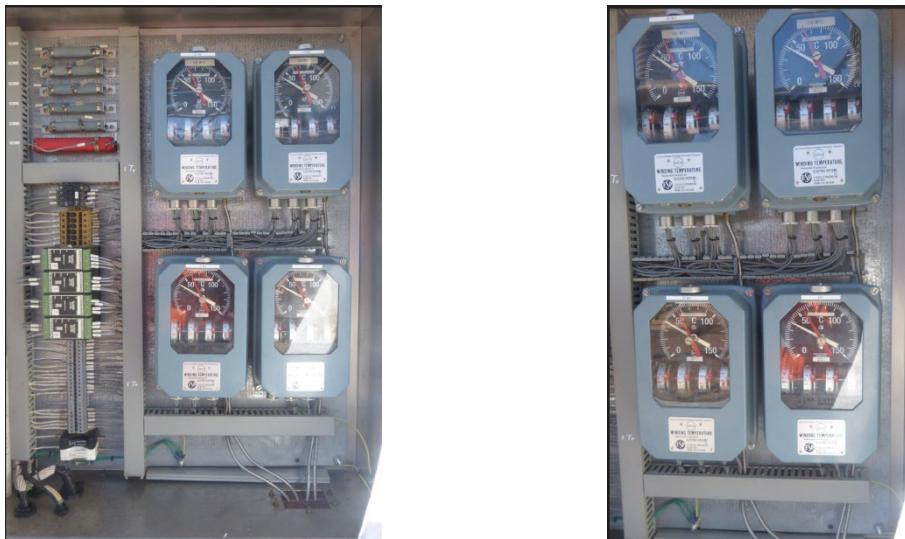
Figure 25- WTI and OTI (Installed in Shared Control Cubicle)

The temperature indication instruments were replaced in 2004 as part of project OR.00113. According to maintenance records, there have been no reported issues with temperature monitoring since the replacement. Additionally, during the site visit, all temperature sensors and associated wiring were visually inspected for physical damage, corrosion, and secure connections, with no issues detected.

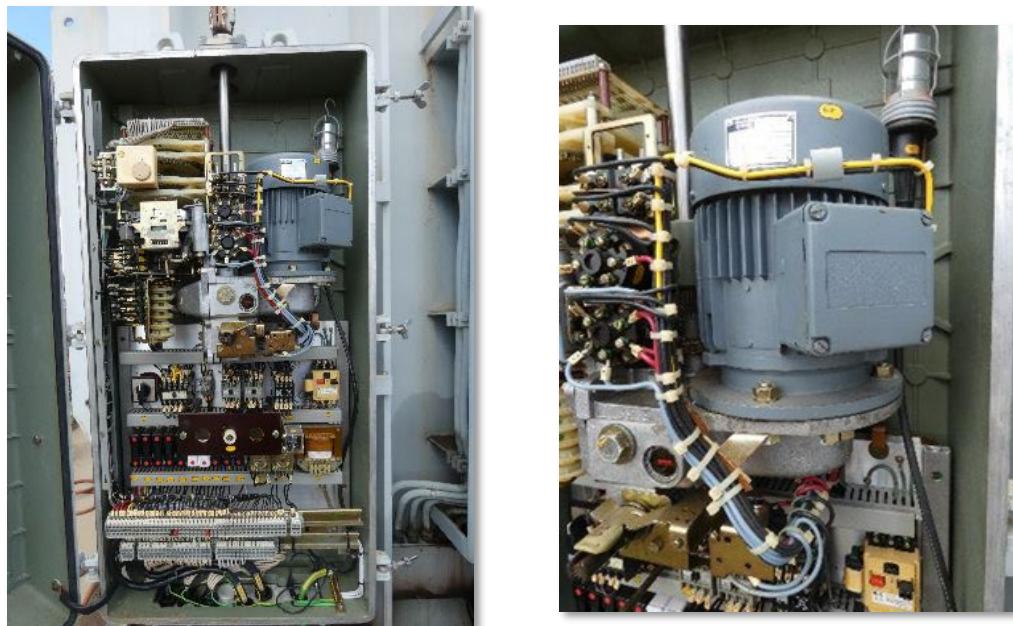
Figure 29- OLTC Control Cubicle in Good Condition

During the site visit, the tap changer control cubicle door could not be opened for an internal inspection. However, the OLTC control cubicle was inspected by OSD in October 2023, and the findings are outlined in report OSD-PSS-CA-009:

- All electrical connections within the control cubicle were observed to be in good condition
- No signs of oil leaks from the gearbox or motor drive mechanism
- There is no electrical safety barrier installed to cover the live terminals. It is required to upgrade the OLTC control cubicle to ensure compliance with AS3000 Standard.

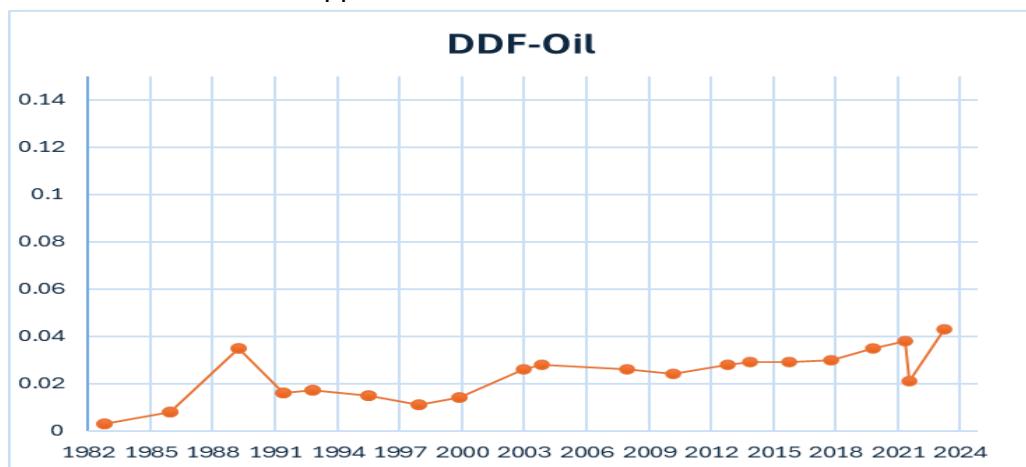
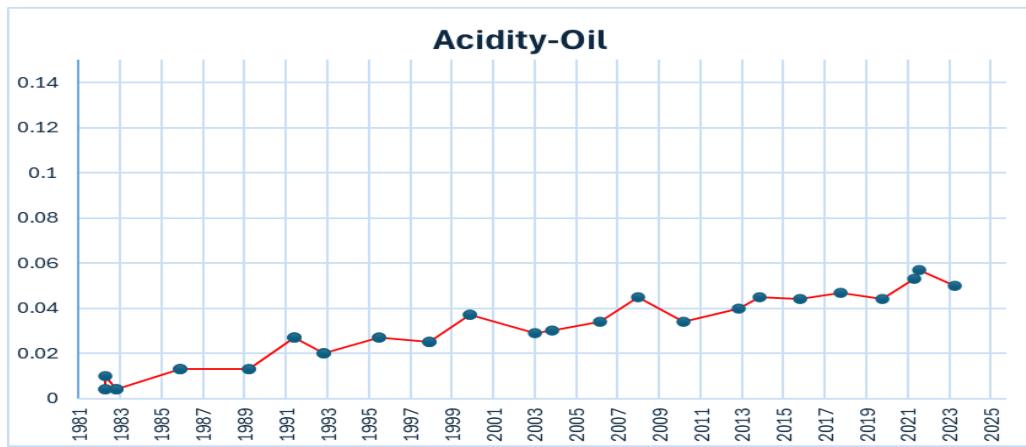
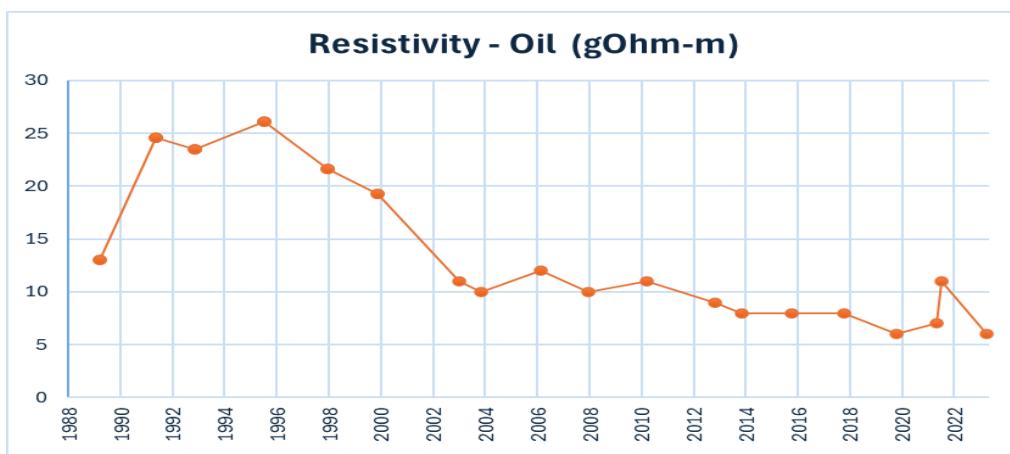
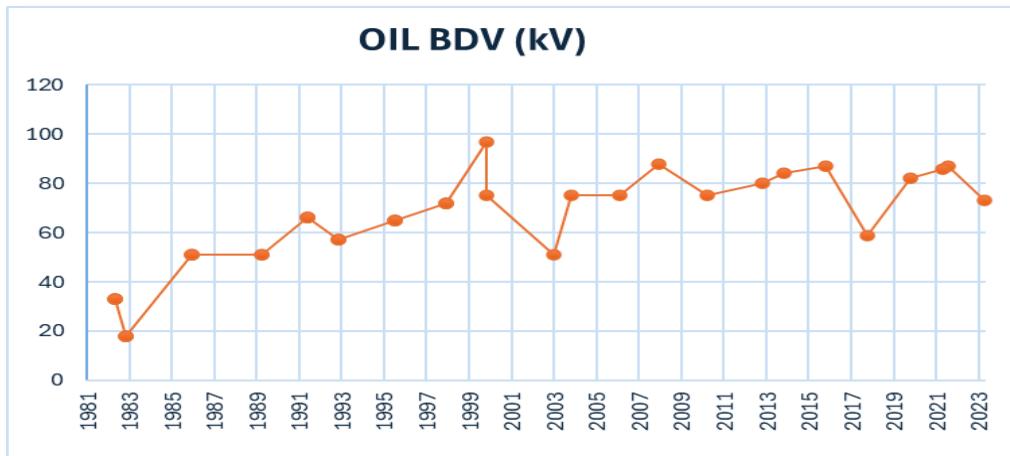
The oil quality still within acceptable limits, with no significant signs of deterioration. Both the oil acidity and resistivity measurements indicate that the oil is still in good condition.

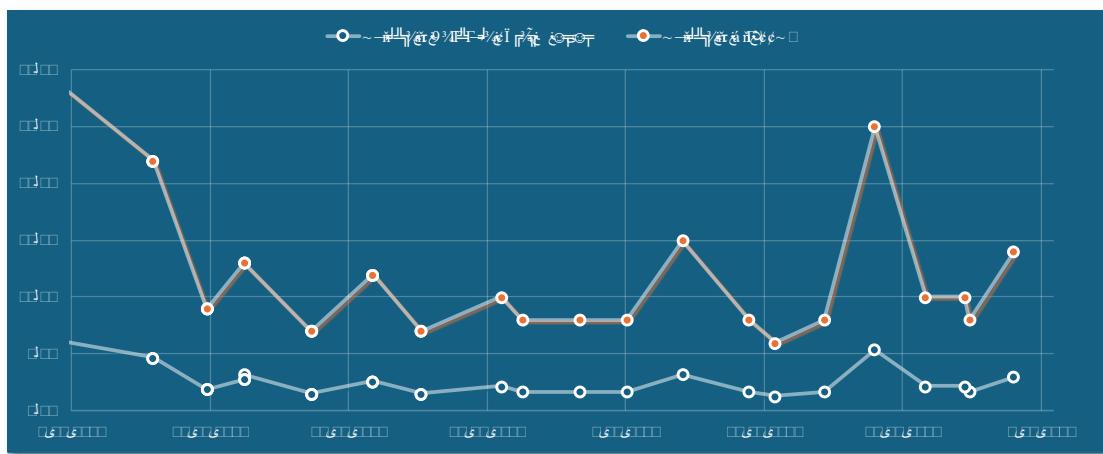
Figure 40- moisture in solid insulation- SD Myer

As detailed in Section 2.4.1.1, the SD Myers method estimates the average moisture content in the solid insulation to be approximately 2.2%, with a range spanning 1.5% to 3.2%. However, the Omicron DIRANA test conducted in 2023 provides a more accurate measurement, indicating a moisture content of 0.8%. Based on the transformer's age and the initial moisture content during its manufacturing in the 1980s, it is likely that the cellulose insulation currently contains between 1% and 1.5% moisture by dry weight. Moisture levels should continue to be monitored as the transformer ages to assess the need for drying interventions in the future.

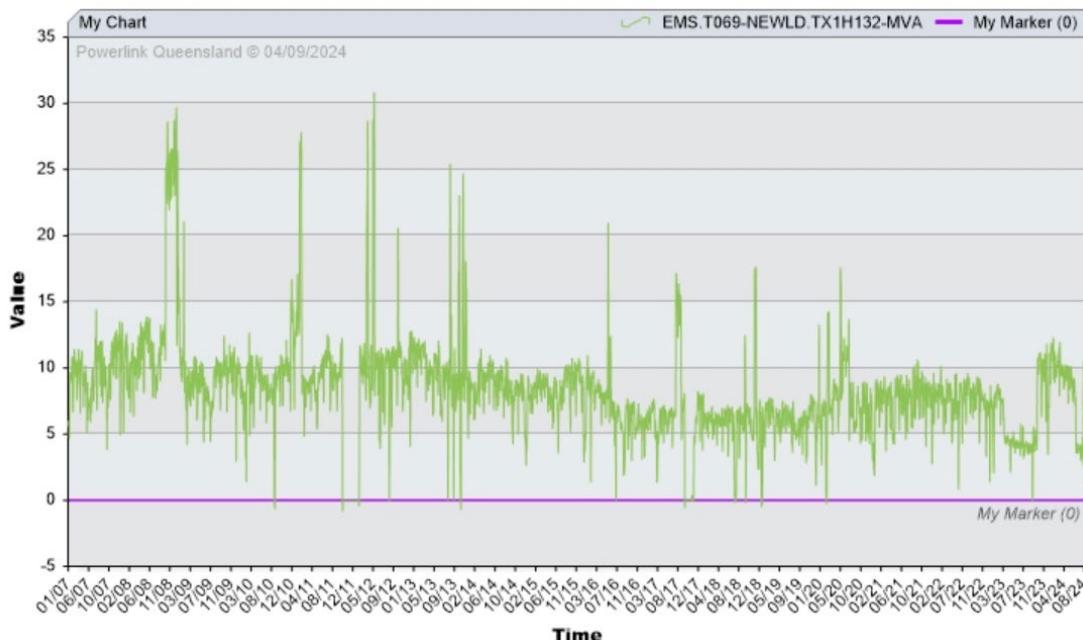
Figure 42 – Transformer 132 kV Loading History

The average loading during this period was 8.24 MVA, which corresponds to 21% of the nameplate rating in ODAN mode and 20.6% of the normal cyclic loading (40 MVA). This indicates light loading throughout the transformer's service life, with the exception of the T2 transformer shutdown period (from October 6, 2008, to October 31, 2008), during which the average load reached 24.8 MVA.

This light loading is consistent with the relatively high calculated Degree of Polymerization (DP) value of the insulating paper, indicating good insulation condition and extended service life.

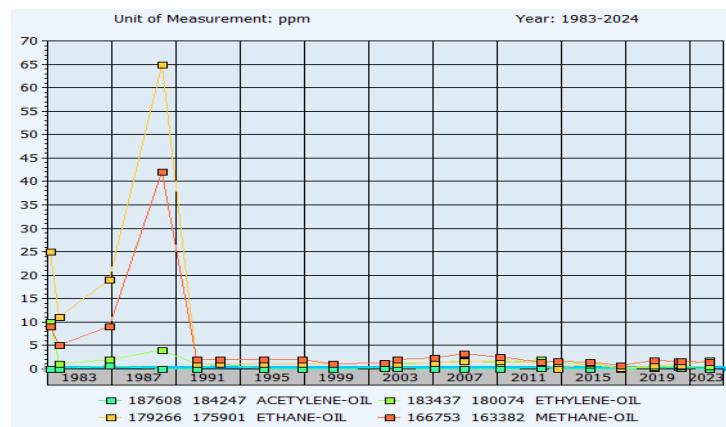
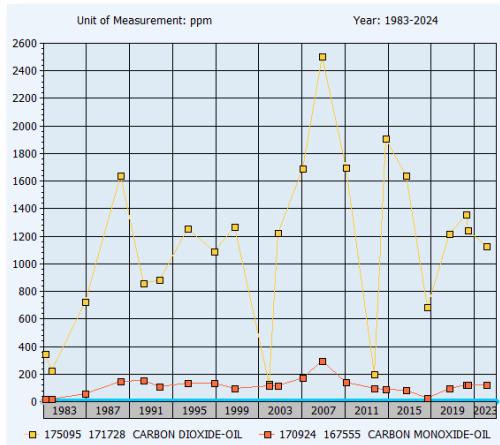
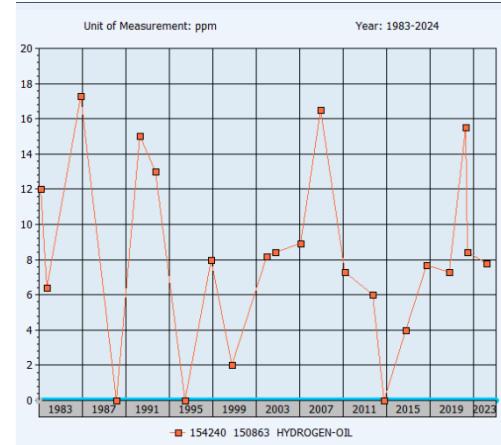
- The minor traces of acetylene dissolved gas found in the main tank oil (ranging from 0.4 to 1.0 ppm) can be attributed to a couple of factors:
 - Minor oil leakage from the OLTC diverter switch compartment. According to Reinhausen, the original equipment manufacturer (OEM), these compartments are not entirely oil-tight. They are prone to minor leaks through the cylinder wall terminal seals.
 - It can be difficult to clean the Laboratory GC column following the testing of an oil sample that had very high levels of acetylene. As a result, the first oil sample to be tested following a very contaminated sample may pick up minute traces of gases that are very soluble in oil and difficult to remove.

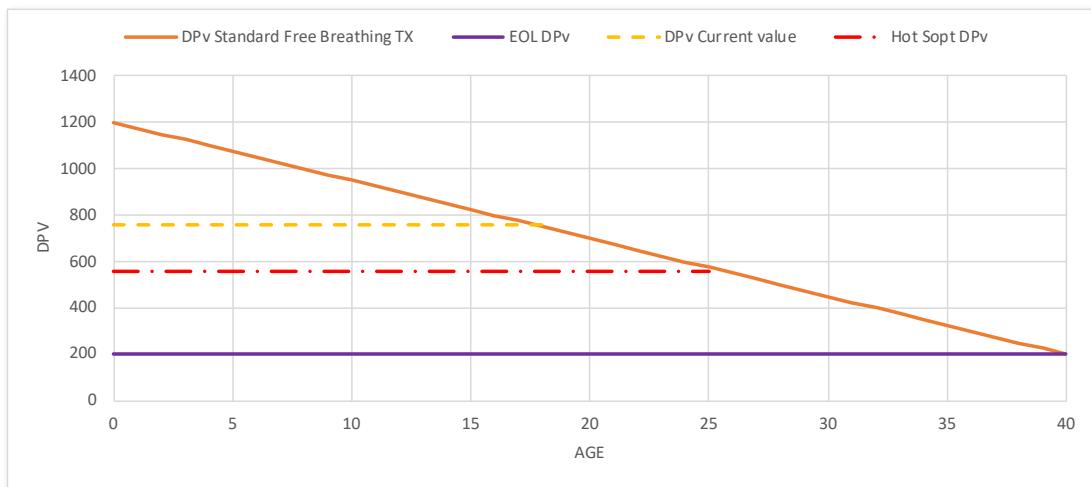
Figure 46- Calculation of cellulose insulation age using a 2-FAL in Oil

For the Newlands transformer T01, the insulation age was calculated to be approximately 18 years based on a DP value of 758, which is significantly below its actual service age of 41 years. However, it is important to note that localized areas of the winding, particularly hot spots, may have lower DP values ranging between 700 and 560, indicating an effective insulation age closer to 26 years.

Since no actual paper samples were taken for this assessment, the DP value was derived from the dissolved furans in oil. The estimated trend is depicted in Figure 52, considering an approximation for the hot spot, which assumes that the furan data only represents an average of the overall cellulose insulation mass.

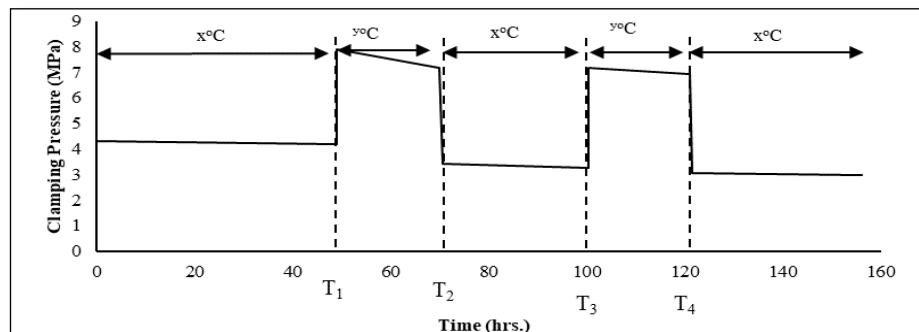
Figure 47- Example of the effect of cyclic compression on a clamped insulation structure

(b) Even with an estimated 0.8% to 1.5% moisture content in the internal winding insulation system partially migrating in and out of the clamped structure due to changes in transformer load, there will be some loss of clamping pressure due to the phenomenon shown in the figure below. It is realised that load changes are not normally as sharp as in the diagram, but the overall cyclic effect is the same.

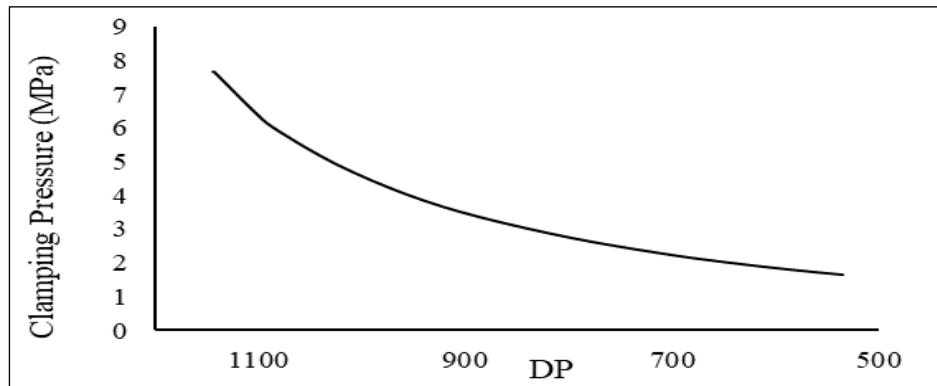
Figure 48- Example of the effect of loss of DPv on Clamping Pressure

(d) A decrease in the internal cellulose insulation mass, reflected by the DP value dropping from 1100 to 759, will lower the winding's residual clamping pressure, though the exact extent of this reduction is currently uncertain.

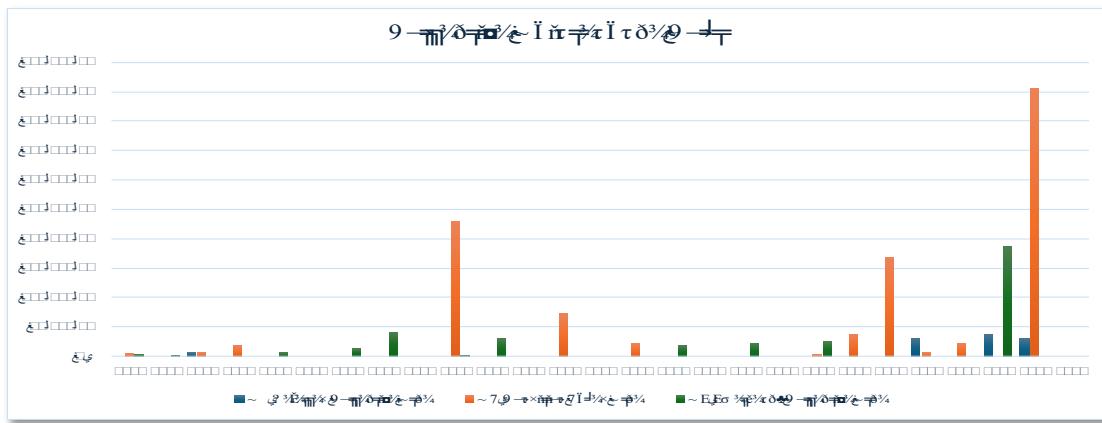
Figure 49– Transformer Corrective Maintenance Cost

The corrective maintenance trend for Newlands Transformer 1 (T01) shows a gradual increase in corrective maintenance cost over time, with significant escalations observed from 2019 onwards. In the early 2000s, corrective maintenance interventions were relatively infrequent, primarily involving minor emergency repairs such as pump failures, oil leaks, and tap changer condition-based maintenance.

From 2019 onwards, there has been a marked increase in corrective maintenance costs. This rise is not primarily due to aging-related transformer failures. Key interventions during this period included the replacement of silica gel breathers (upgraded from non-standard PVC to standard breathers) in 2019, an investigation of a transformer trip caused by a 66kV Shutdown Device failure in 2022, and condition-based maintenance of the tap changer along with electrical testing for condition assessment in 2023.
