# Powerlink 2027-32 Revenue Proposal

CP.03196 BS1009 Mudgeeraba to Terranora Refit

## Condition Assessment Report

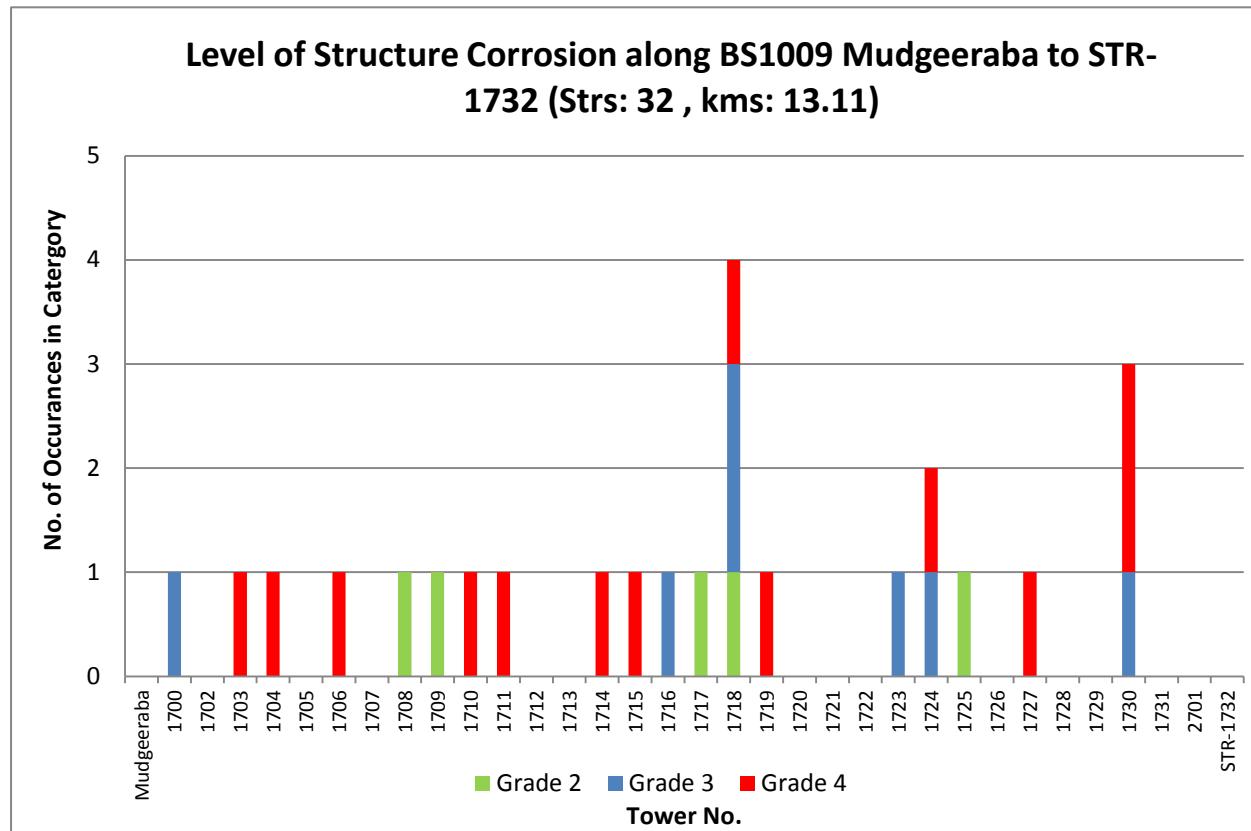
## 1.3 Notification Overview for Structures

The above graph shows the number of notifications relating to corrosion on each structure. It can be seen that a number of Grade 4 notifications have been raised and are being addressed through maintenance procedures. Many of the Grade 4 notifications were in relation to the condition of the suspension insulator pins, which have since been replaced.
