Powerlink 2027-32 Revenue Proposal

Project Pack

CP.03208 Mudgeeraba Selective Primary Plant Replacement

SITE CONDITION ASSESSMENT REPORT

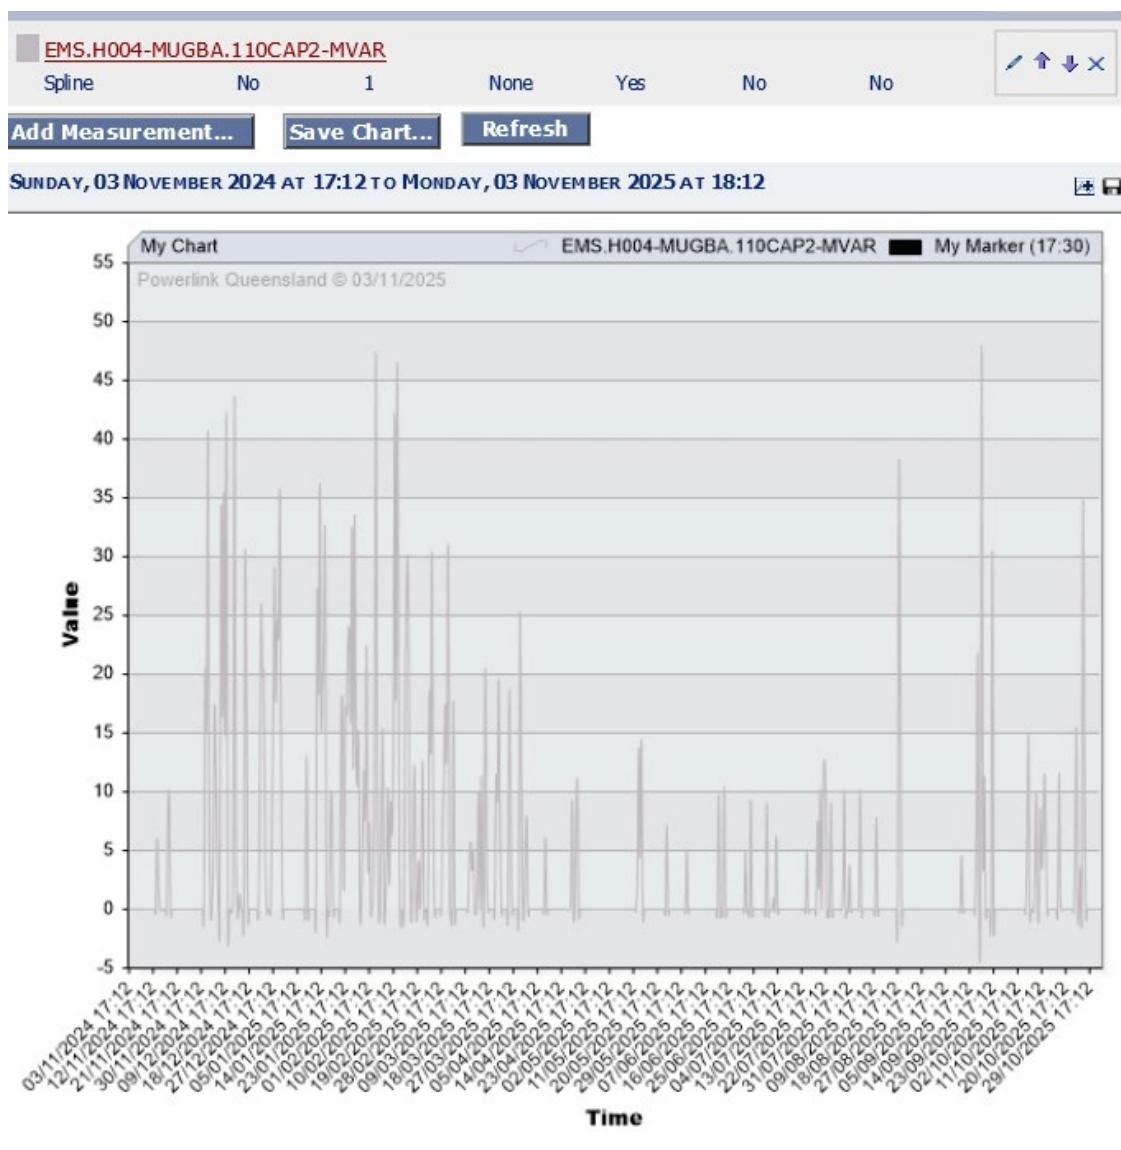
Figure 17- EMS 110 kV CAP2 Graph

Any equipment failure in this bay can cause capacitor bank not to be available for switching during high load periods. Considering there is another cap bank at this site (4 cap) albeit connected to 275 kV bus, the need for 2 Cap needs to be confirmed by network planning and operation engineers. Based on the usage data showed below, it is likely there is an enduring need for it.

Considering the condition and maintenance history of the equipment in this bay but also the age and condition of the capacitor bank (29 years old), it is recommended to replace two LOW+BONAR STANGER CTs in this bay within next 3-5 years and replace all other equipment in 10 years with the cap bank replacement, if the enduring need remains.
