# Powerlink 2027-32 Revenue Proposal

### CP.02800 Alligator Creek Substation Reinvestment

# PRIMARY PLANT CONDITION ASSESSMENT REPORT

# T065 Alligator Creek 132kV Substation and SVC Secondary Systems Condition Assessment

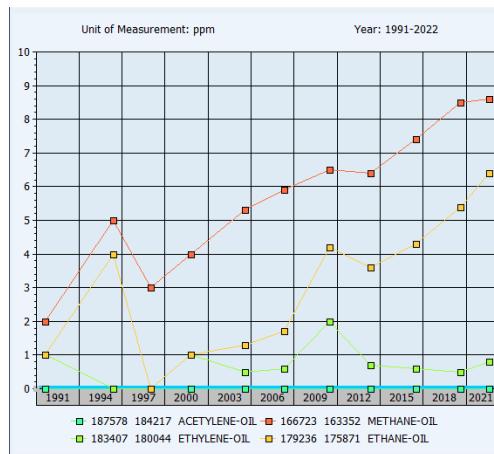
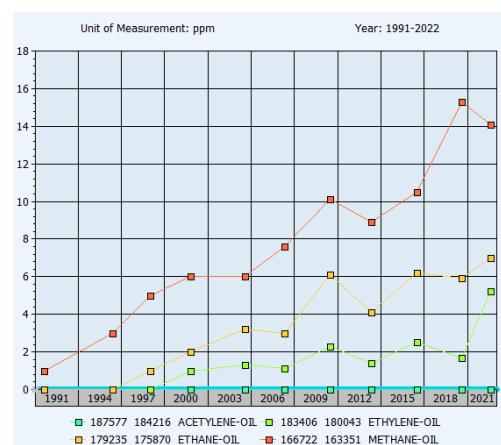
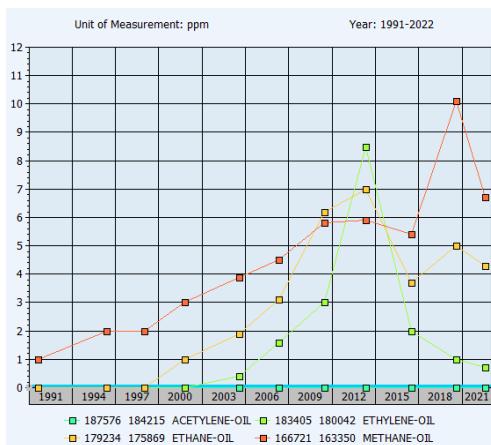
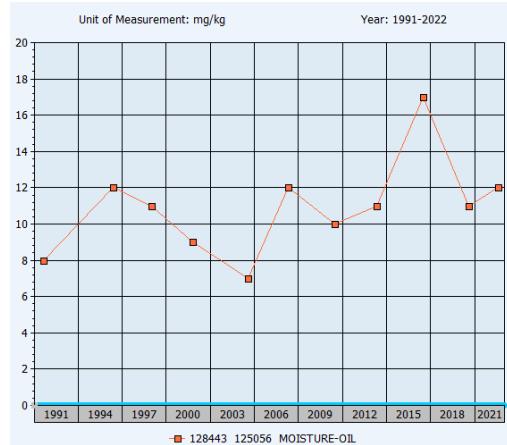
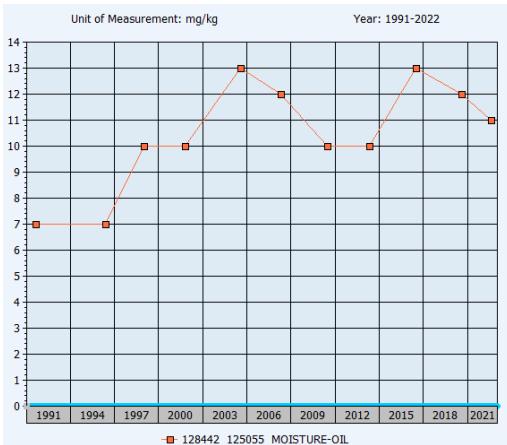
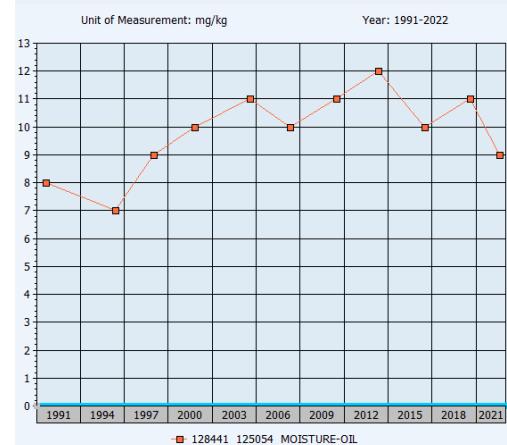
Routine oil sample analysis has not detected any abnormalities, and levels of key dissolved gases and moisture remain within acceptable limits.

Figure 11- Key Dissolved Gases in Oil-PH-A

Figure 12- Key Dissolved Gases in Oil-PH-B

**Figure 13- Key Dissolved Gases in Oil-PH-C**

**Figure 14- Moisture in Oil-PH-A**

**Figure 15- Moisture in Oil-PH-B**

**Figure 16- Moisture in Oil-PH-C**

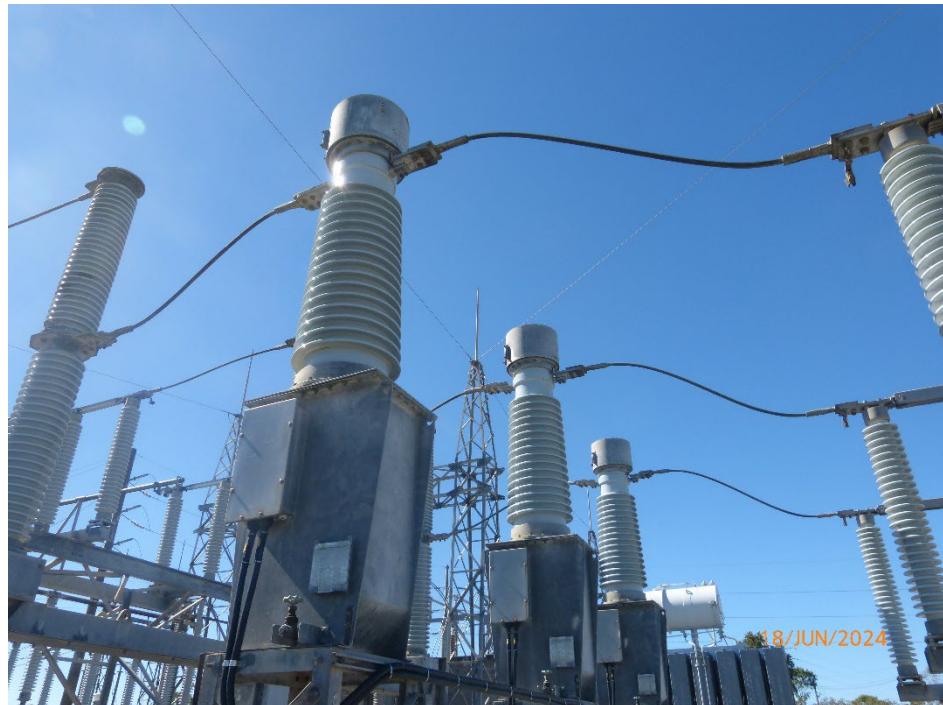
Figure 17-Current Transformers overall View

Maintenance records indicate no issues with these current transformers since their installation. The oil levels for all three phases were noted to be normal during the site inspection. Minor corrosion was observed on several bolts and nuts across the three phases (Figures 16-18).

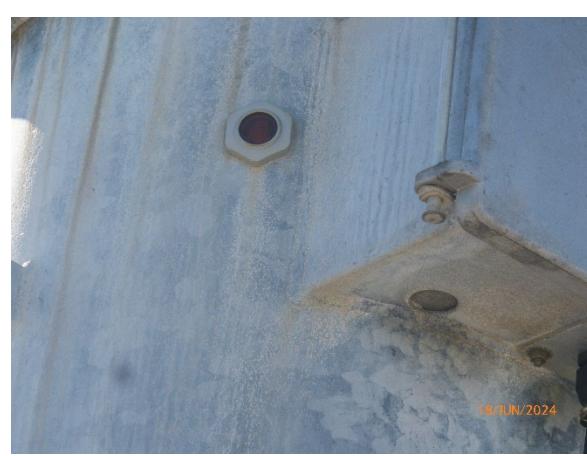
Figure 21- A- Voltage Transformer with Dark Oil

**Given the observed condition, it is recommended to replace the A and B phase voltage transformers within the next two years.**

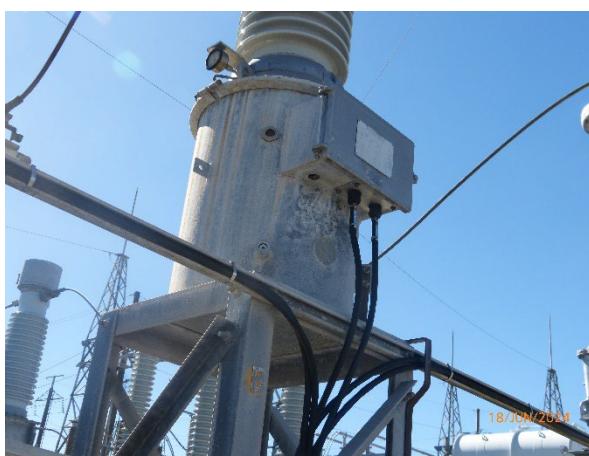
Figure 22- B- Voltage Transformer with Dark Oil

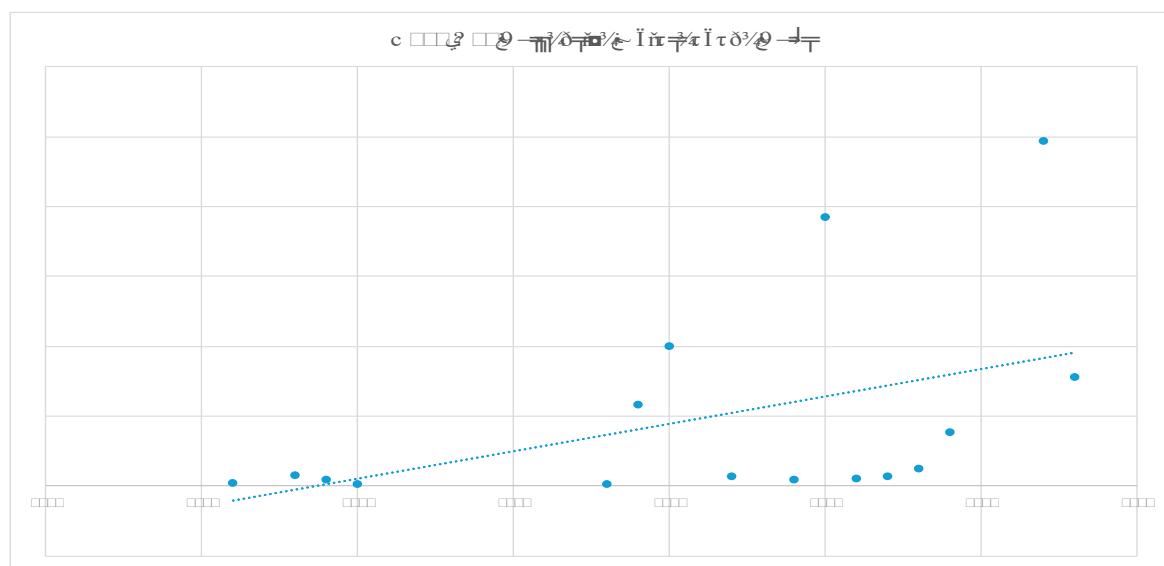
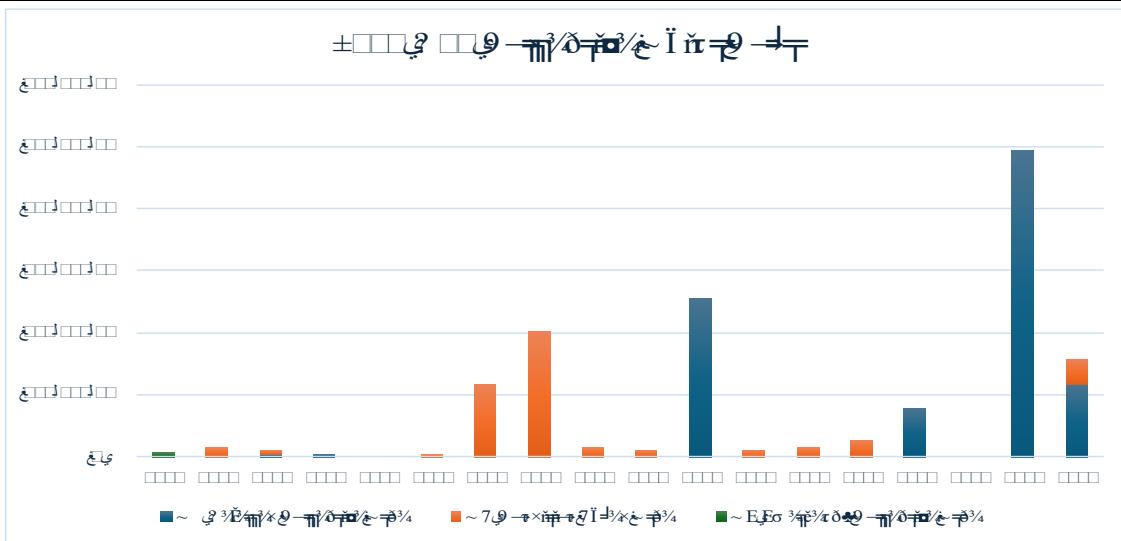
Figure 24 - H065-D06 Corrective Maintenance Cost

The corrective maintenance costs associated with this bay have exhibited an increasing trend over time. Critical components contributing to these increasing costs include the CVTs (Capacitive Voltage Transformer) and the isolators. Notably, a significant expenditure was incurred in 2015 for the replacement of the C phase voltage transformer. From 2016 onwards, the corrective maintenance costs were predominantly influenced by the bus and line isolators, addressing corrosion and high contact resistance defects.

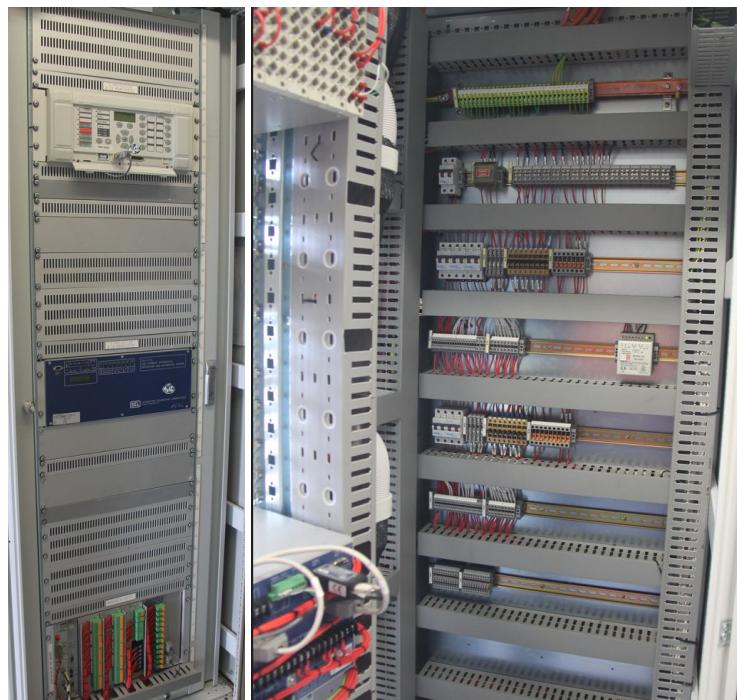
Typical swing frame protection/control panel

Panels and associated cabling are in good condition, consequently condition based replacement has been recommended by 2048. However, screw CT links and terminals shall be upgraded under associated secondary system replacement to mitigate associated safety risks according to SU0049 New physical disconnect terminal for CT circuits.

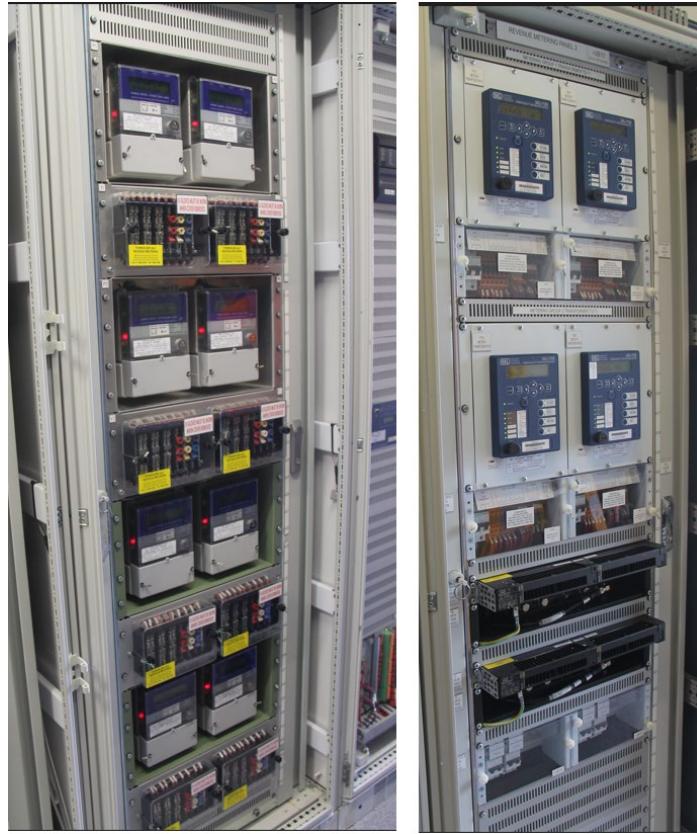
Metering panels +2B3 (left) and +2B10 (right)

The risk of revenue meter failure affecting the transmission network is considered to be moderate. The older EDMi metering equipment in +2B3 (Feeders 7319, 7320, 7336, SVC) can be kept in service until 2028, and are recommended to be replaced as part of the secondary system replacement project by 2028. The newer metering equipment in +2B10 (2T, 3T) can be kept in service until 2042.

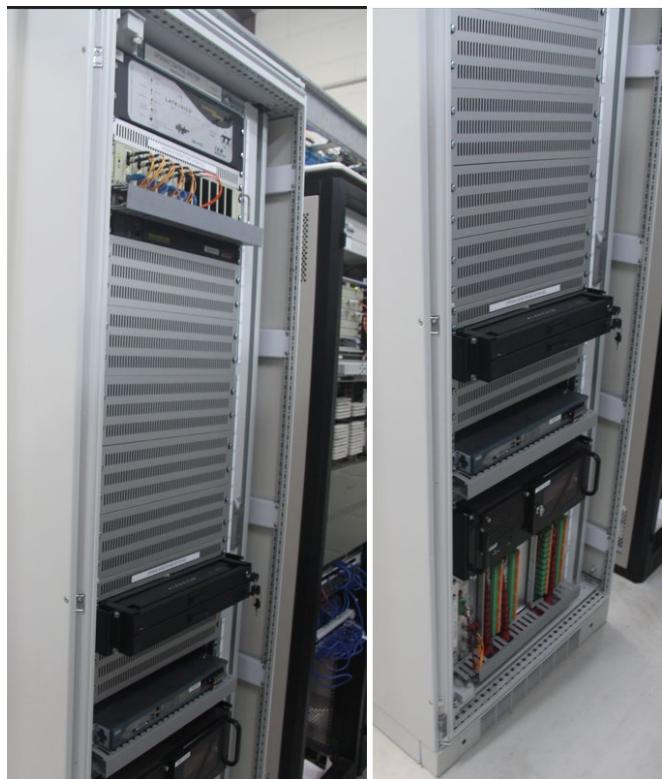
OpsWAN Cubicle +1.2.3.3

Indoor IONS/OpsWAN systems in buildings +1 and +2 are recommended to be replaced as part of the secondary systems replacement i.e. by 2028.

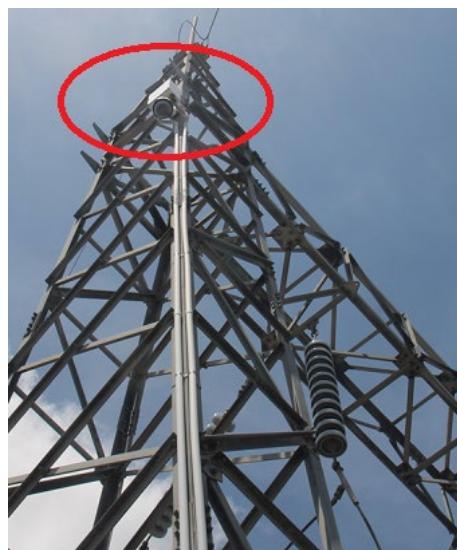
The three OpsWAN cameras (outdoor OpsWAN equipment), two of which were installed in 2009, shall be replaced under a secondary system refurbishment project by 2028. This shall include relocating all related devices from the OpsWAN camera housing at the top of the pole to the camera patch box at the base of the pole according to the ETR 10434041 OpsWAN Camera Lowering Device Trial – Task Report (Objective ID: A4982111).

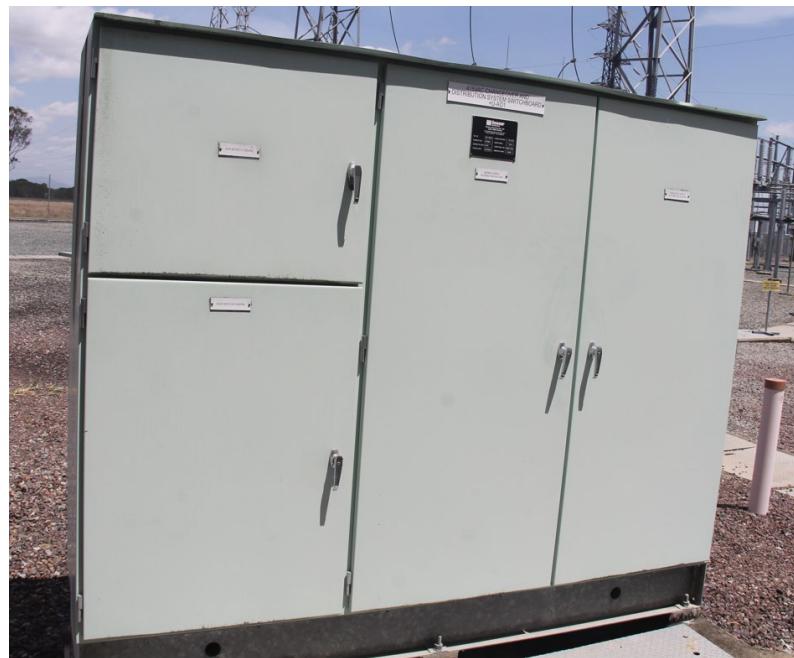
Main AC changeover board +U-A01

The outdoor main AC changeover board manufactured in 2007 and installed in 2008 is located near building +1. As part of the Secondary Systems refurbishment, this board shall be assessed for compliance with the current AS/NZS 3000 Wiring Rules, current Powerlink design standards and applicable Standard Updates (including Arc Flash risk and labelling). Once compliance assessed, this board would remain in operation until 2048.

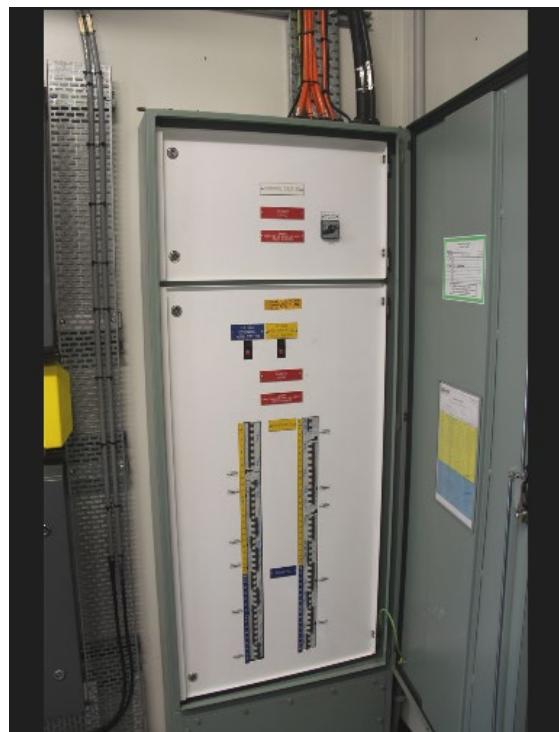
### Building +2 400VAC distribution board +2C10

The AC distribution board in the demountable building +2 installed in 2008 is in good condition. Similar to the AC change over board, as part of the Secondary Systems refurbishment, this board shall be assessed for compliance with the current AS/NZS 3000 Wiring Rules, current Powerlink design standards and applicable Standard Updates (including Arc Flash risk and labelling). Once compliance assessed, this board would remain in operation until 2048.

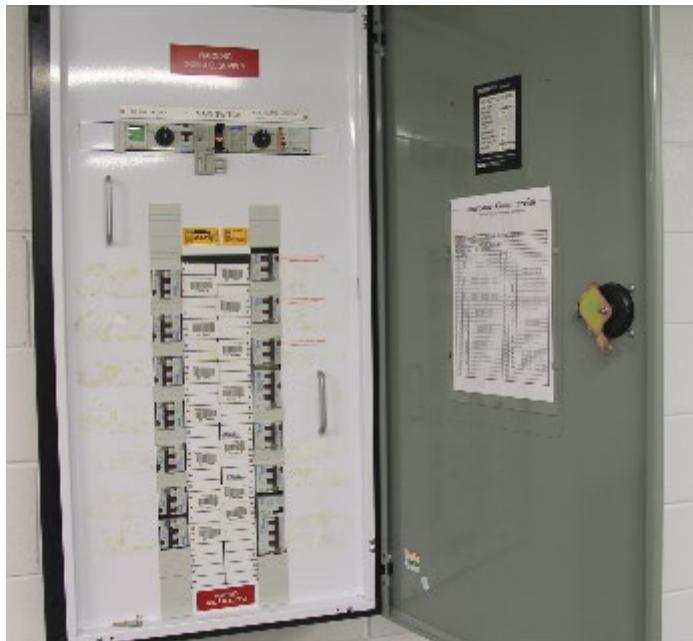
SVC Building +3 400VAC distribution board DB-NE2+SN23

The AC distribution board in the SVC building +3 installed in 2009 is in good condition. As part of an SVC Secondary Systems refurbishment, this board shall be assessed for compliance with the current AS/NZS 3000 Wiring Rules, current Powerlink design standards and applicable Standard Updates (including Arc Flash risk and labelling). Once compliance assessed, this board would remain in operation until 2049.
