Powerlink 2027-32 Revenue Proposal

CP.02818 Woolooga to South Pine 275kV Line Refit

Transmission Line Condition Assessment Report - 2025

Built Section 1020 – South Pine - Woolooga

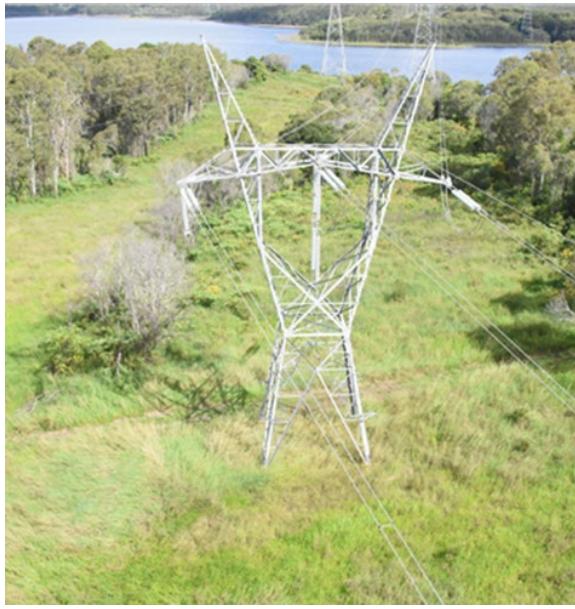
Figure 2 - 1020-STR-4025 - Tension Tower

There are live climbing restrictions on S2S2 and S2S0 delta towers installed on this built section. Refer HSE Alert ID 2024.01. Due to a restricted climbing corridor, many maintenance activities including inspection can be more complicated and costly on these structures. Typical structures are shown in Figure 2 and Figure 3.

- Review options for resolution of the live climbing restriction on S2S2 and S2S0 towers and implement if cost effective. Should live tower climbing be feasible, the scope of work shall include replacement of all step bolts on all towers to comply with current Powerlink standards. Alternately, if no solution can be found, only replace corrosion grade 3 and 4 step step-bolts.

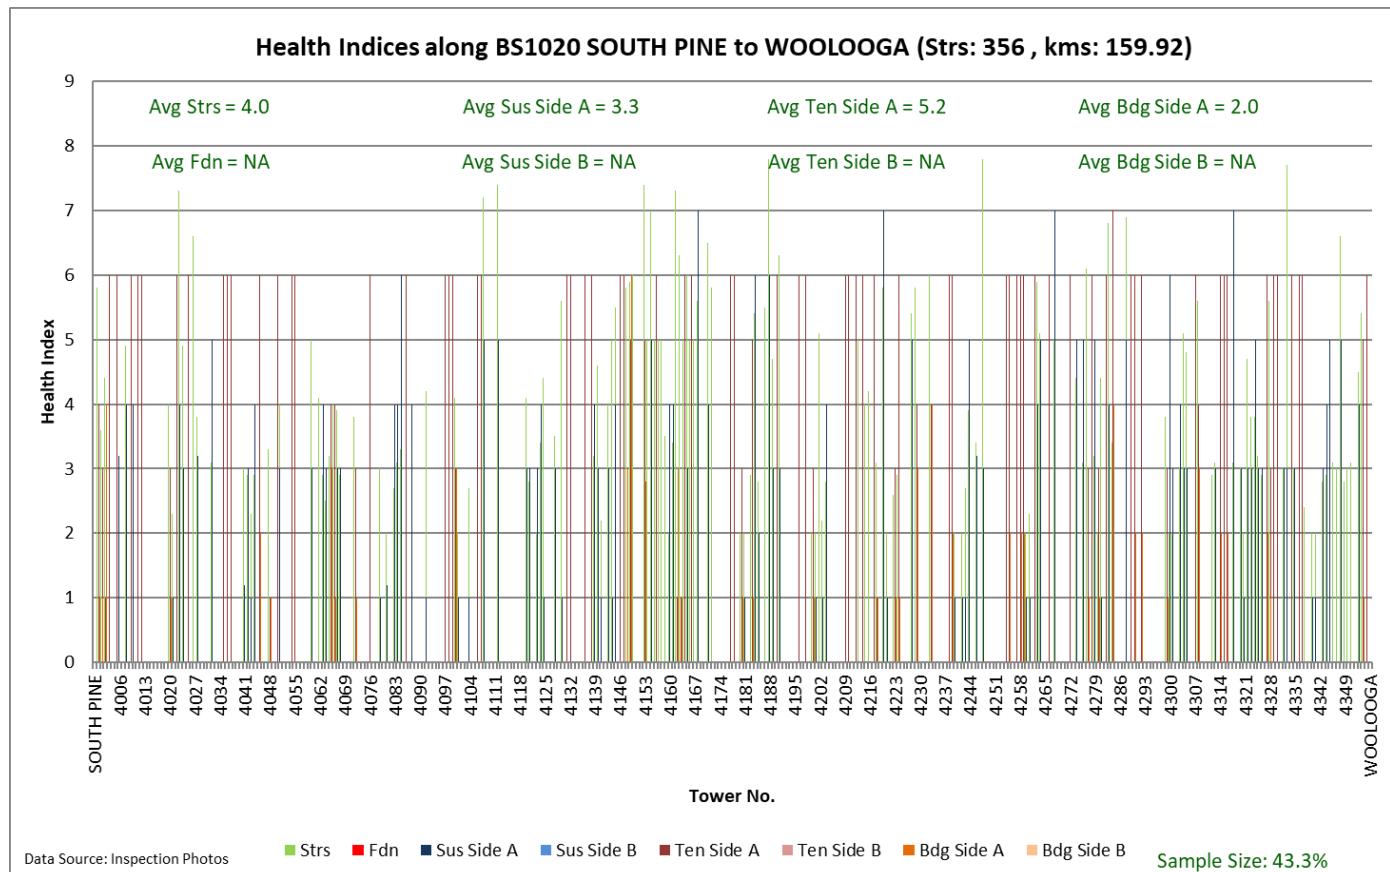
Figure 6 - Graph of BS1020 Health Indices

The condition data detailed in the sections below has been summarised in Figure 6 which is a graph of available health indices for the major components of BS1020.

Corrosion related defect notifications have been visualised in Appendix 7.1. These graphs highlight the microclimates found along this built section with higher levels of Grade 3 and Grade 4 corrosion found in the Sunshine Coast hinterland and towards the southern, South Pine substation end of the line. There is some correlation between the notification graphs and the health index graph above, which shows slightly higher percentages of corrosion (and higher health indices) in the same areas.

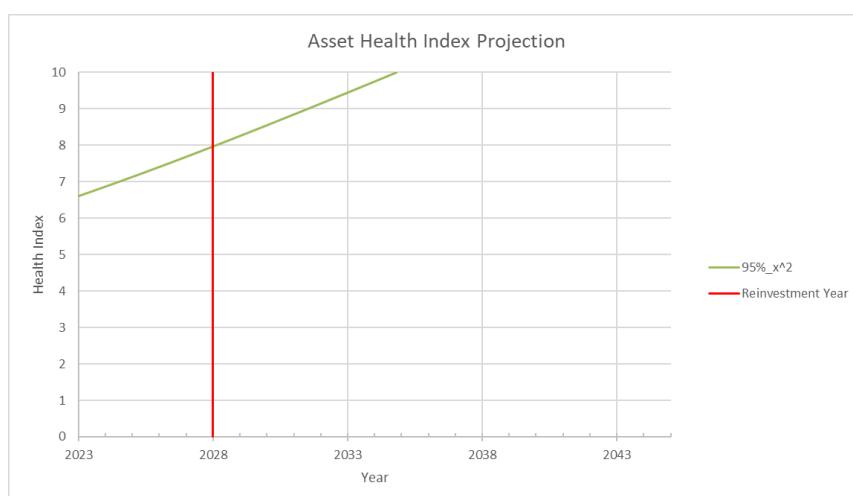
Figure 8 - Asset Health Index Projection

It is noted that this assumes 5% exceedance across the line, i.e. 95% of structures will have a lower health Index while 5% will exceed this value. Using this method, it is estimated that a Built Section Health Index of 7 has already been exceeded, and a Health Index of 8 will be reached by 2028. Refer Figure 8.

The percentage of health indices which exceed 95% equates to approximately 35 structures.

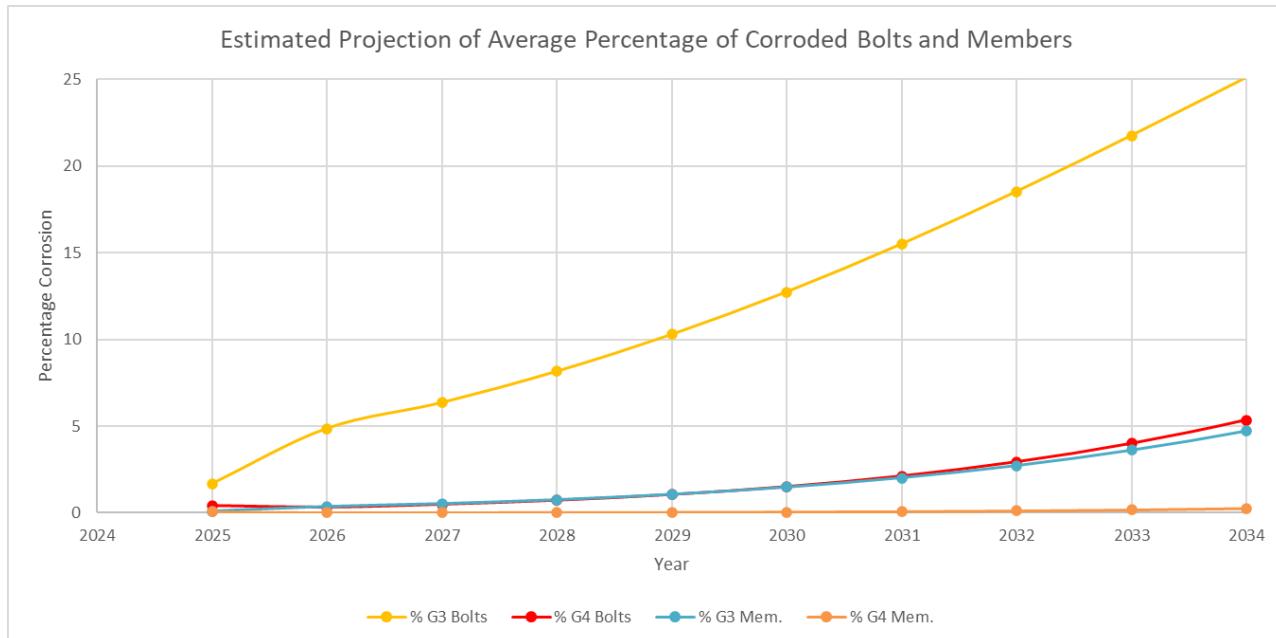
Figure 11 - Estimated Projection of Bolt and Member Corrosion

To aid with estimation, the average levels of corrosion are calculated. Below is the projection of the average level of bolt corrosion on the entire built section based on the sample of data and an estimated service life of 57 years for bolts.

- Replace tower members and fasteners with G3 corrosion and above.
- Replace OHEW and hardware exhibiting G3 corrosion and above and review OHEW fault capacity in the vicinity of South Pine substation.

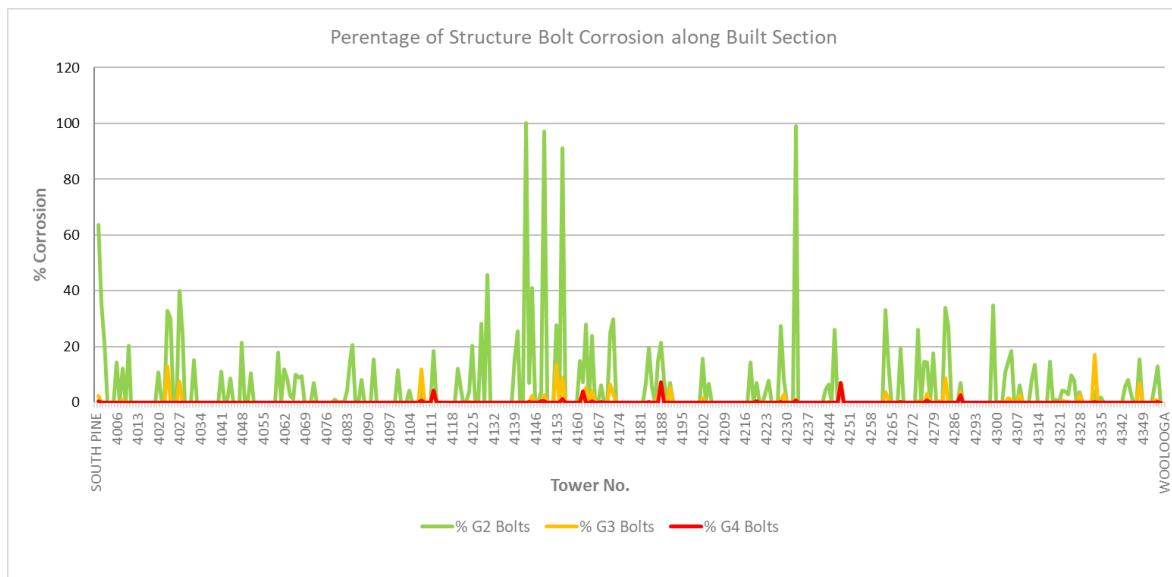
Figure 12 - Percentage of Structure Bolt Corrosion along Built Section

Figure 9 and Figure 10 below structure corrosion along the built section based on the sample of data. A strong trend of increased bolt and member corrosion in the Sunshine Coast hinterland can be seen.

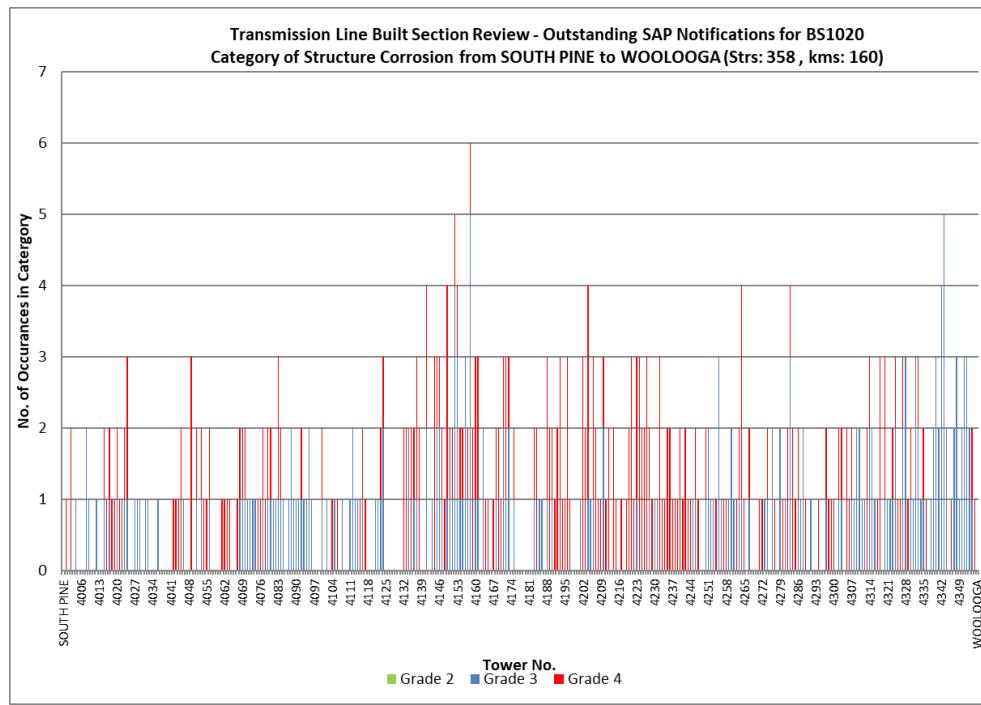
Figure 20: Graph of SAP Outstanding Notifications for Corrosion on Structures

At the time of this condition assessment there are significant open Grade 3 and Grade 4 notifications under 'monitor and review' status. Based upon the data presented in this report and health indices for sample of structures, this line will require reinvestment in the short term.
