# Overview of 2019-20 Bushfire Damage to TransGrid's Network

Cost pass through application for 2019-20 Bushfire  
season event

13 November 2020

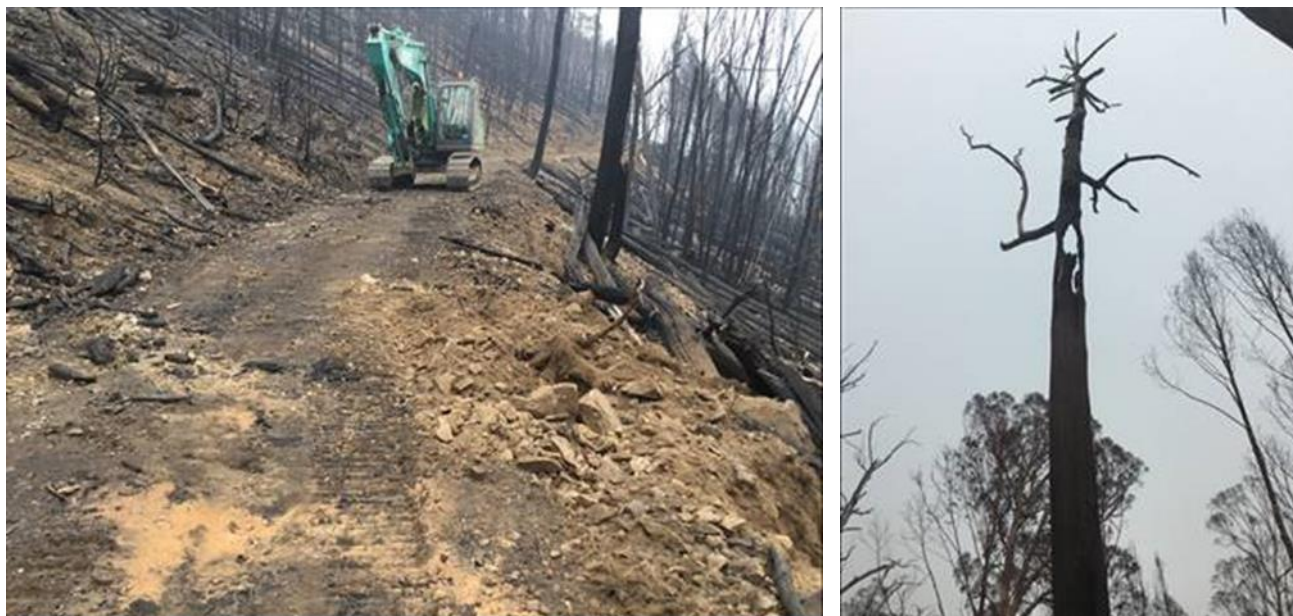
On 8 January 2020 TransGrid received advice from Snowy Hydro of dispatch problems and a possible line fault. A helicopter was dispatched and confirmed that conductors were down between structures 11 and 12 on 330 kV line U3. TransGrid's easement contractor worked throughout the day clearing safe access to the site. The site was accessed from the ground in the late afternoon to assess the extent of damage and prepare to make safe. Extensive damage to the aluminium conductor was found, with much of it melted and one phase with conductor separation.

Extensive access works were required to be able to perform the repair works. The conductor used on this transmission line is also a size and aluminium alloy which is no longer available from suppliers as a standard. A special order for the conductor size of a similar alloy was placed but had a significant lead time and as such a temporary conductor was strung to replace the damaged conductor and return the transmission line to service on 14 April 2020. The temporary conductor is a different size and alloy to what is required for the ongoing operation of the transmission line.

**Figure 8 – Access track works on Line U3**

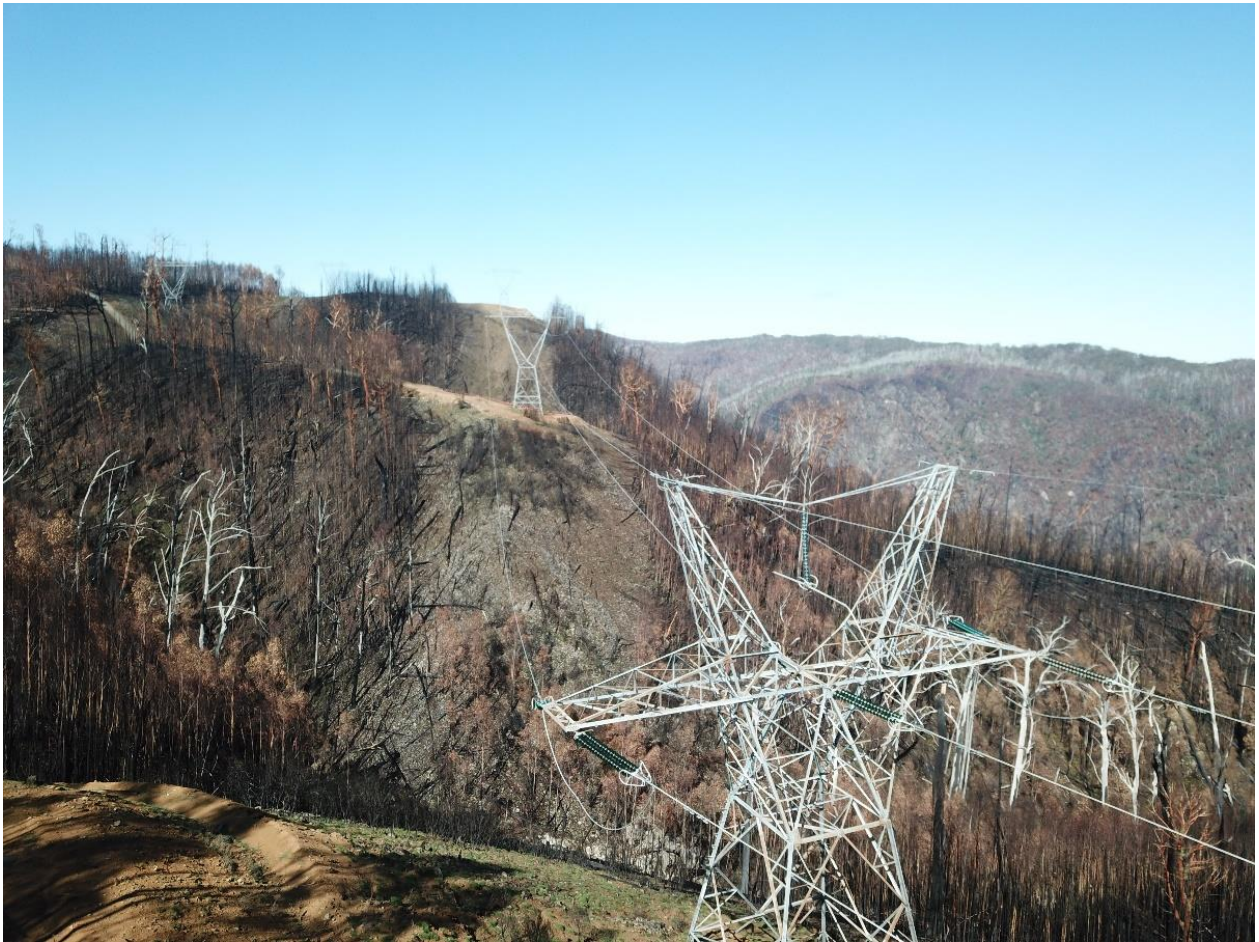
**Figure 10 – Terrain on Line U3**

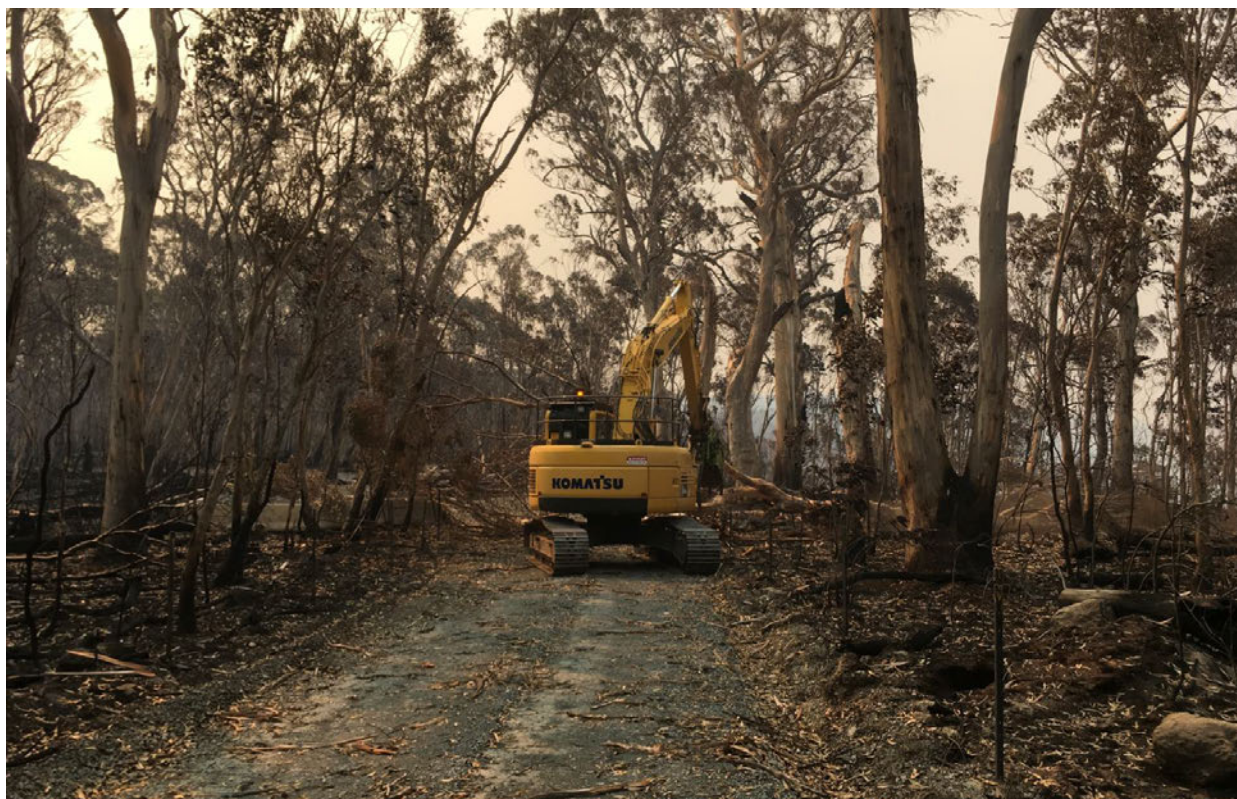
Figure 12 – Clearing bushfire-damaged trees for access to Line 2

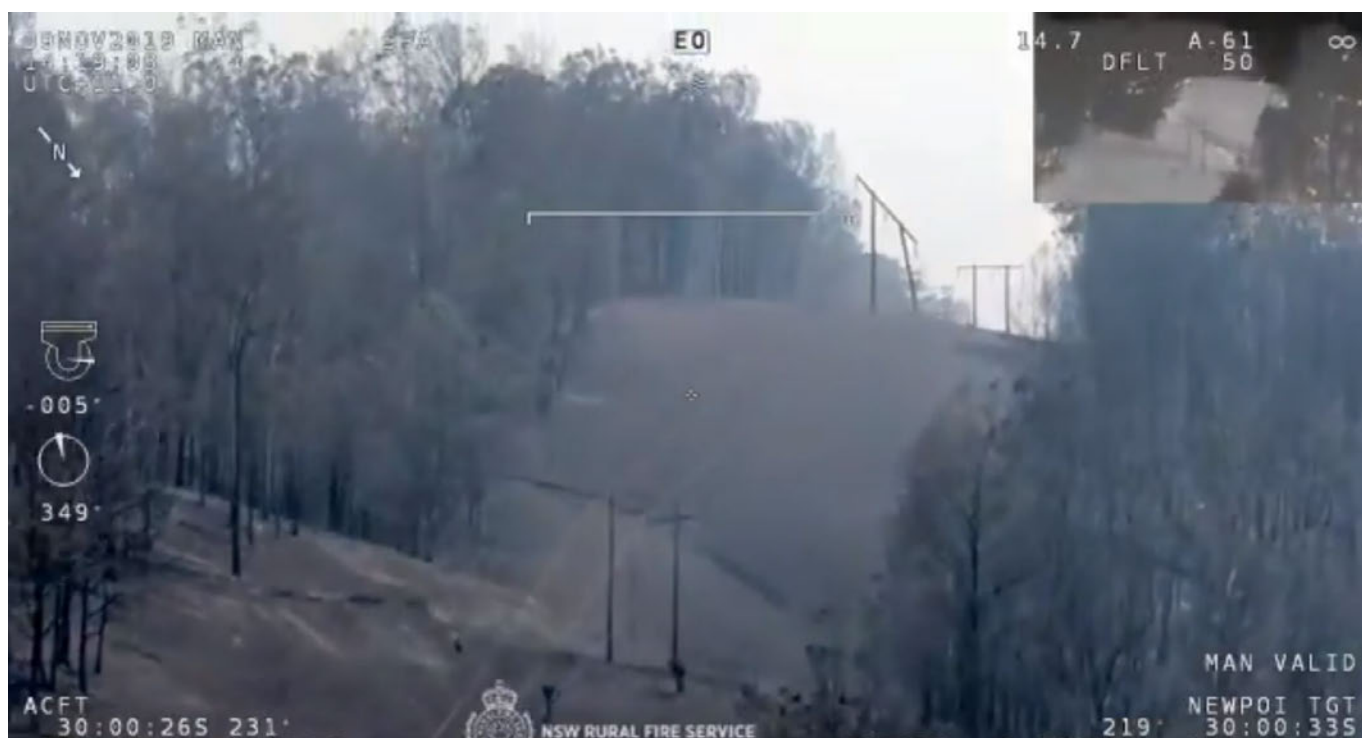
Line 966 was impacted by the Liberation Trail Fire. Multiple fault outages occurred on 8 November 2019. Six structures required replacement to restore the transmission line. Active fires prevented immediate access to all structures. Some access clearing and construction of equipment pads were required. The six structures were restored and the line returned to service on 17 November 2019.

Figure 16 – Line 966 NSW RFS Twitter 09/11/2019

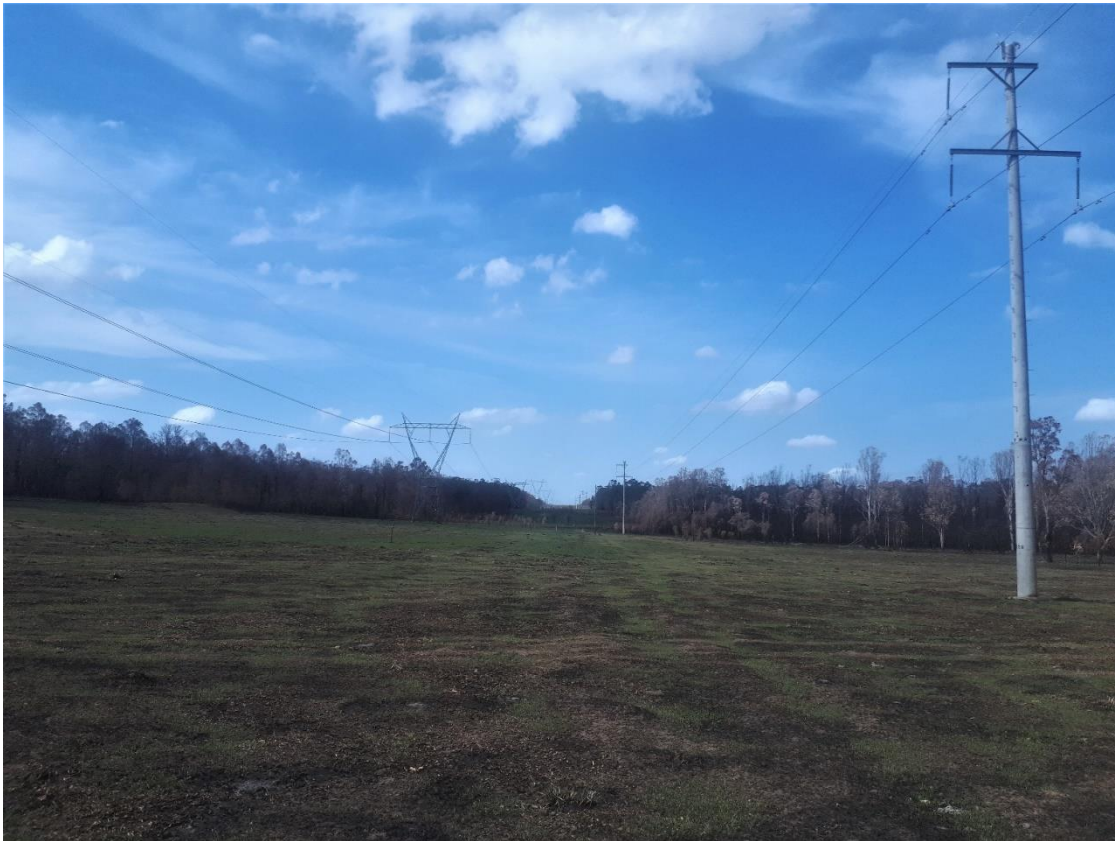
- > 967 – Koolkhan to Coffs Harbour – 132 kV concrete pole line
  - Impacted by Myall Creek Road fire and Busby Flat Road fires
  - Eight fault outages
  - After fire lines and easement patrols were conducted from structures 102 to 254 (39.2 km route length).

**Figure 20 – Line 89 and 967 late October 2019 (three weeks after Busbys Flat Rd fire fire)**

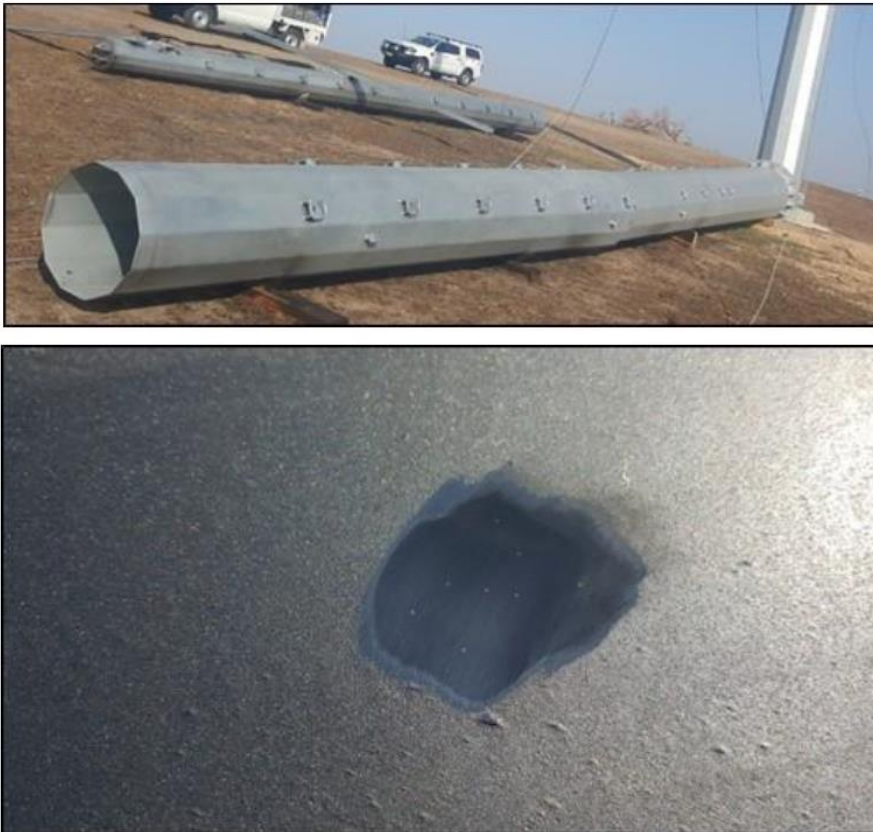
Figure 28 – Representative view of steel pole structure on Line 993

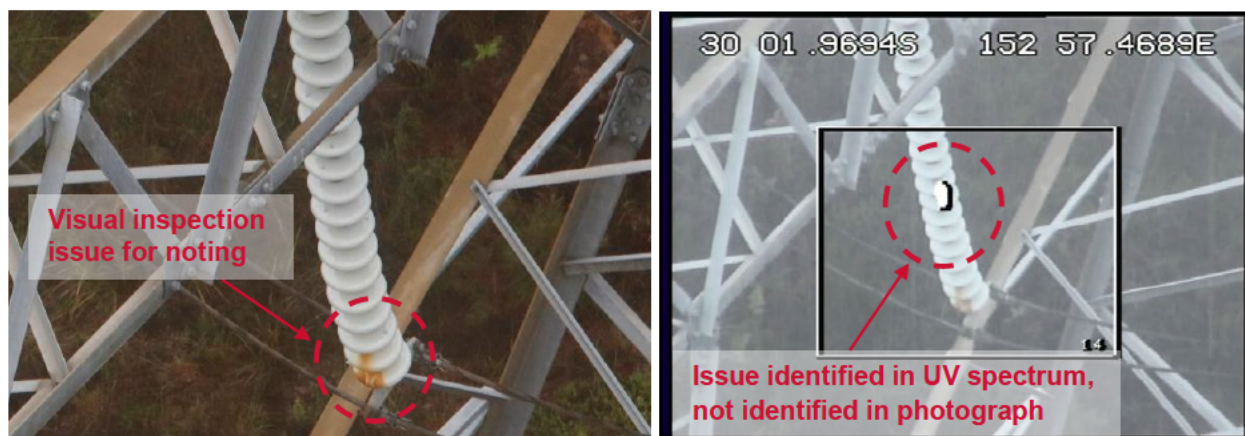
The inspections identified 201 issues across all spectrums. Examples of the inspection results are shown in the figures below.

Figure 29 - Example UV (corona) inspection results

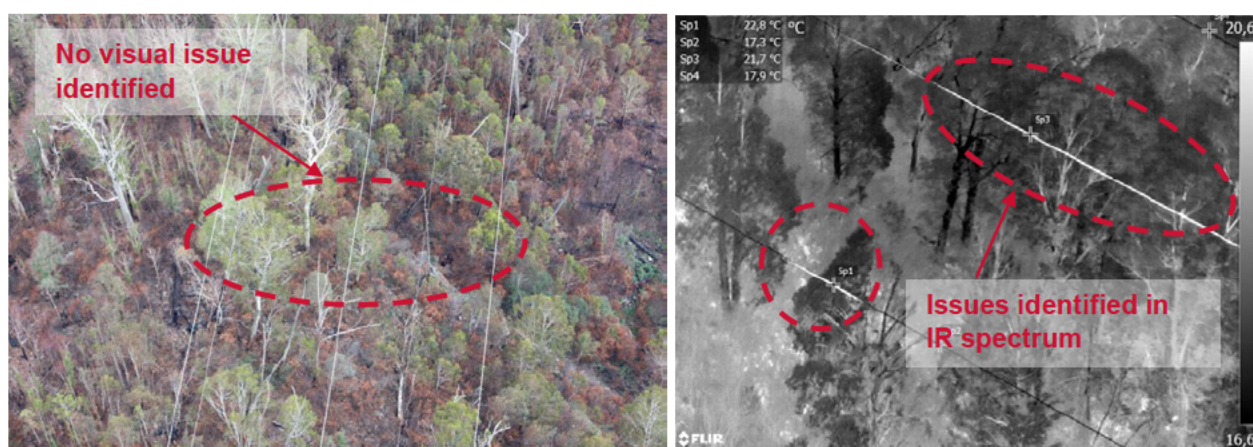
Figure 30 - Example IR (infrared) inspection results

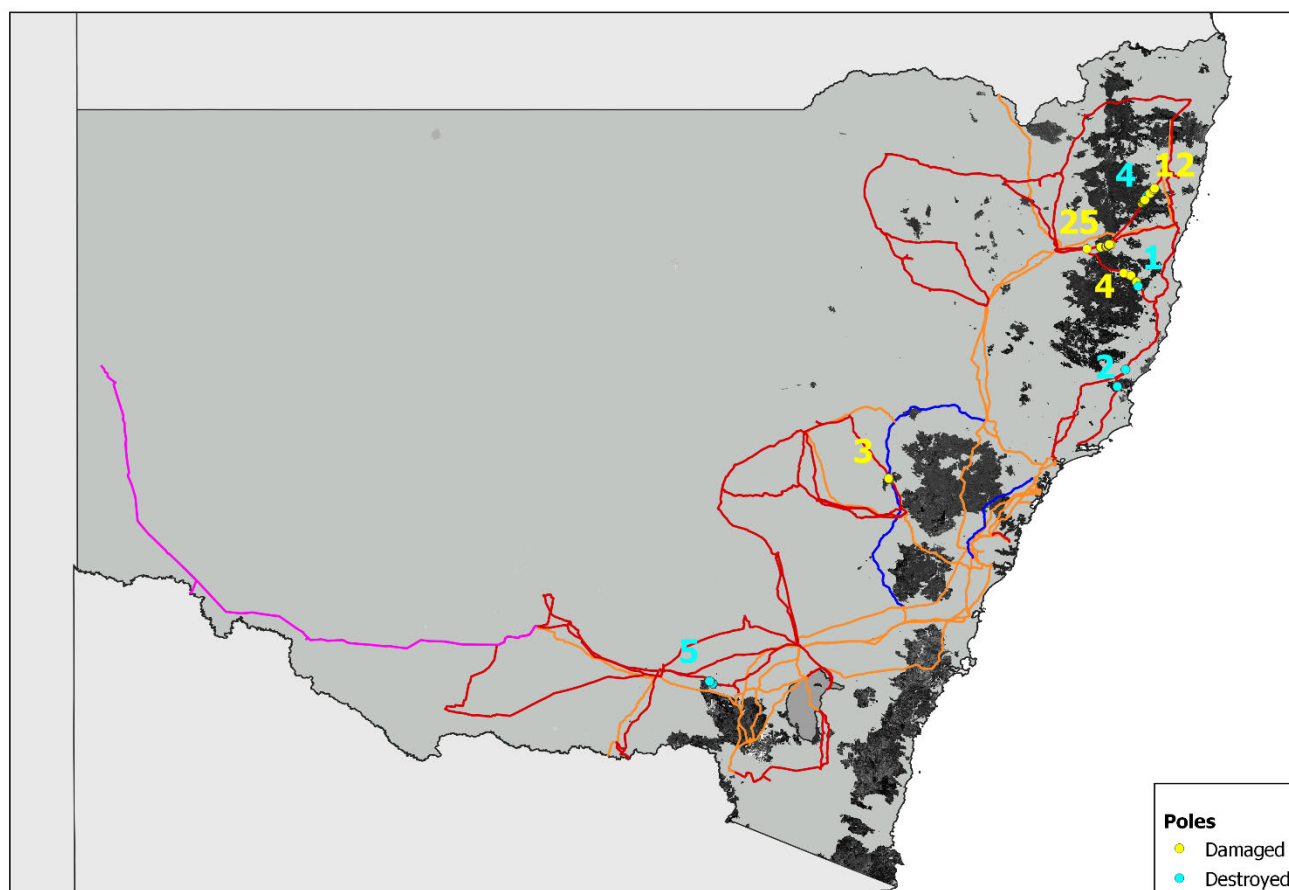
Timber poles being combustible are susceptible to fires. TransGrid uses hardwood poles, which require more energy to burn out compared to soft wood poles. There is no evidence to suggest that pole damage is exacerbated by fuel loads. TransGrid history of pole failures caused by fire is often in grass fields. The extent of wood pole damage is shown in Figure 41.

Figure 41 - Wood pole damage

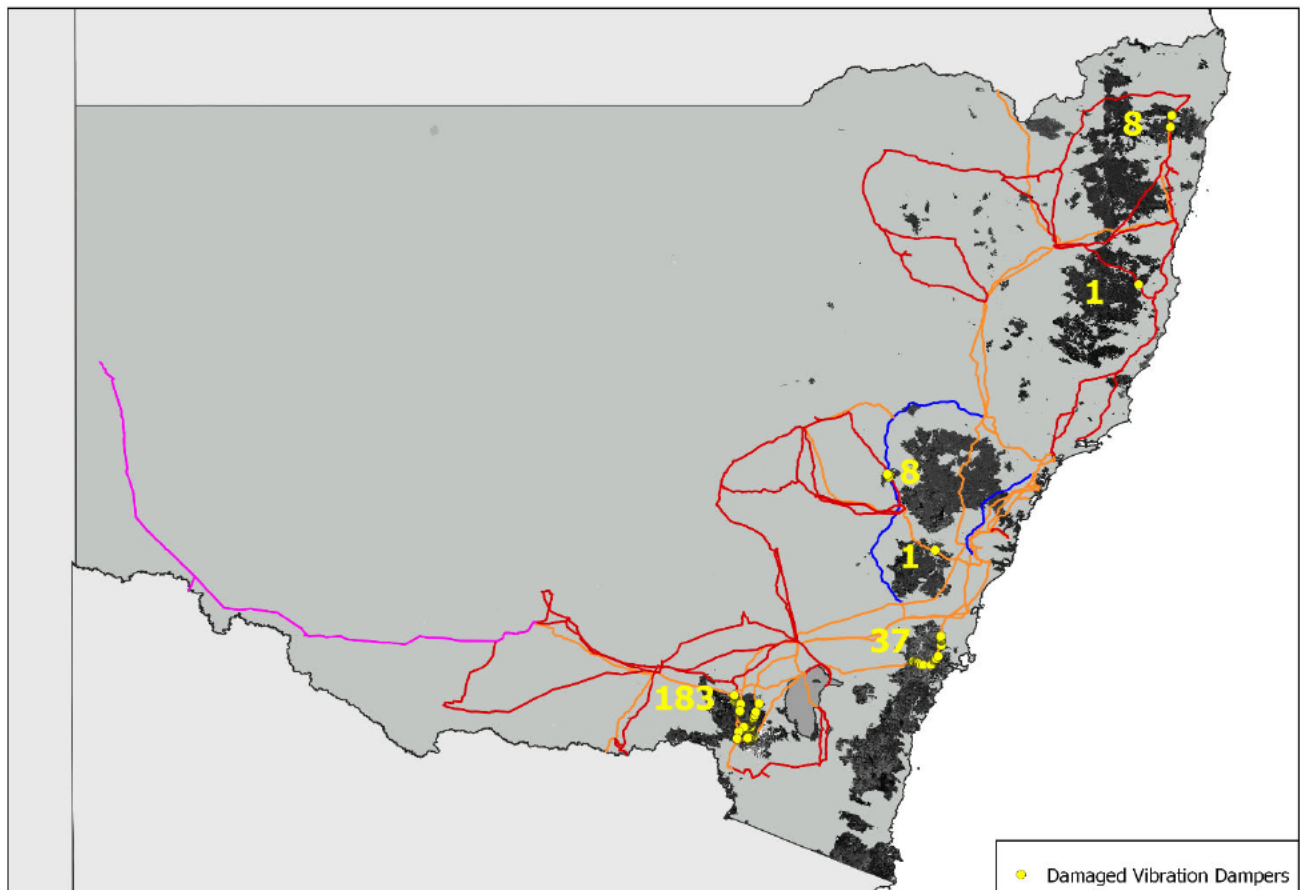
The melting point of PVC vibration dampers is approximately 100 °C to 150 °C, depending on mixture of the material. This can make them especially prone to bushfires. Damage to these vibration dampers were widespread.

Figure 44 – Map of melted vibration damper defects

For defects on earthwire dampers TransGrid states a one-year (P4) remediation and three months (P3) in the case of OPGW, due to the potential for fibre damage. The extent of damage for spiral dampers was widespread.

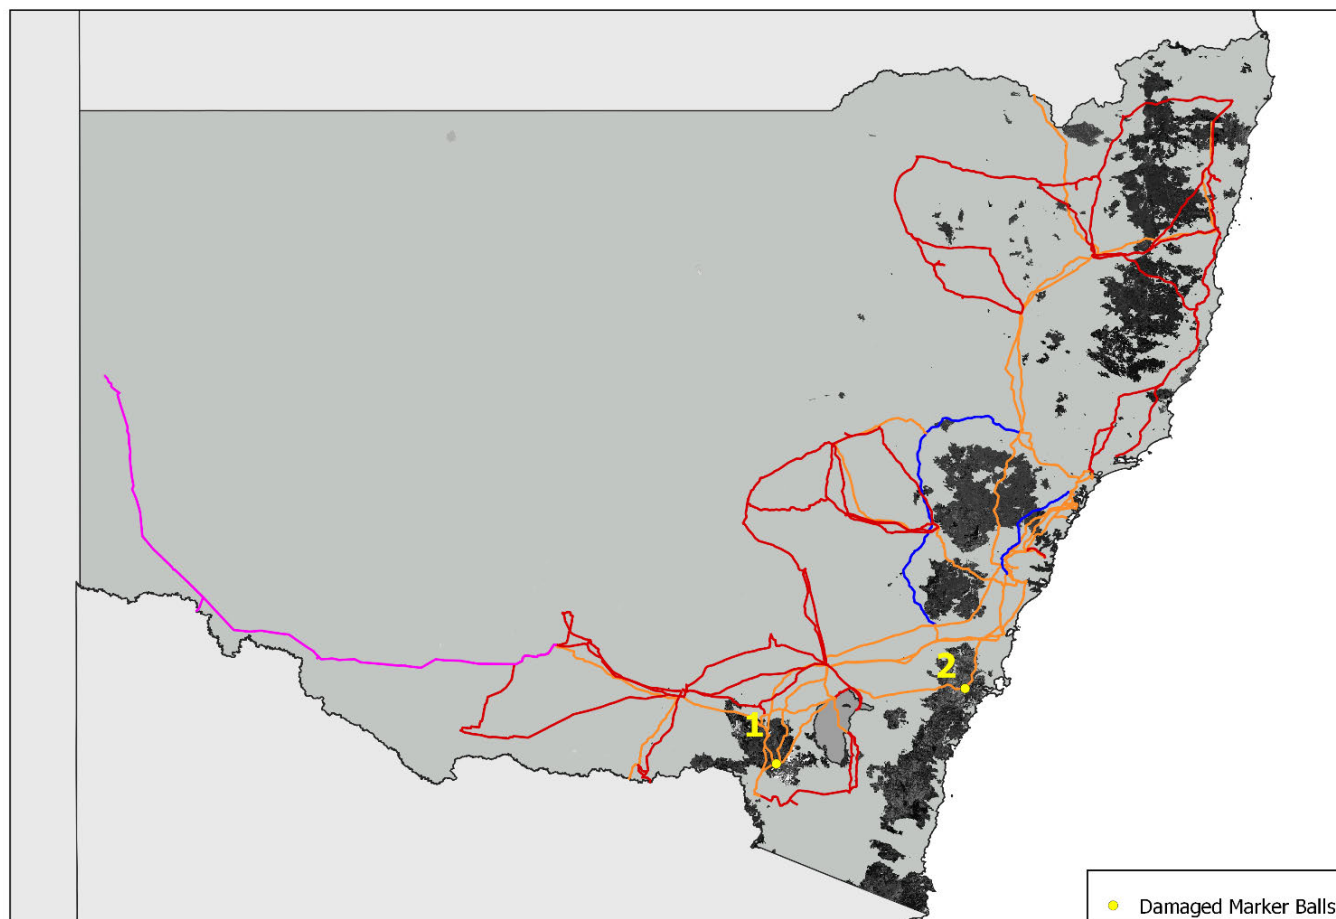
Three spans were identified with melted aerial markers (refer Figure 46). Two spans were on Line 3W Capital to Kangaroo Valley (refer Figure 47) are installed for low level operation safety. One span, on Line 64 (refer Figure 48), is installed due to the 90 m requirement. This is significant due to the distance of the ball from the ground to be engulfed with enough heat to cause damage.

Figure 46 – Map of melted marker ball defects
