# SEYMOUR CITY GATE REGULATOR PIT

## ELECTRICAL SURGE EVENT NOVEMBER 2009

Rev O      5 May 2010

Geoff Cope & Associates Pty Ltd

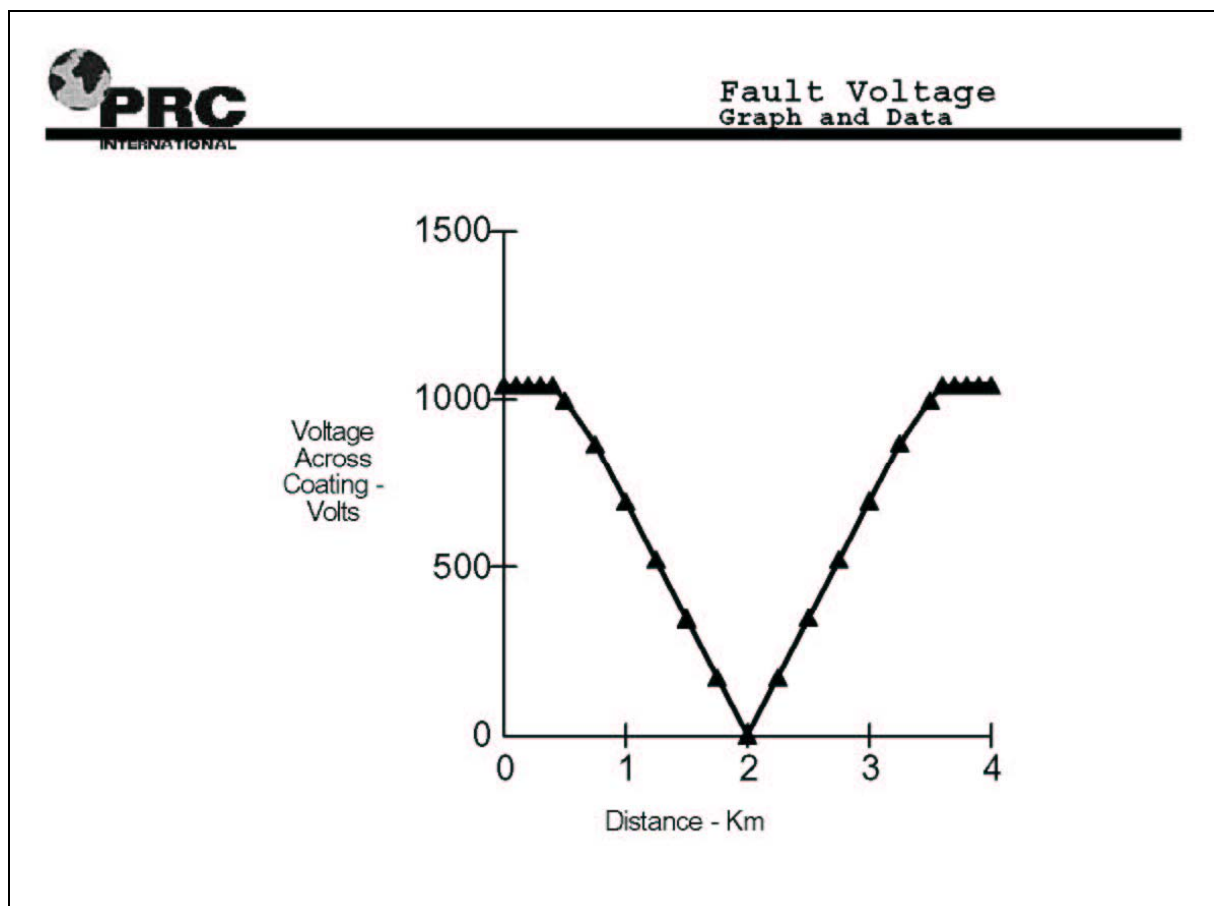
## Voltage induced from 66 kV powerline along Goulburn Valley Highway

Faulted Tower Data Comments
Comments	<p>200 mm gas supply pipeline into Seymour. Calculation of induced voltage using nominal typical parameters. Length of exposure = 3 km ( approx. actual), along Goulburn Valley Highway. Offset from powerline = 130 metres (typical actual along length). Pipe coating resistance 1 Meg ohm cm (assumed, conservative high figure). Fault current = 5 kA (assumed as a typical high fault current on a 66 kV rural supply). Soil resistivity = 10,000 ohm cm. (Assumed from observation of soil type. Not a highly critical parameter.) Assumed no mitigation or earthing - worst case evaluation.</p> <p>File Sey66kV1.acd</p>
