Warrego Scraper Station

Coating Assessment Report

Document No. BGS-RP-A-0009 Rev 0A				
File Path: \\falcon\exword\2012\12109\Engineering\APA Project Folders - 130513\23.3_BGS_Below Ground Station Pipework Recoating\20. Coating Defect Analysis\Warrego\BGS-RP-A-0009 Warrego coating assessment Rev 0A.docx				
Author	Adam Nuske <i>Adam Nuske</i>			
Report Checked by				
Report Approved by				
Changes to be approved by				
Version control	Date	Version	Nature of Change	Approved (Name) by
	10/07/2013	0A	Final	<i>Stephen [Signature]</i>

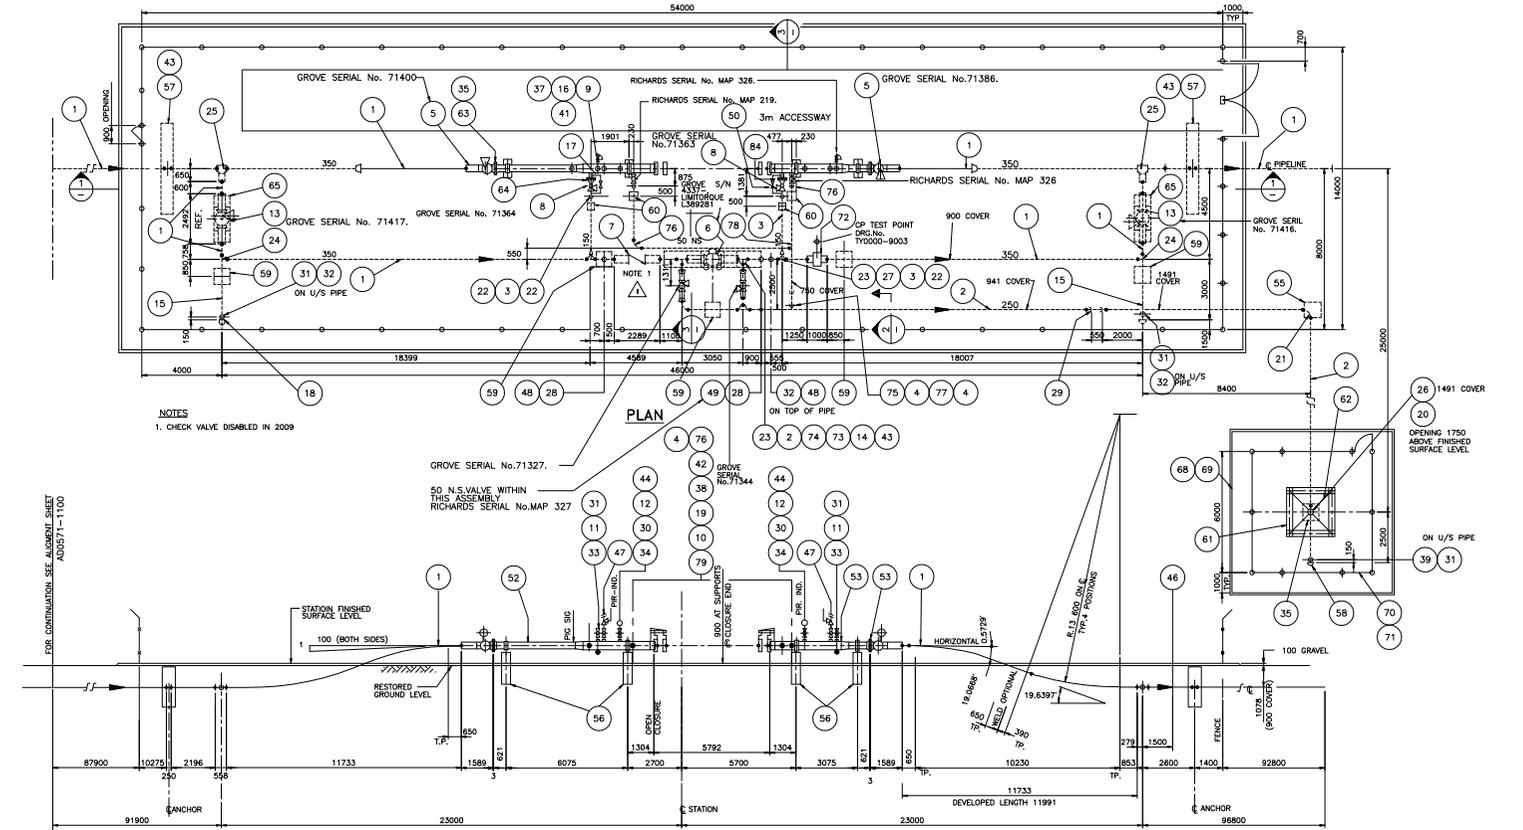
WARREGO DCVG, COATING DEFECTS & METAL LOSS

COATING DAMAGE ASSESSMENT REPORT ID#	DEFECT DIMENSION (mm) LxWxDDEPTH O'CLOCK POSITION ON PIPE	CAUSE OF METAL LOSS
1	220 x AROUND PIPE x 0.55	CORROSION
2	8x12x0.80 3 O'CLOCK	CORROSION
3	30x5x0.61 2:30 O'CLOCK	CORROSION
5	8x5x2.28 6 O'CLOCK	CORROSION
