Tanami Road Scraper Station

Coating Assessment Report

Document No. BGS-RP-A-0011 Rev 0A				
File Path: \\falcon\exword\2012\12109\Engineering\APA Project Folders - 130513\23.3_BGS_Below Ground Station Pipework Recoating\20. Coating Defect Analysis\Tanami Rd\BGS-RP-A-0011 Tanami Rd coating assessment Rev 0A.docx				
Author	Adam Nuske <i>Adam Nuske</i>			
Report Checked by				
Report Approved by				
Changes to be approved by				
Version control	Date	Version	Nature of Change	Approved by (Name)
	10/07/2013	0A	Final	<i>Stephen Hughes</i>

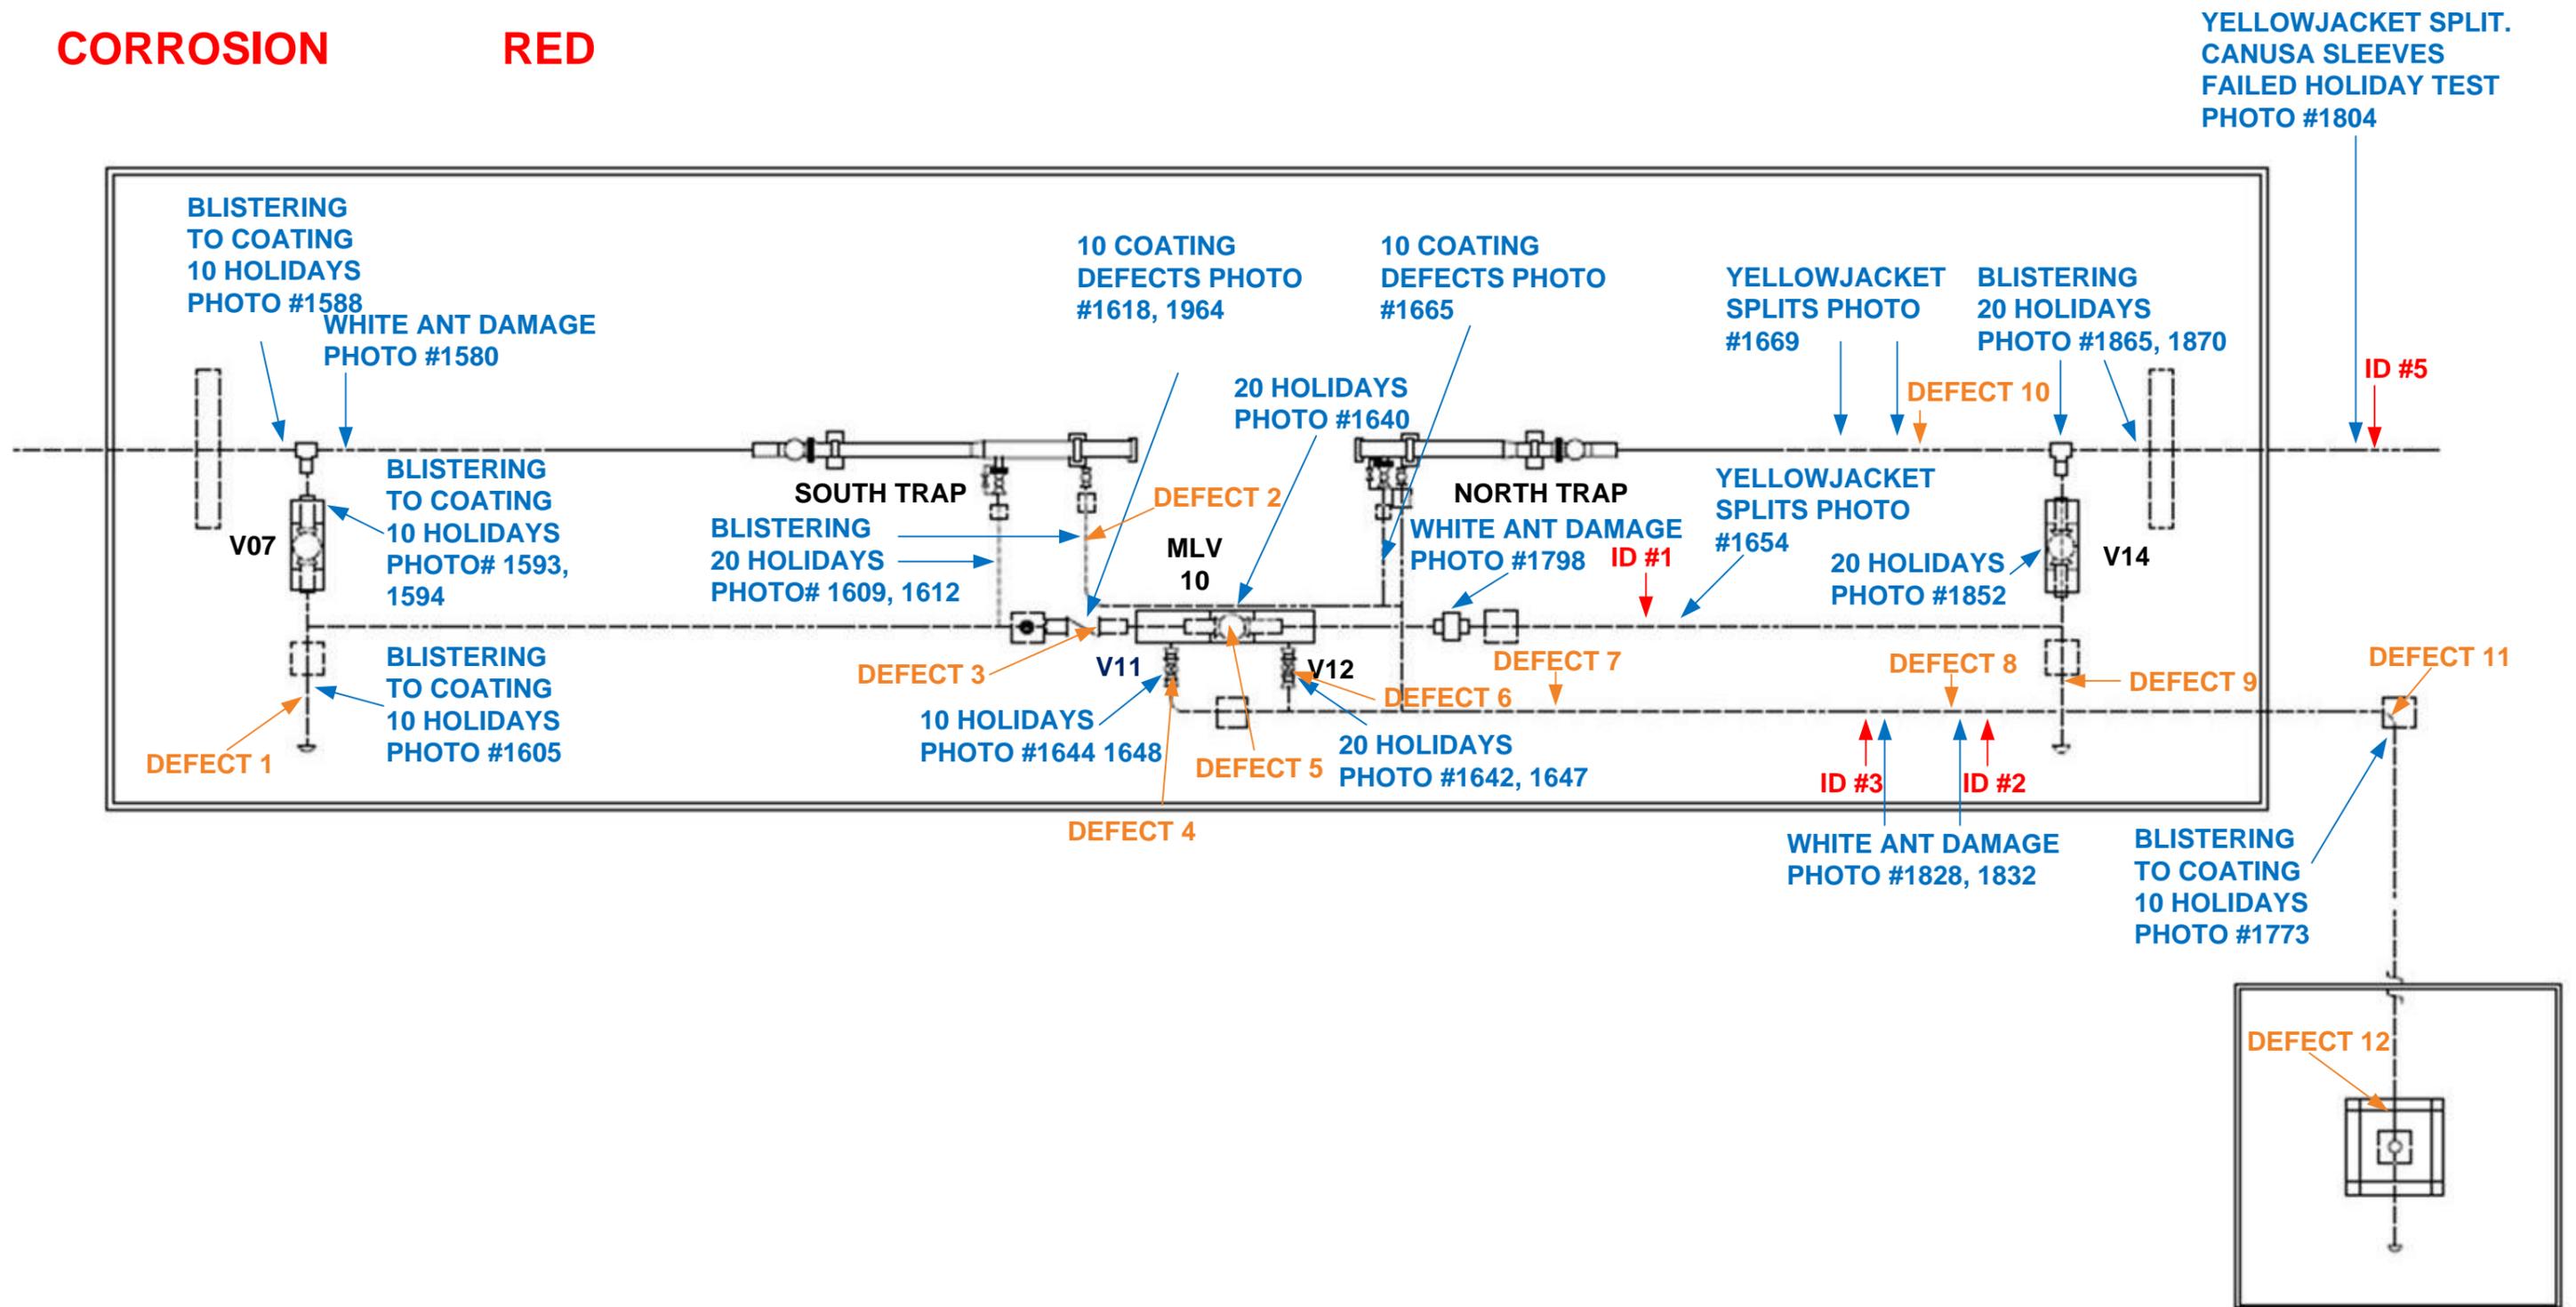
WARREGO DCVG, COATING DEFECTS & METAL LOSS

DCVG	IR (%)
DEFECT 1:	24.0
DEFECT 2:	9.0
DEFECT 3:	4.2
DEFECT 4:	6.8
DEFECT 5:	7.1
DEFECT 6:	2.3
DEFECT 7:	9.4

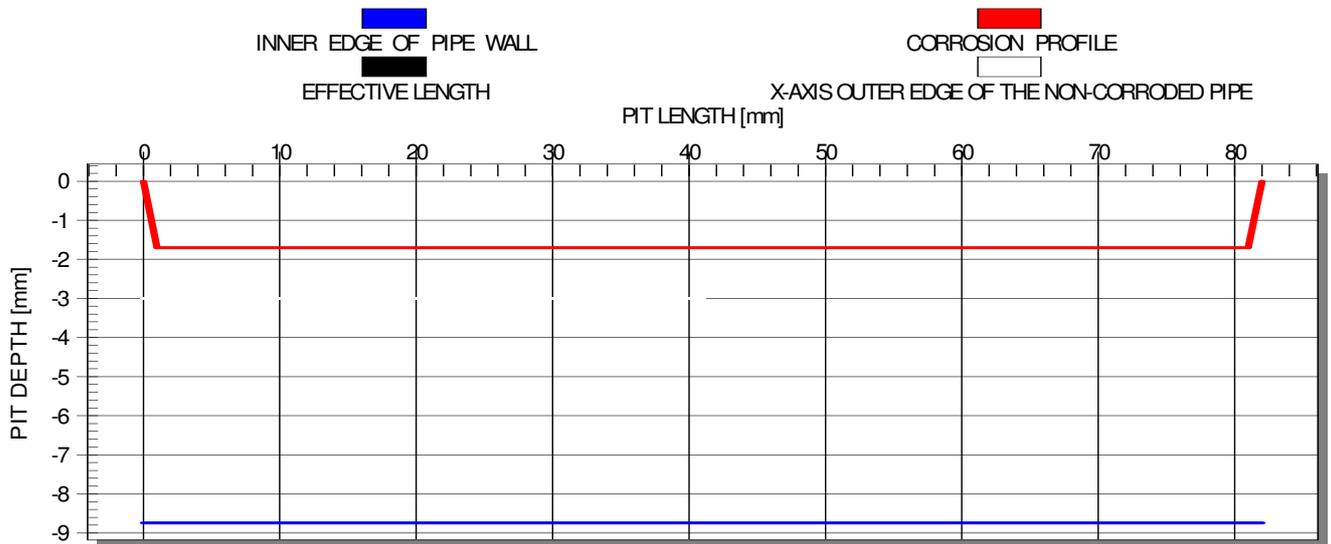
METHOD	Max.Safe Pressure [kPa]	Burst Pressure [kPa]	Safety Factor
RSTRENG - Effective Area	14617	21887	2.27
RSTRENG - 0.85dL	14617	22169	2.3
ASME B31 G	14617	21091	2.19

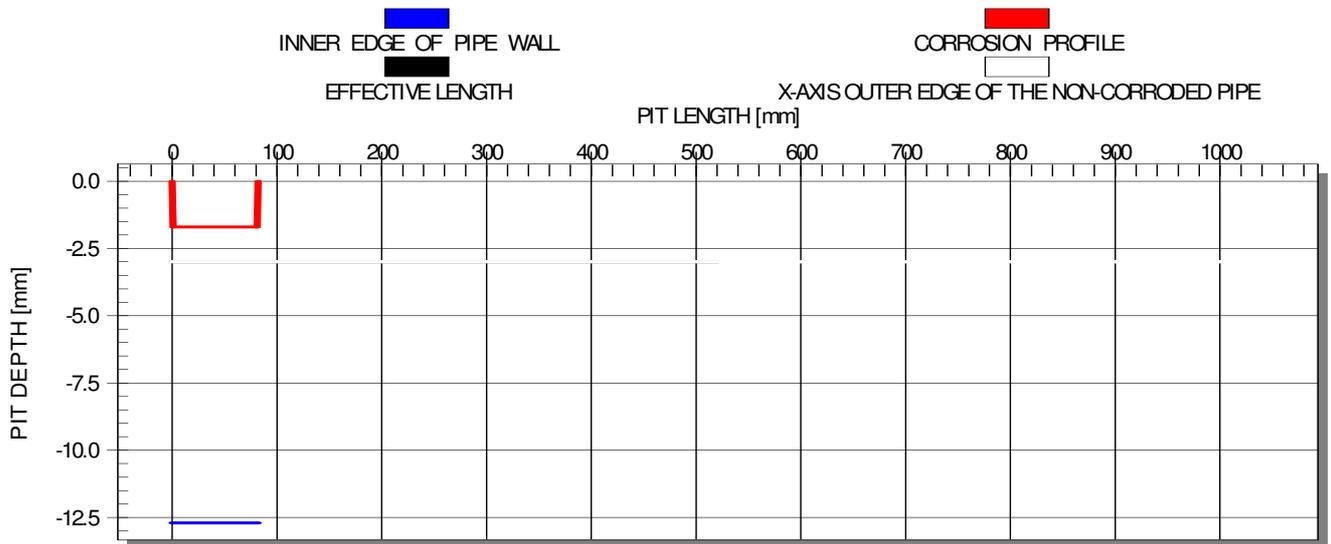
METHOD	Max. Safe Pressure [kPa]	Burst Pressure [kPa]	Safety Factor
RSTRENG - Effective Area	18411	29250	3.03
RSTRENG - 0.85dL	18411	29440	3.05
ASME B31 G	18411	27262	2.83
