GHD Vegetation Audits 2015-2018

2020-2025
Regulatory Proposal
January 2019

2015 Pre Fire Danger Season Vegetation Clearance Audit Report

2017 Cyclic/Pre-Summer Vegetation Audit

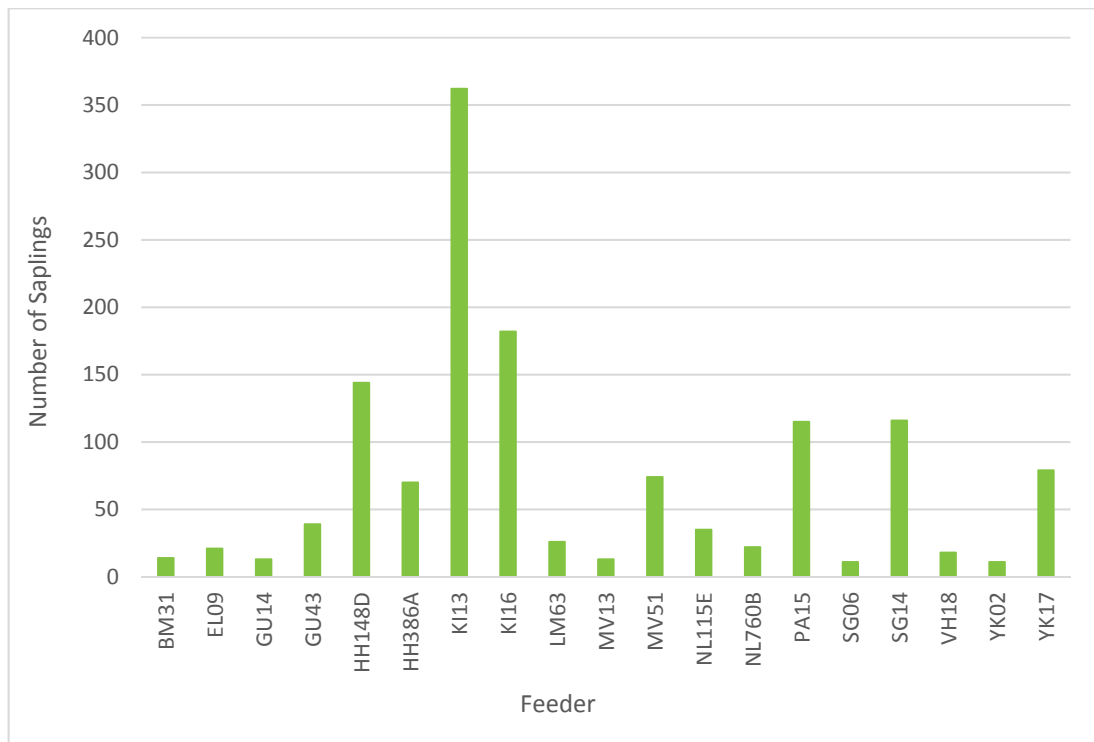
Figure 7-2 Number of saplings identified across a range of Feeders in the 2017 Pre-Summer audit ¹

At the Feeder level, the highest number of saplings are again associated with the Kangaroo Island District, localised around the KI13 Island Beach 11 kV and KI16 Brown Beach 11 kV Feeders (Figure 7-2). The HH148D Burnside 11 kV Feeder also contained a high density of saplings. A sapling count above 100 was recorded for Port Augusta and Stirling Districts.

^a Figure 7-2 is a subset of the audit dataset, and does not reflect many of the Feeders which had sapling counts of 10 or less.

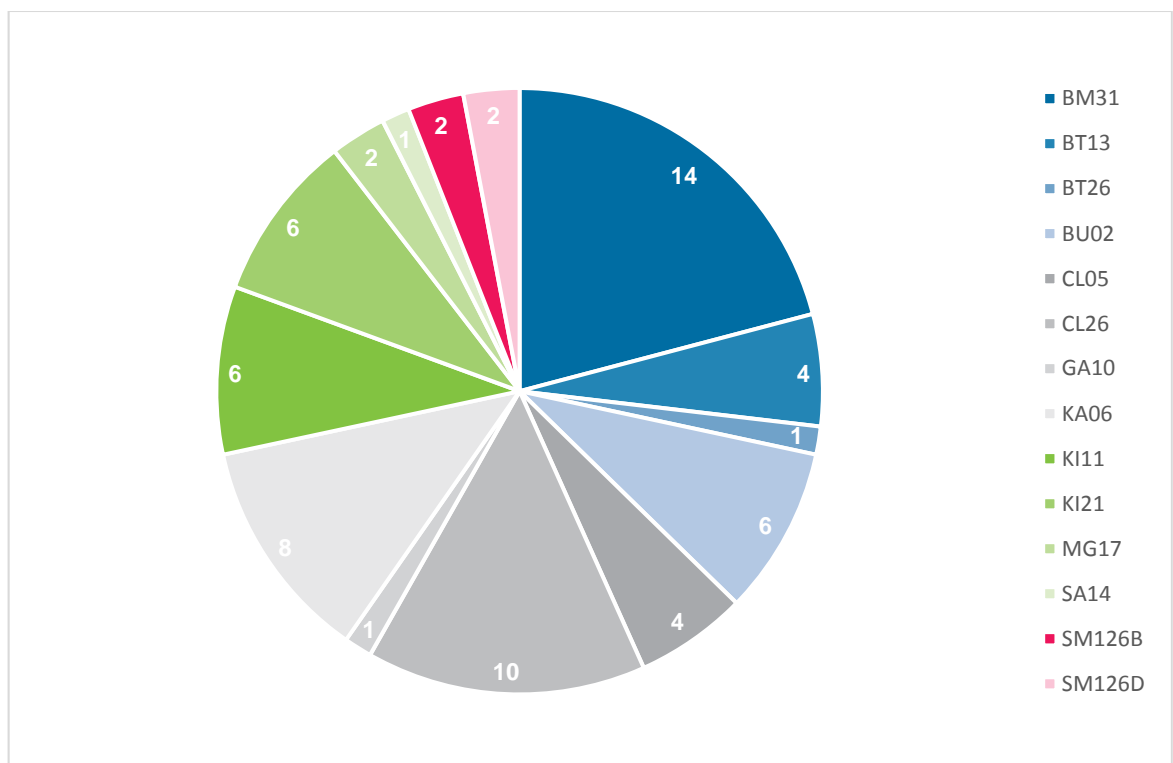
Figure 7-3 The number of saplings observed on only one span within the respective Feeders

Across 14 Feeders, saplings were identified on only one span for each of those Feeders. This is presented graphically in Figure 7-3.

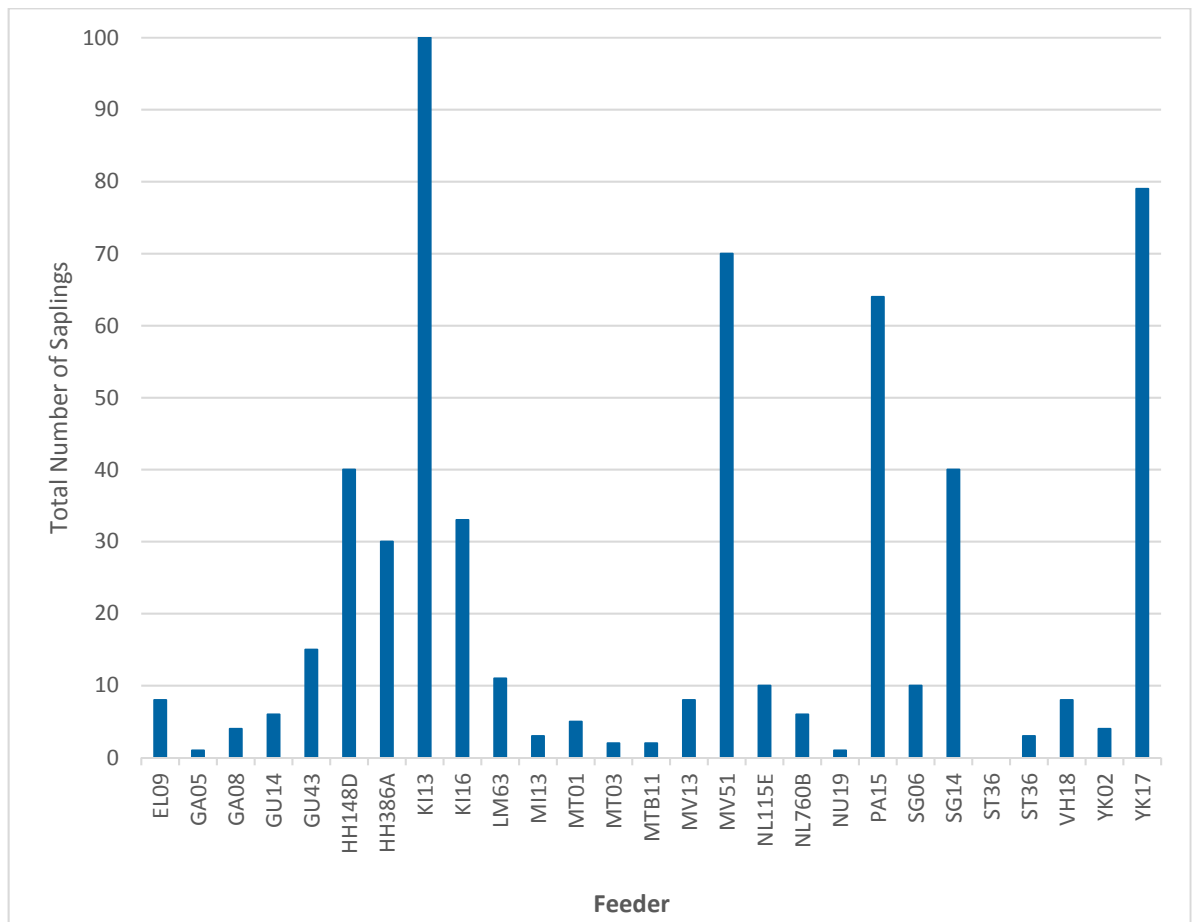
Figure 7-4 Total number of saplings across one span within the respective Feeder

At the span-level, sapling predominance in any one span within a Feeder is represented graphically in Figure 7-4. From this figure, the sapling count within any one span was highest in the KI13 Island Beach 11 kV and the YK17 Point Turton 11 kV Feeders.

- The greatest number of saplings identified on a per span basis was on the KI13 Island Beach 11 kV Feeder.
- Very few saplings were identified in the West Coast and Yorke Peninsula Districts. However, a significant number of saplings (79 in total) were identified in one span on the YK17 Yorketown 11 kV Feeder.
- A significant number of saplings were identified in Holden Hill near the Cleland Conservation Park. Approximately 20 saplings per span were observed for four consecutive spans. These saplings were mostly identified as gums and wattles.
- The high number of saplings identified is indicative of a potentially significant increase in cutting volumes in the future – unless appropriately addressed and managed.
