Unmodelled repex: Business cases for “other” repex

Reactive Asset Replacement Program

Reactive Asset Replacement Program 2015/16 - 2019/20

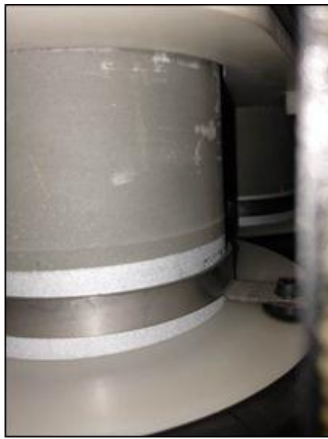
Damaged screen SSLYT CB1022

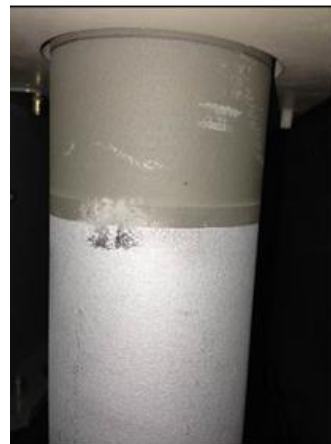
Damaged screen SSLYT CB1T32

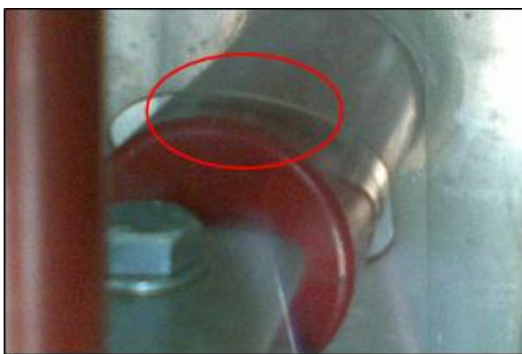
SSBTA Problematic high stress air gap

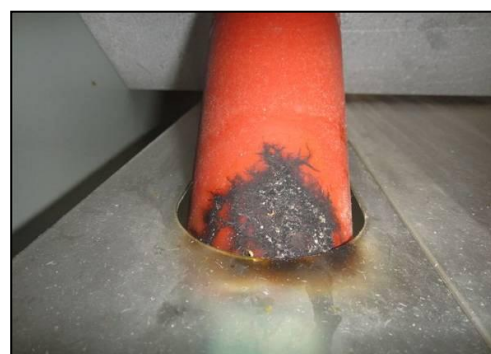
SSCPC Degraded bushings

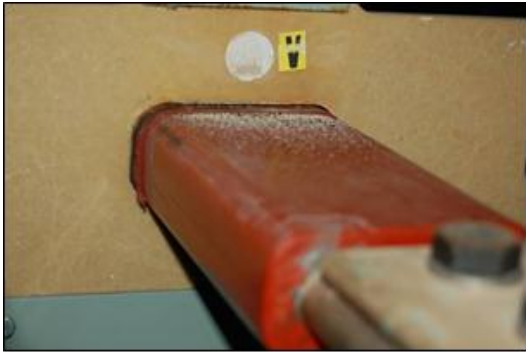
SSCVL Damaged earth screen

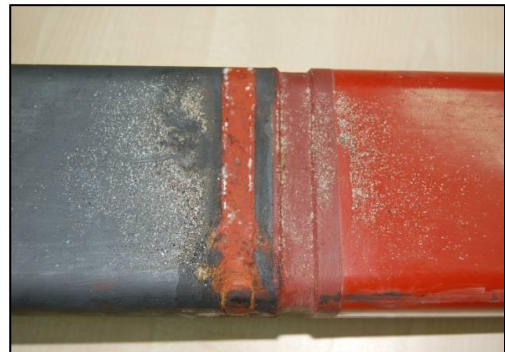
SSCVL Close up of earth screen damage

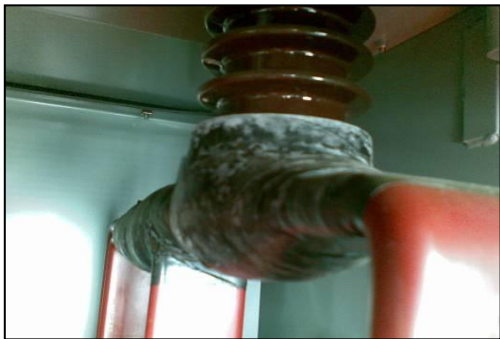
SSGVN Degraded joints

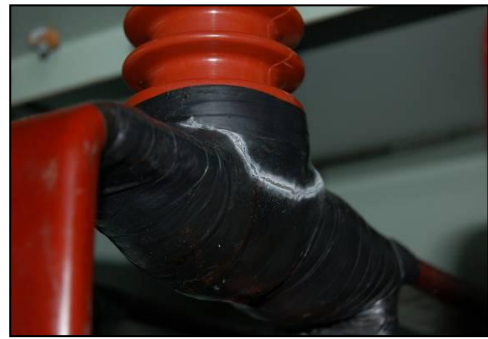
SSRBA degraded joints

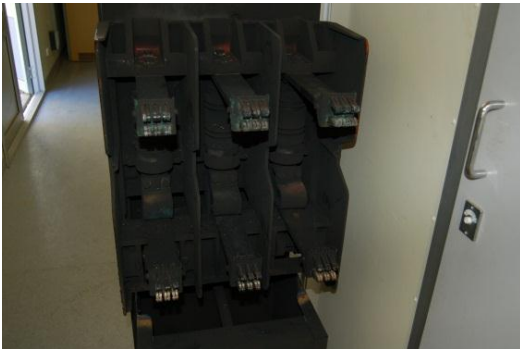
SSMFD Catastrophic CB failure

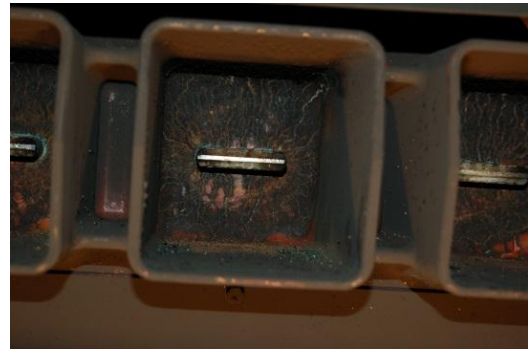
SSMFD Catastrophic CB failure

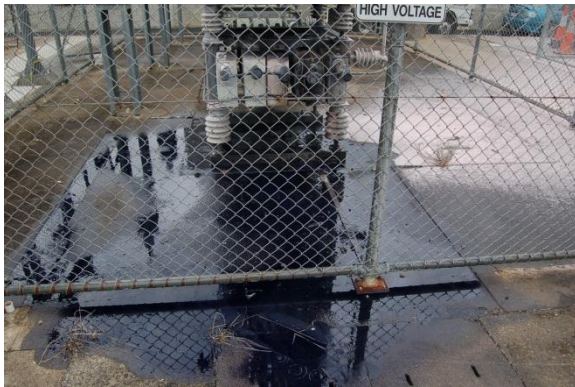
The overvoltages due to switching with vacuum CBs may damage the connected apparatus (capacitor banks, transformers), and with regular switching of the CB, damage can occur again and again! A replacement option would be to utilise a more appropriate CB for the routine switching of the capacitor bank such as a puffer type SF₆ CB or other device designed for capacitor switching which is less likely to cause switching problems. In a restriking event at substation SSRVW, a cable box on a transformer at an adjacent substation SSIPS simultaneously suffered a flashover. Another case was the complete destruction of the capacitor bank at substation SST108 during a restriking event.

Failure of capacitor bank at SST108

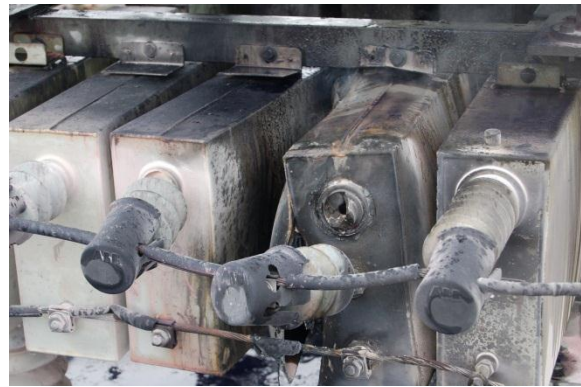
Capacitors from SST108

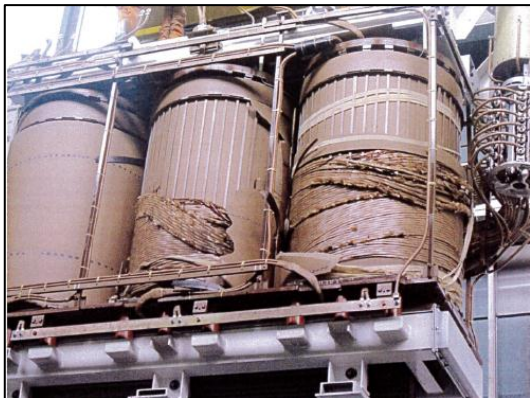
In November 2012, an 80 MVA power transformer, TR52854 (TR6 at Coomera) failed catastrophically, with an internal fault leading to the displacement of the three windings. The windings were damaged and required rewinding. The presence of corrosive sulphur compounds in the oil was identified by the transformer and on load tap changer (OLTC) manufacturers as a predisposing condition to the failure. In the case of this transformer the corrosive sulphur oil reacted with silver on the contact tips within the OLTC selector forming a coating of conductive silver sulphide. This lowered the dielectric strength of the oil and insulation breakdown occurred.

SSCMA winding damage

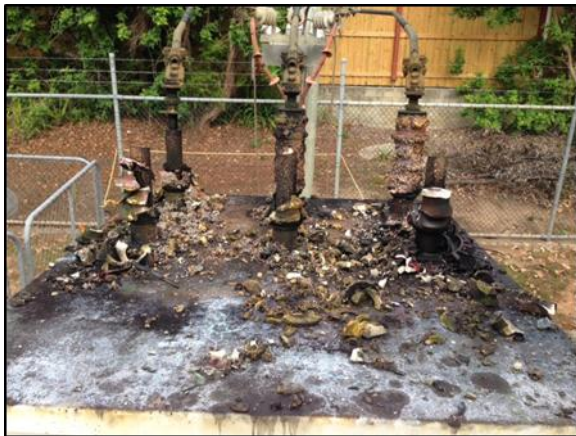
In the past 2 years Energex has experienced 4 catastrophic failures ██████████ outdoor CBs. This particular model of CB is an indoor withdrawable OCB that has been modified to fit inside a cubicle, with outdoor porcelain bushings on the top to facilitate connection to overhead open busbar type 11kV substations. The failure arises when the small volume of insulating oil in the top of the bushing is lost resulting in moisture ingress. As the bushing core is paper based insulation and thus hygroscopic, water absorption over time leads to catastrophic insulation failure.

Destruction of bushings at SSLDR

Taking into account the age of the CB (44-47 yrs.) and the fault rating of 13.1kA is less than the typical fault levels on the network, it is not economically viable to repair the bushings. The only safe course of action is to replace with the new CBs.

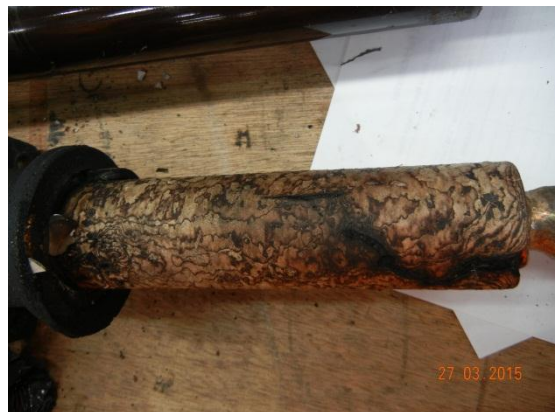
SSLTN tracking due to water ingress

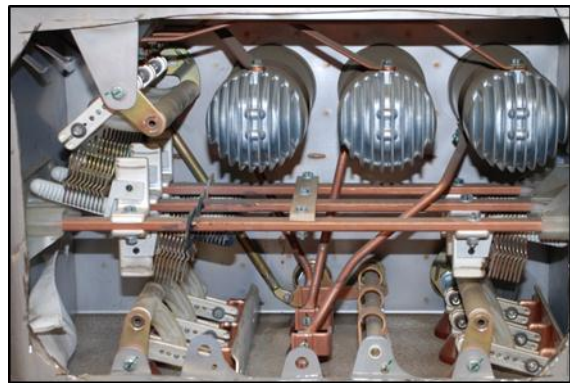
Energex operates a population of approximately 8,500 11kV RMUs. On several occasions, a design fault on a mechanical switch allowed the contacts to overtravel into an indeterminate position between OFF & Earth, which initiated an internal arcing fault. This situation is dangerous to operators and also destroys the asset. To rectify this, a large high risk batch was rectified (1,000) and the entire population, which can still fail are required to be operated with an overtravel arresting device (mounted on the front panel). This objective of the device is to limit travel of the mechanical switch and this will allow the unit to survive, and can be repaired.

Rear of RMU with overtravel arcing

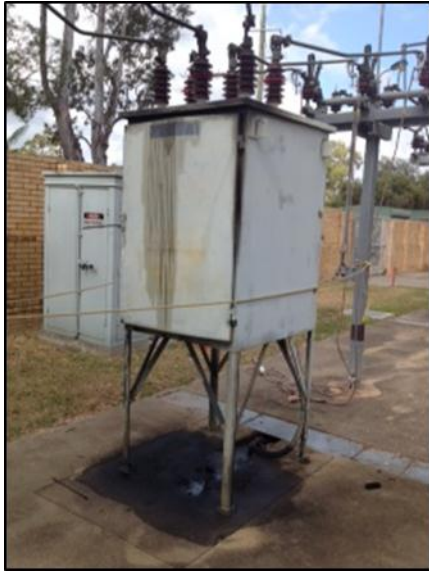
SSLTN 11kV OCB failure exterior

The photographs above from substation SSLTN show an 11 kV OCB that actually cleared a fault, but in doing so, suffered internal structural damage. During the reclose dead time (20s) the CB flashed over on the live side bushings inside the oil tank and failed catastrophically, ejecting oil from the enclosure.

Failure to replace these OCBs in a timely manner may significantly increase the risk of catastrophic failure. The failure of oil switchgear has been attributed to serious injuries and even fatalities in certain cases.

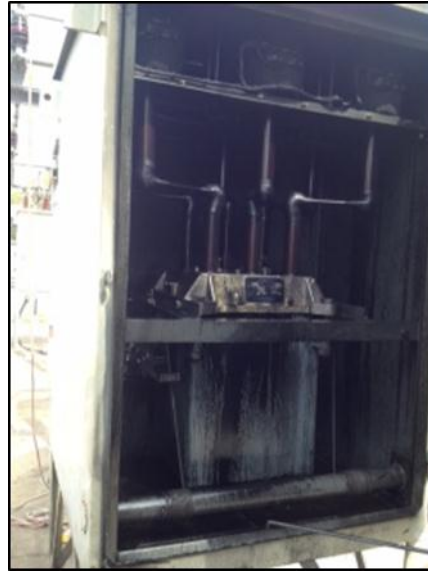
SSLTN 11kV OCB failure internal view

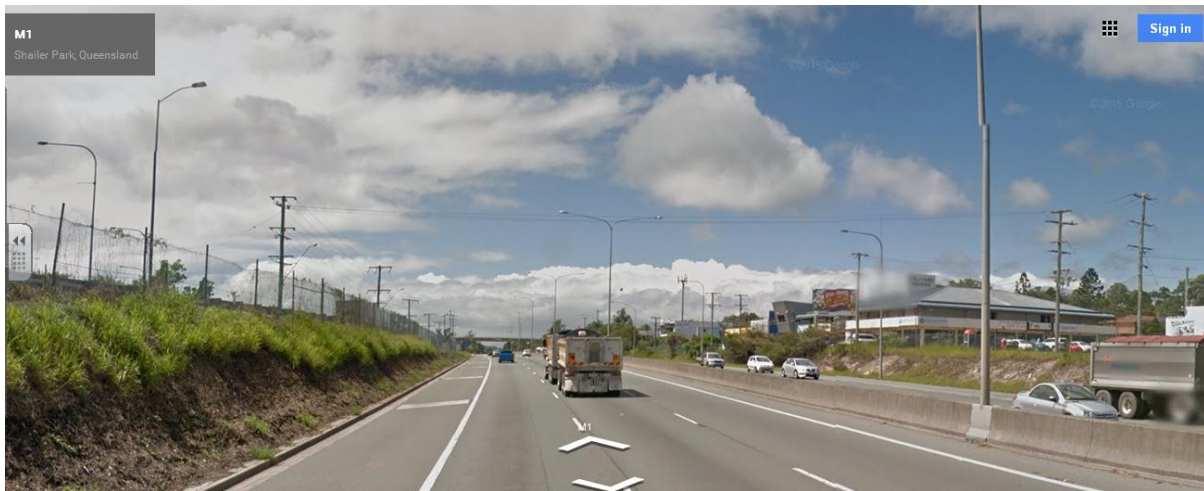
The concern for this feeder is that there are spans of this feeder that traverse a major interstate 6 lane carriageway, the Pacific Motorway (M1), which carries high volumes of domestic vehicles as well as being rated as a multi-combination dangerous goods route. This presents a safety risk to the public if the feeder was to experience a fault and fall over the motorway. This also presents significant difficulty in accessing the area to make safe and to repair any damage.

Figure 10: F419 crossing over the Pacific Motorway (M1)

The risk of failure of overhead conductors and associated equipment such as bridges and clamps increases as the fault current and clearing time of protection systems increases. The safety risk that this presents is not considered to be as low as reasonably practicable as high speed protection on this type of asset is expected by the community and the industry. An upgrade of the protection scheme reduces the risk and avoids the more significant capital expenditure to relocate the motorway crossing or to underground the supply.
