Jemena Electricity Networks (Vic) Ltd

Replace Broadmeadows (BD) Zone Substation Transformer

2021 and 2022 Business Case

31 January 2020

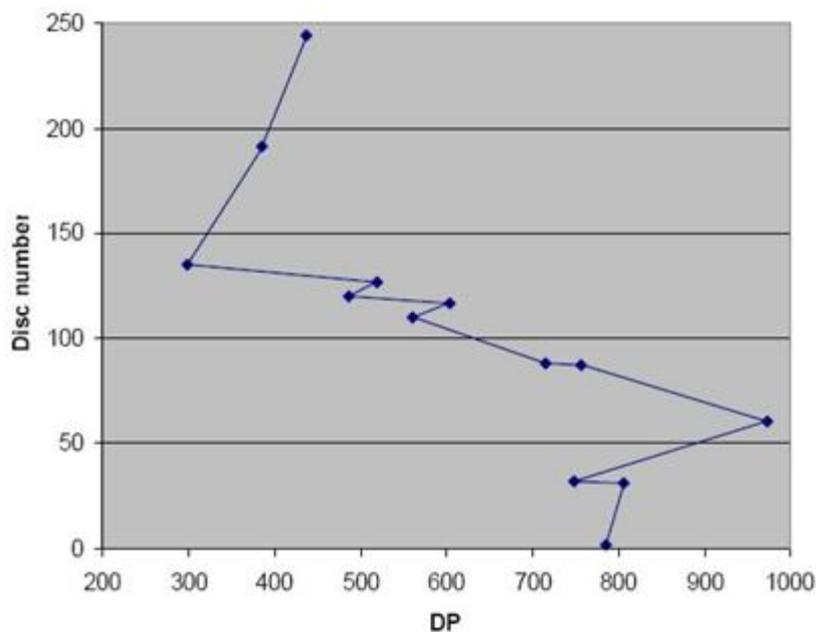
Figure 2-6: Degree of Polymerisation along a Transformer Winding

The paper samples at zone sub BD were taken from leads located within the top of the main tank, but DP values will be significantly lower within the transformer windings. Statistically it can be expected that failure rates will increase quite rapidly as a result of the transformers present condition.

In addition the degradation of paper of a small localised area of insulation in the vicinity of the hottest spot within the transformer winding can be just as terminal as the degradation of the entire winding insulation. The DP of the No.1 and No.2 transformers at BD can be as low as 150 within the hottest spot of the winding which is well below industry standard.

- The hottest part of the transformer – the middle of the winding – exhibits the lowest DP value.
- The insulation at the base of the transformer remains cool for most of its life and typically suffers little degradation.
