Cockatoo Conductor Replacement Program

Regulatory Business Case (RBC) 2024-29

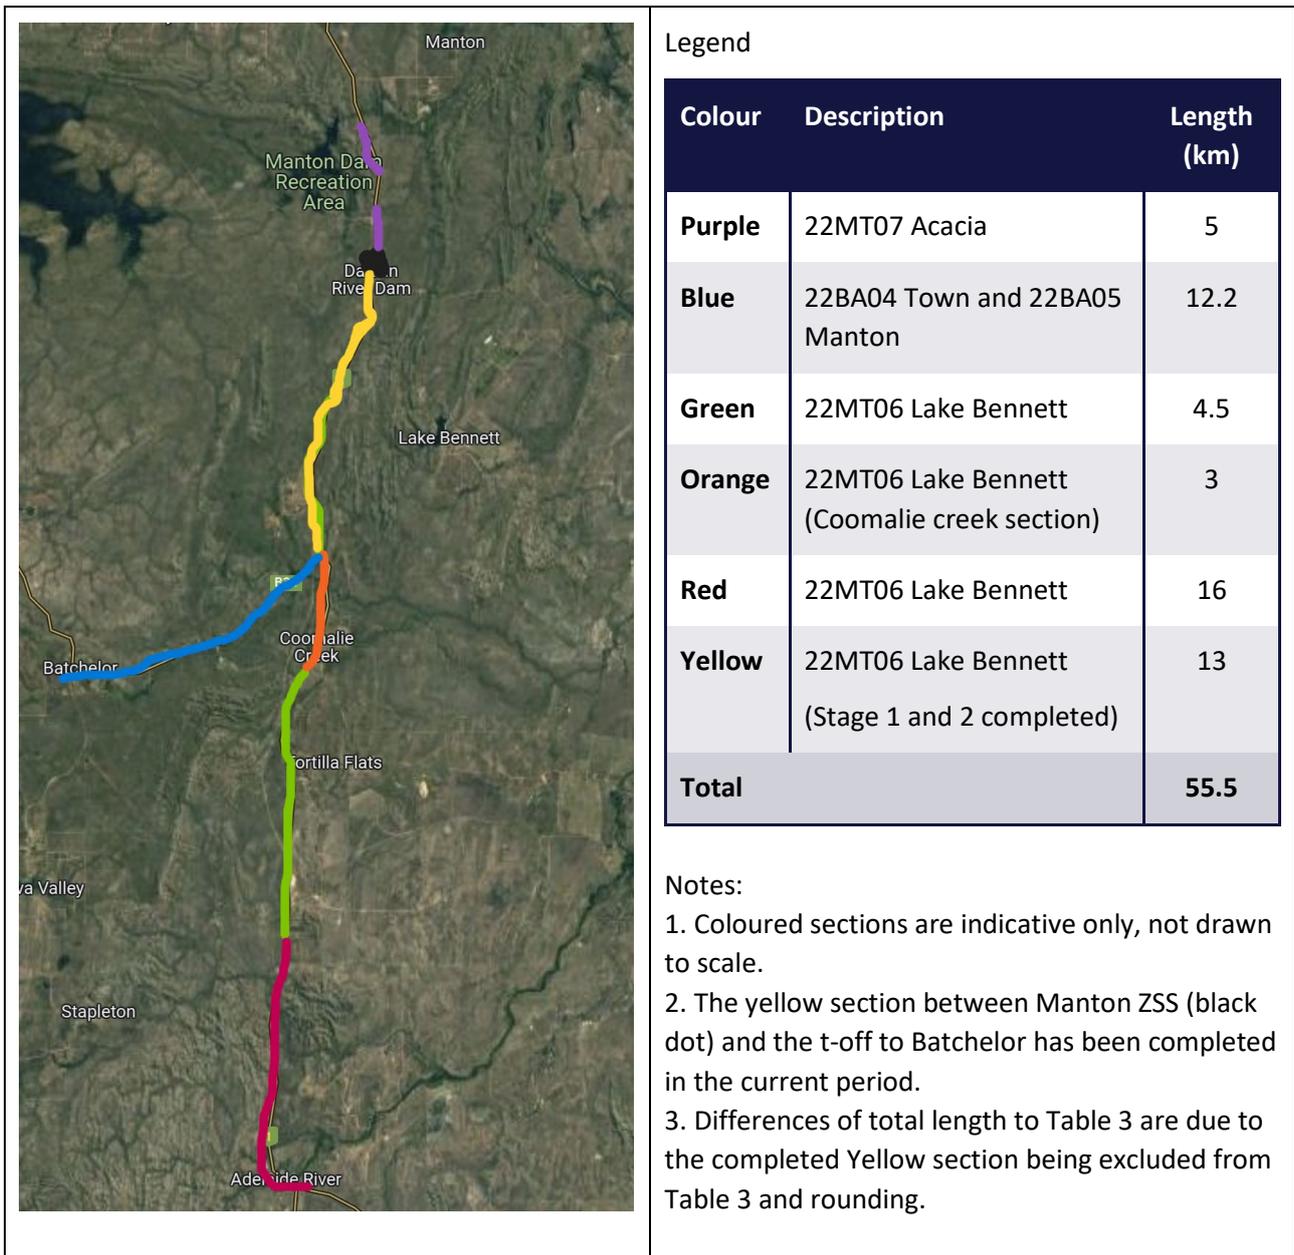
Figure 1 Cockatoo conductor

Figure 1 below shows the geographical area where the affected Cockatoo conductor is located on the network. There is a radial 22kV overhead feeder emanating northward from the zone substation, a radial 22kV overhead feeder emanating southward, and a tee-off towards Batchelor.

- 5 km of Cockatoo conductor on the Acacia feeder (purple line in Figure 1).
- 3 km of Cockatoo conductor on the Lake Bennett feeder (orange line in Figure 1), and
- 16 km of Cockatoo conductor on the Lake Bennett feeder (red line in Figure 1).

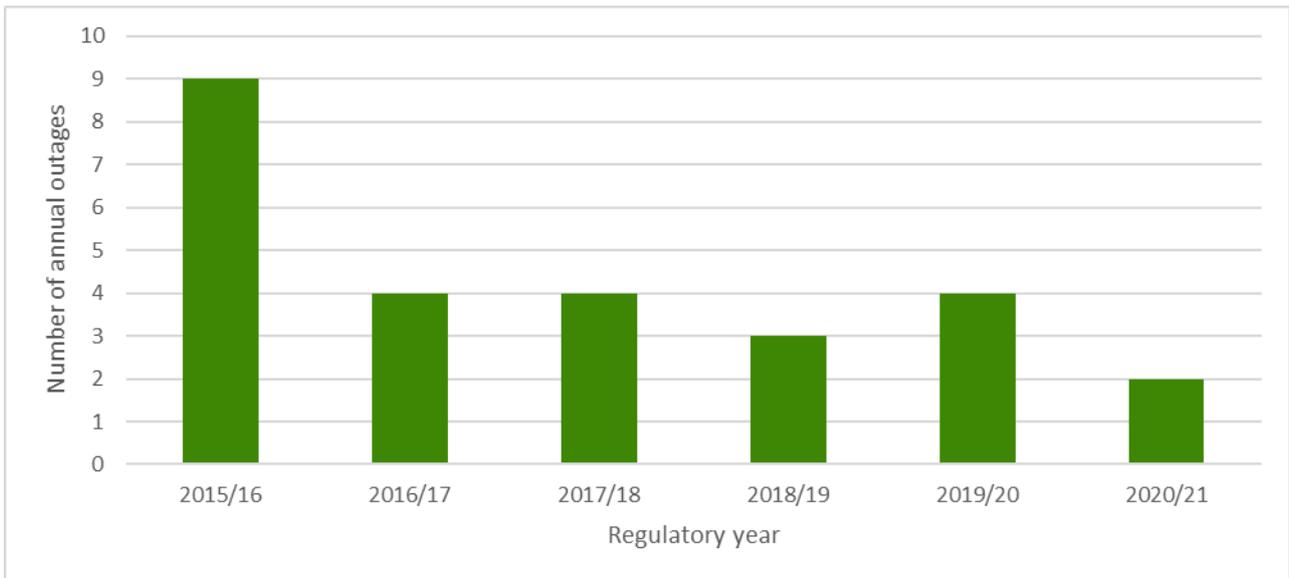
Figure 3 Historical number of outages caused by asset failure

Figure 3 shows there have been four outages per year caused by asset failure, and Figure 4 and Figure 5 show examples of the different deterioration and failure modes of the cockatoo conductors.

Figure 3 (above) shows that there is a high number of outages annually on the feeders with Cockatoo conductors. There are approximately 4 outages occurring every year and the time to repair depends on the extent of the consequential damage to poles and insulators, as well as the time of the year as heavy equipment is required to re-string the lines. Field crews have reported failures without secondary damage requiring up to eight hours to repair, while in at least one case it has taken several months. For most of the feeder, supply can be restored through back feed from Adelaide River or Batchelor zone substations.

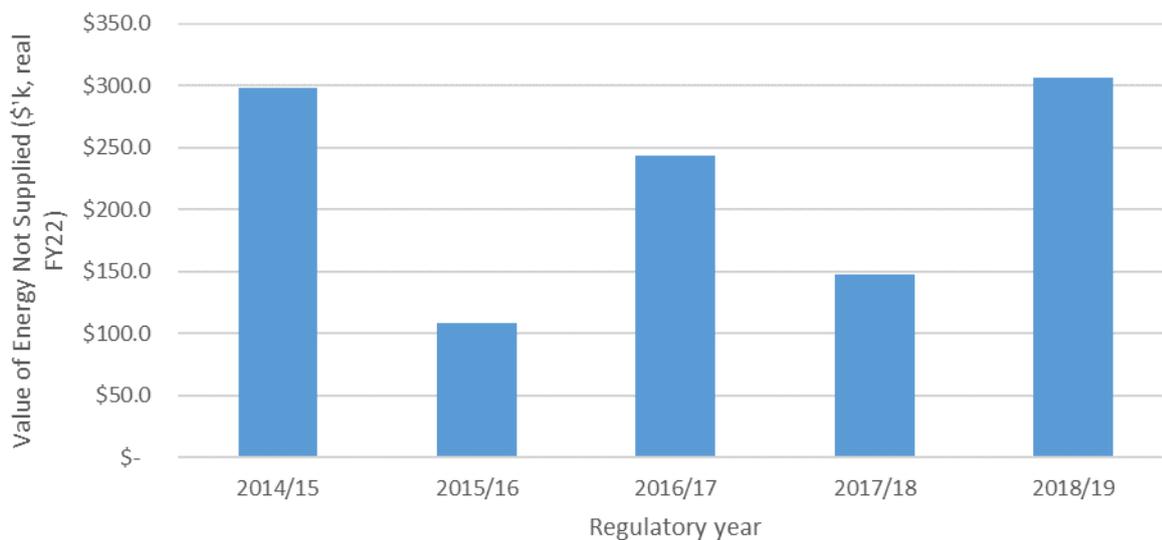
Figure 6 Value of energy not supplied

The economic cost of these outages is shown in Figure 6 below, using the Northern Territory value for residential Value of Customer Reliability (\$18.99 per kWh). There is no clear trend, but the average value of energy not supplied across the five-year period is \$220,000 per year.

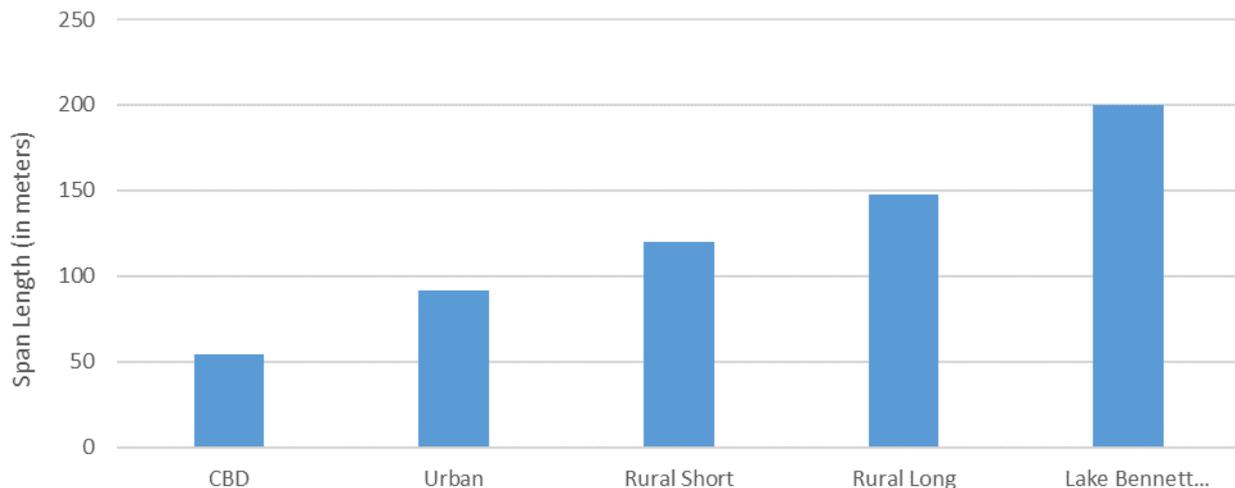
Figure 7 Average span length comparison

The Lake Bennett feeder design involved long span lengths of 200 - 300m which, as shown in Figure 7, are very long compared to the standard design of feeders on Power and Water's network. This feeder design was achieved by increasing the conductor tension which has several implications:

- High conductor failure rate (discussed above) as excess tension leads to reduction in asset life due to mechanical stress.
- Routine maintenance and repairs are very challenging for the field crews to perform as specialised equipment and training is required for field crews who work on this asset so that all the maintenance work carried out on this feeder can be done in a safe manner.
- Any repairs carried out on this feeder have long restoration times due to the feeder location and terrain, the conductor tension and large span length, and access to the appropriately trained crews and equipment. All these factors make it difficult to complete repairs and cause delays in restoring the power supply to affected customers.

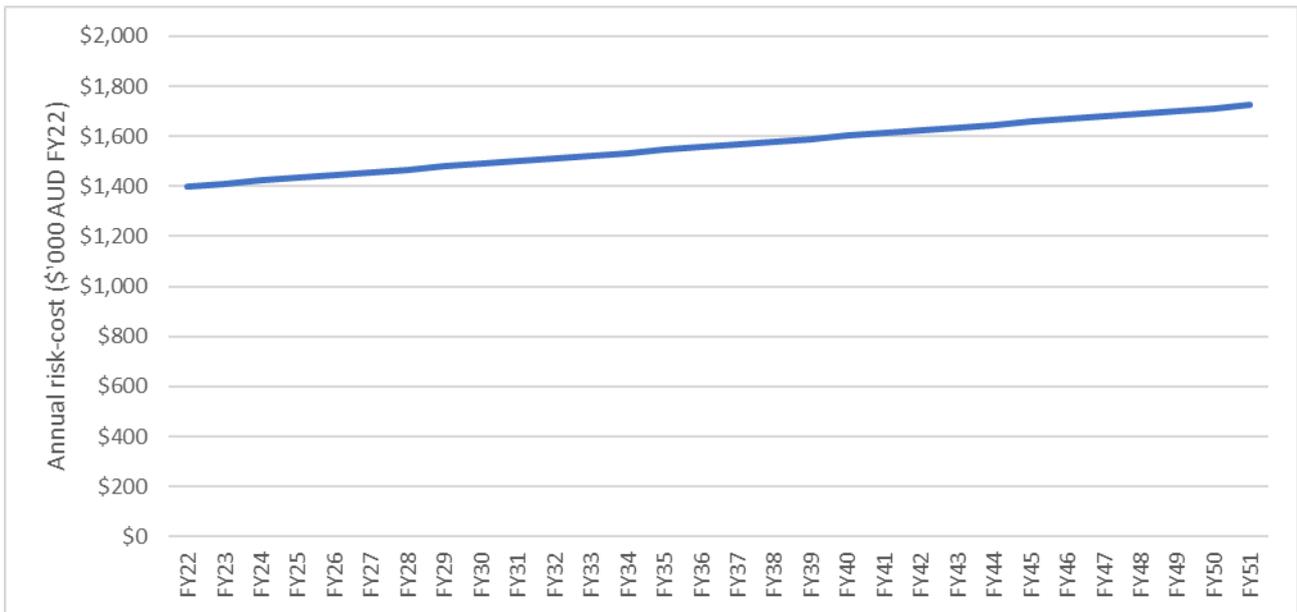
Figure 8 Annual risk cost applying the Values and Model Framework if only replacing at failure

This assessment has been undertaken based on the counterfactual case, that is, on the basis that Power and Water does not undertake any mitigation measures to address the risk and only addresses faults reactively as the base case scenario. Figure 8 shows the increasing level of risk that would be carried by Power and Water in the absences of any mitigating actions.

The dominant components of this increasing level of risk are the economic impacts of outages which are calculated based on the Value of Customer Reliability (VCR) and the risk of penalties for non-compliance with clearance (distance from the ground to the conductor) requirements. While the consequence of health and safety impacts are significant, the probability of them materialising is very low as the feeder is in a rural area and offset from the road with few spans that cross over roads or driveways.

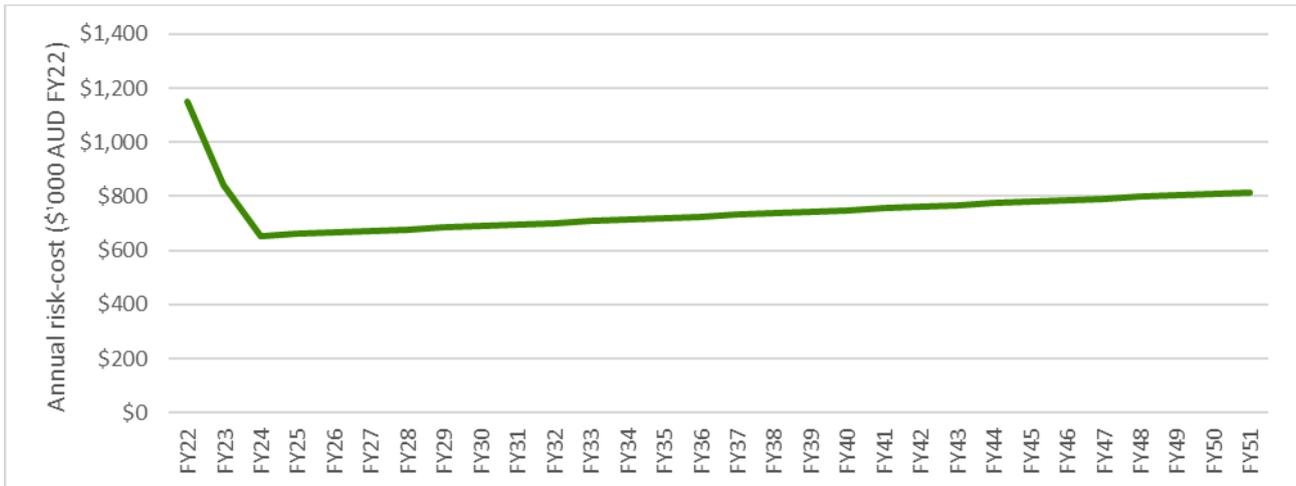
Figure 9 Risk profile achieved through Option 1

The Risk Quantification Procedure was applied to assess the risk posed by this asset. The resultant quantified risk-cost is shown in Figure 9 below. This option was assessed to result in the highest residual risk cost of the three credible options, indicating the worst network performance and highest risk to health and safety. The decrease in risk up to FY24 represents the benefit achieved from the current project that is forecast to continue until FY24 based on the currently approved scope and budget.

There is no capex associated with this option for the next 2024-29 regulatory period. However, it has the highest risk, with an increasing annual risk-cost (as shown in Figure 9 Risk profile achieved through Option 1), and does not address the underlying need that was identified in section 2.3.

This option proposes to only repair the Cockatoo conductors in a reactive manner post failure. This means incurring the cost of the outages and accepting the risk to public and worker safety. In addition, the cost per unit of emergency replacement or repair of conductor post failure is higher than a planned outage and programmed replacement work.

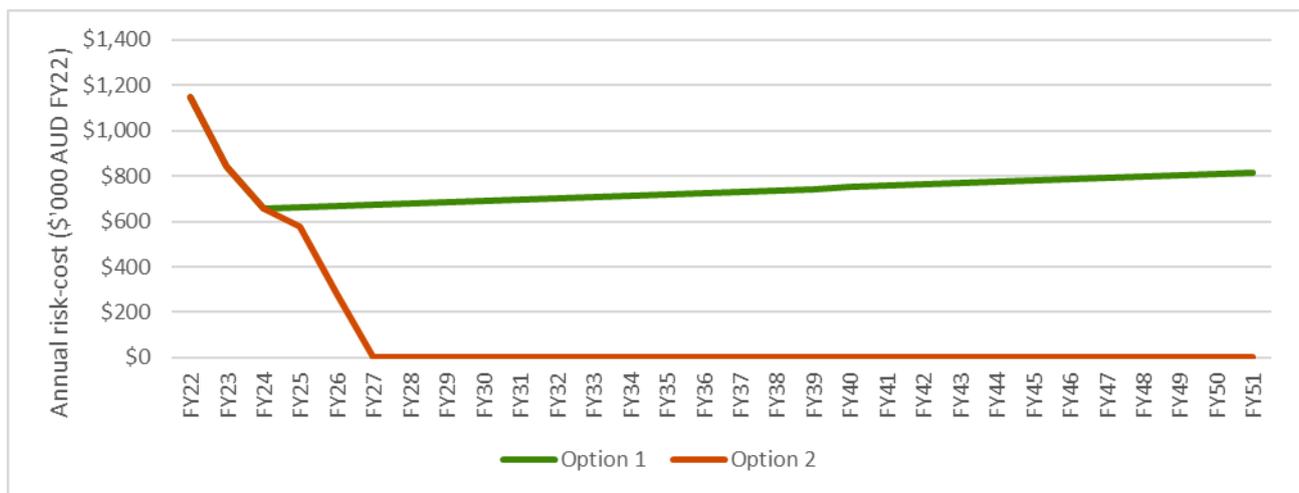
Figure 10 Risk reduction achieved through Option 2

The residual quantified risk-cost of this option is shown in the Figure 10 below. This analysis have been completed on the basis that the scope of works planned for the current regulatory period will proceed.

This option proposes to replace all sections of cockatoo conductor along with the installation of mid span poles and pole tops. It involves standard conductor installation with ready availability of suitable equipment and training which operational crews are already familiar with. This option can be delivered within time and budget. It has the following benefits:

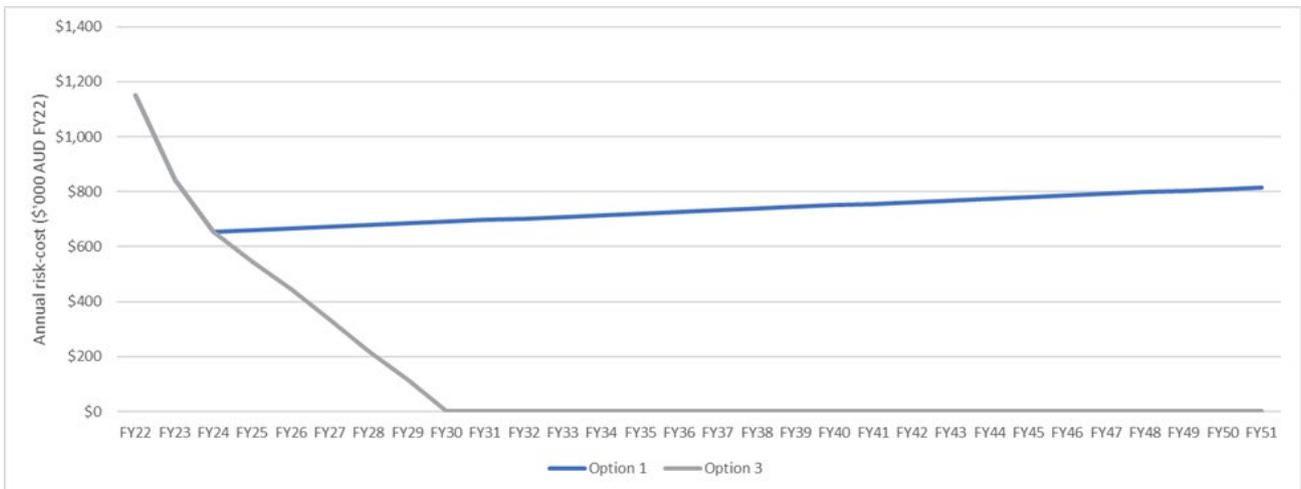
Figure 11 Risk reduction achieved through Option 3

The resultant residual quantified risk-cost of this option is shown in the following Figure 11. This option was assessed to result in the second highest risk cost of the three options, indicating an improved network performance.

A complete line rebuild will involve constructing a new feeder parallel to the existing feeder which involves installation of poles, installation of new overhead conductor and also involves decommissioning and disposal of existing poles, pole tops and existing overhead conductor.
