Supporting document 5.23.2 Marleston North Photographs

2020-25 Revised Regulatory Proposal 10 December 2019

Marleston North Asset Condition Photographs

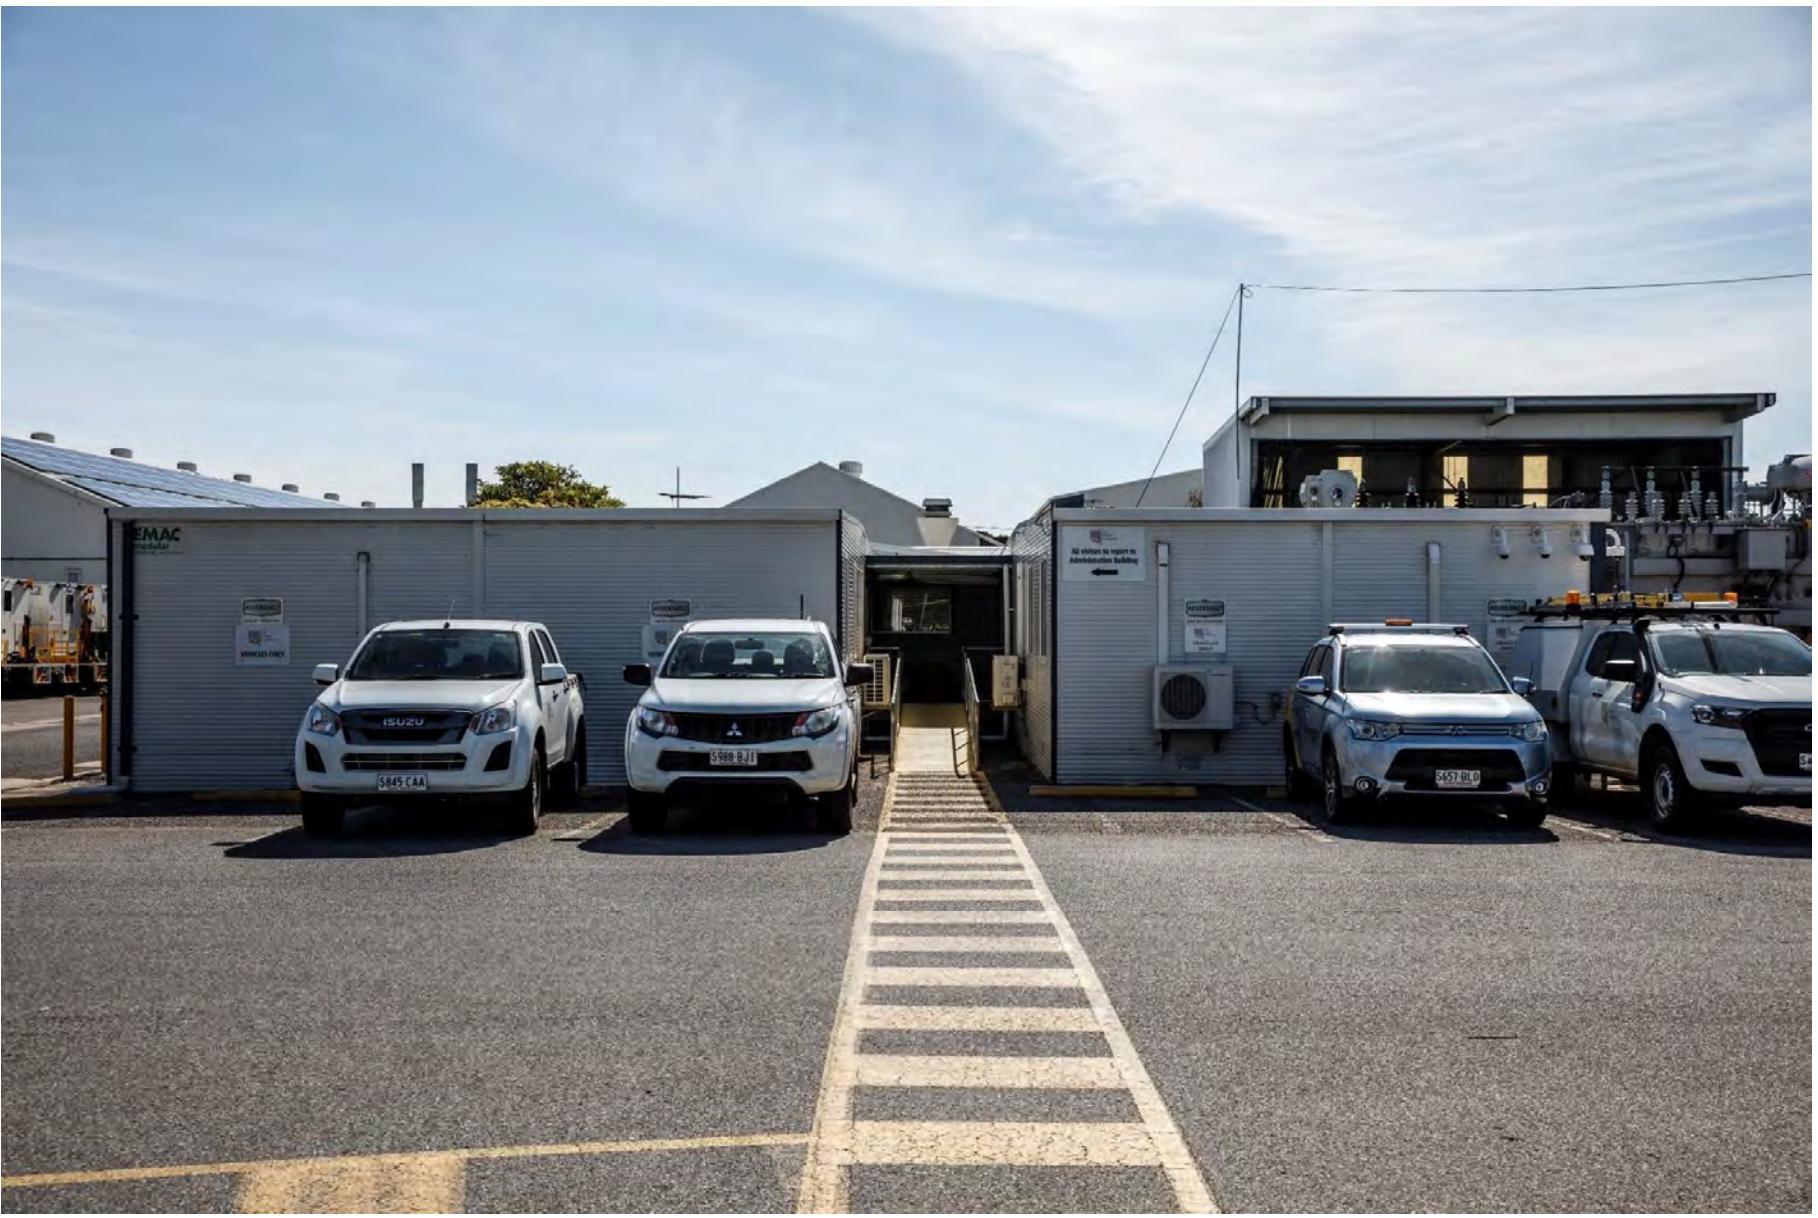
ATCO Modular Style Buildings – Admin office and substation maintenance office with bitumen cracking and previous patching.

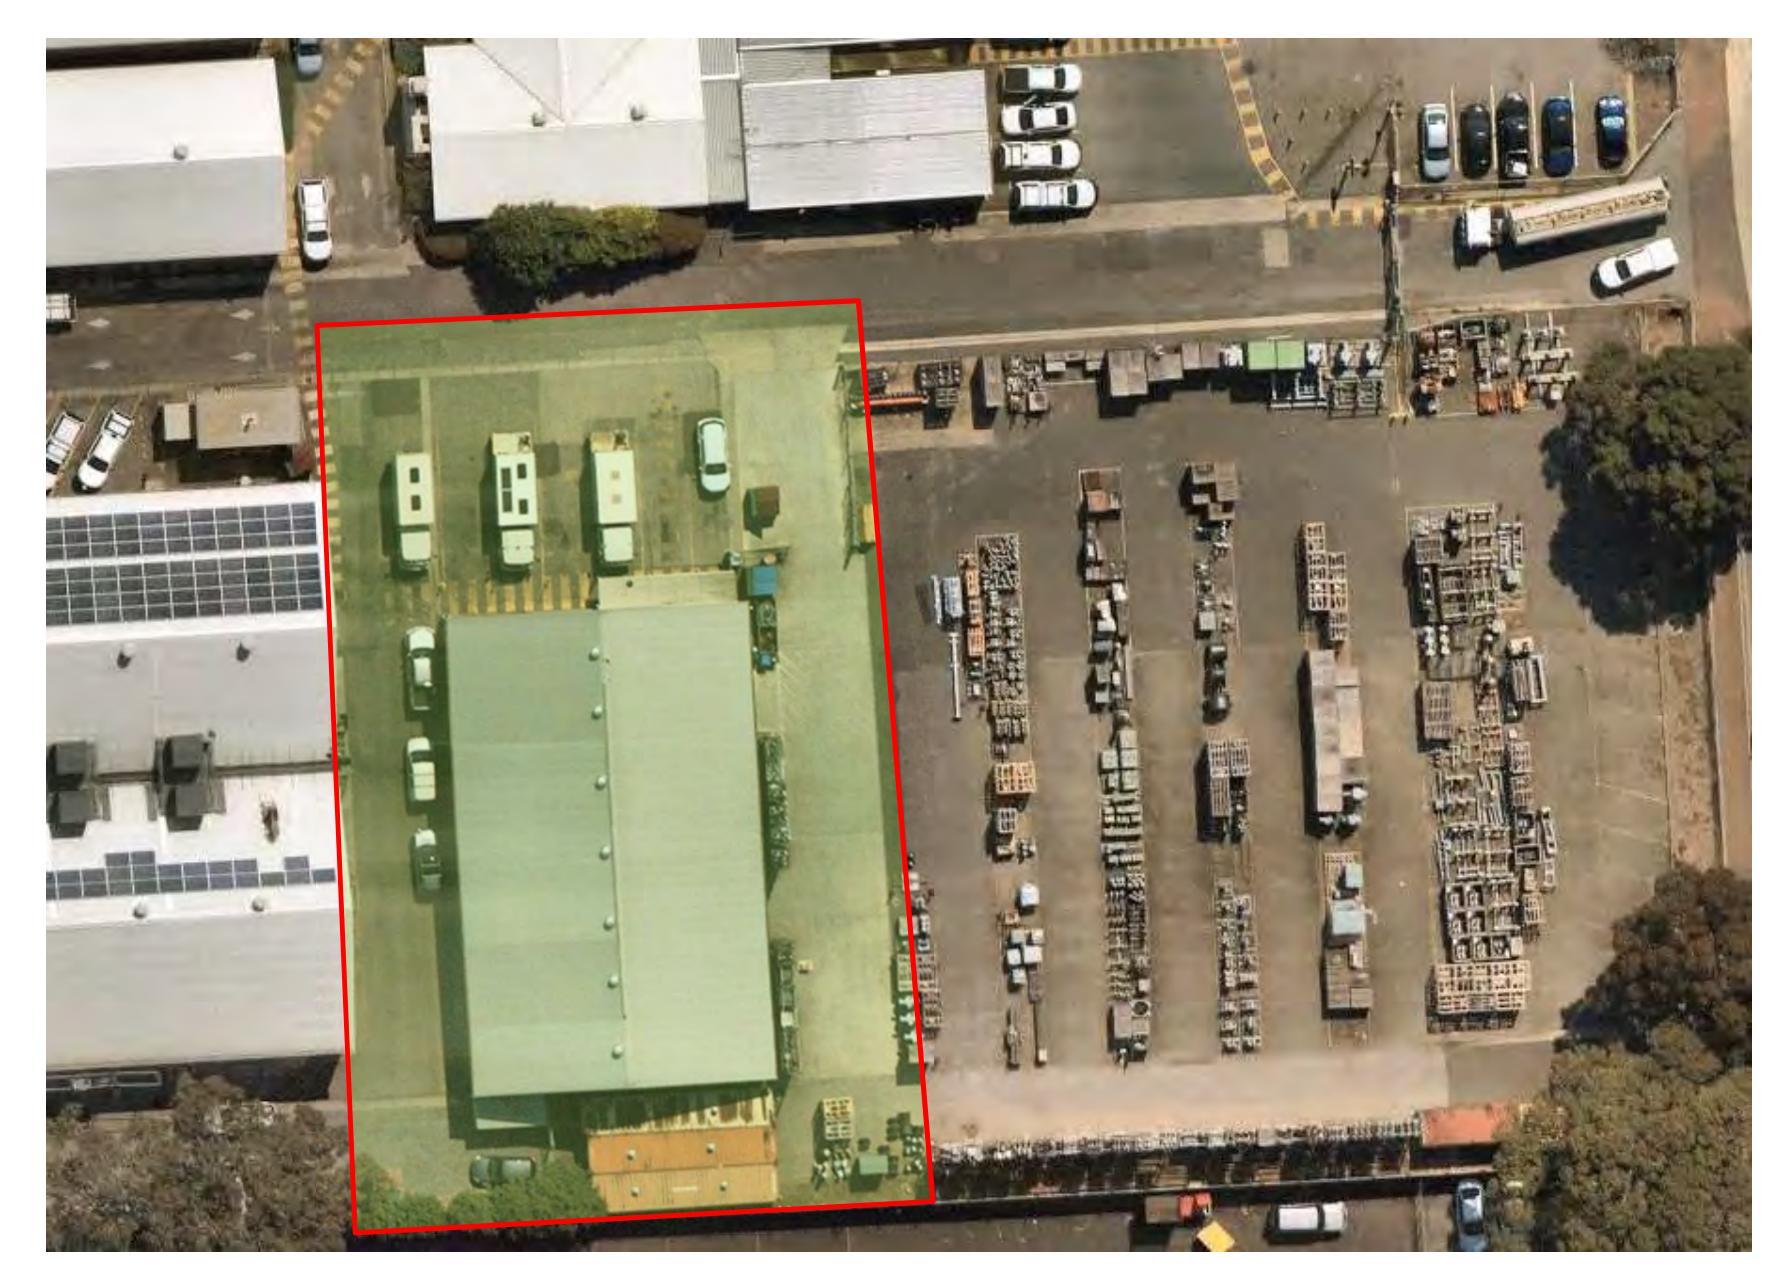
• Substation Store – Wood Rot to timber beams and gutter corrosion, with cracked bitumen to pedestrian walkway.
