Supporting document 5.25 Clare Business Case

2020-25 Revised
Regulatory Proposal
10 December 2019

SA Power Networks

Clare Business Case

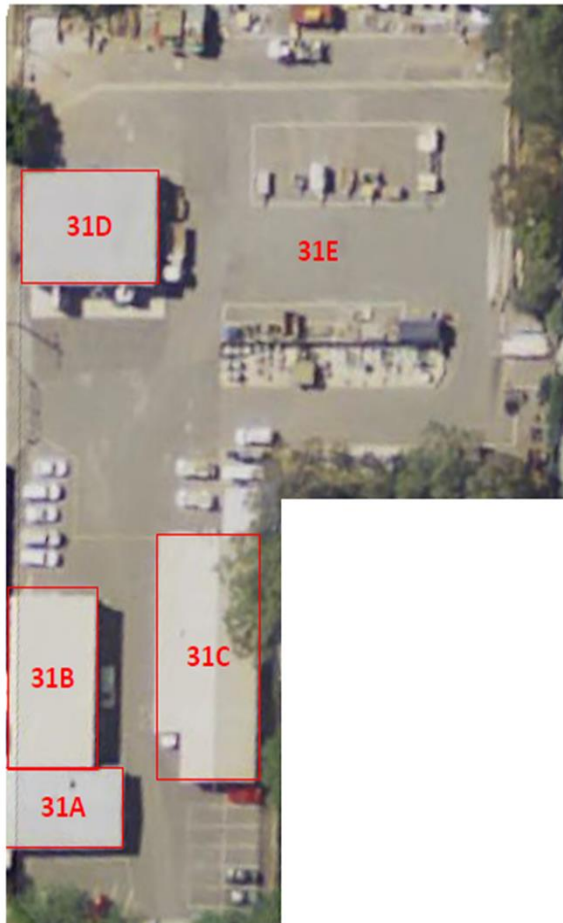
Figure 1 Diagram of Clare showing the main facilities.

31	Clare - 14 Lennon Street
31A	Office Building
31B	Engineering Office / Lunchroom Building
31C	Workshop
31D	Truck Shelter
31E	External Works
