BUILDING CONDITION REPORT

TransGrid

Mt Piper 500KV Sub-Station, via Mt Piper Power Station, Portland Road,
Portland NSW 2847

6 May 2016

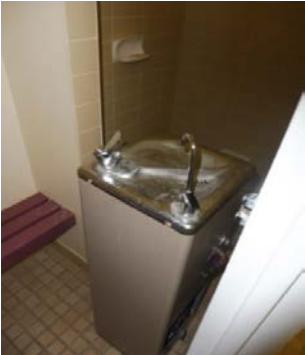
| PREDICTED CAPEX & MAINTENANCE COSTS (\$) excl GST | | | | | | | | | | | |
|---|---|---|---|---|---|---|---|---|---|---|---|
| 2.9.15 | Water Fountain | Stainless steel mains fed water fountain. | In poor to fair overall condition. | Aged water fountain. Replace in the short term. | CAP | 2 | | \$ 500.00 | | | \$ 500.00 |

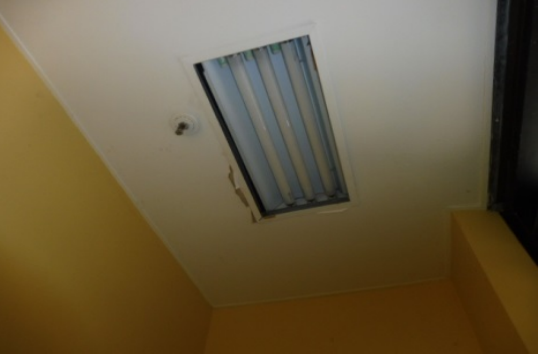
| PREDICTED CAPEX & MAINTENANCE COSTS (\$) excl GST | | | | | | | | | | | |
|---|---|---|---|---|---|---|---|---|---|---|---|
| 2.10.2 | Ceilings | Suspended plasterboard ceiling with paint finish. | In poor to fair overall condition. | Allow for repainting works in the medium term and touch up paint in short term. | R&M | 2 | | \$ 50.00 | \$ 240.00 | | \$ 290.00 |
