BUILDING CONDITION REPORT

TransGrid

Tumut 132/66Kv Substation, Adelong Road, Tumut, NSW

6 May 2016

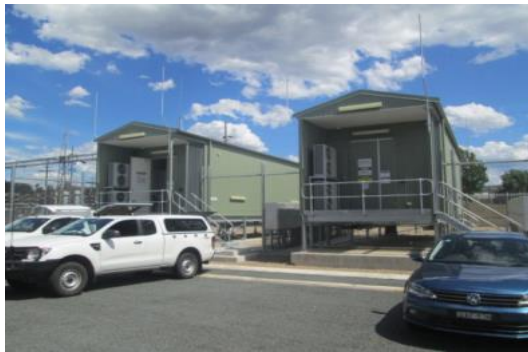
1.3.3.2	Secondary Systems Buildings (SSBs)	Surface mounted strip lights.	In good overall condition.	Allow to replace light tubes during reporting period.	R&M	4			\$	200.00	\$	320.00	\$	520.00

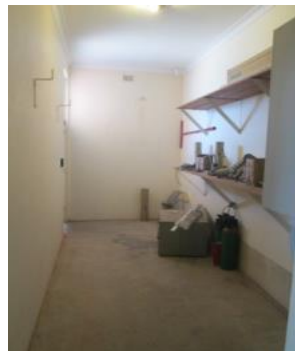
2.4 Store													
2.4.1	Ceilings	Suspended plasterboard ceiling with paint finish.	In fair overall condition.	Allow to repaint ceiling surfaces.	R&M	2		\$	240.00		\$	240.00

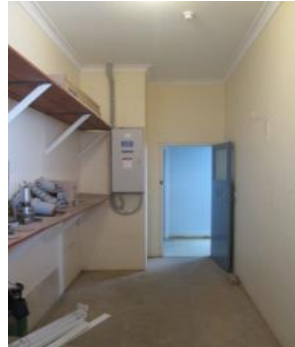
2.4.2	Walls	Painted rendered walls with flush vinyl skirting.	In fair overall condition.	Allow to repaint wall surfaces.	R&M	2		\$	697.00		\$	697.00

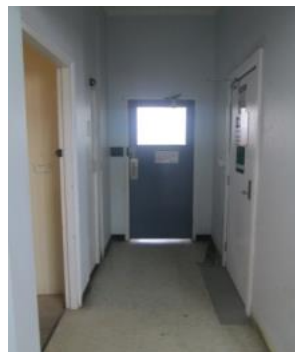
2.5.3	Walls	Painted rendered walls with flush vinyl skirting.	In poor to fair overall condition.	Vinyl skirting debonded and missing in places. Allow to replace as part of refurbishment works.	R&M	2		\$	100.00		\$	100.00

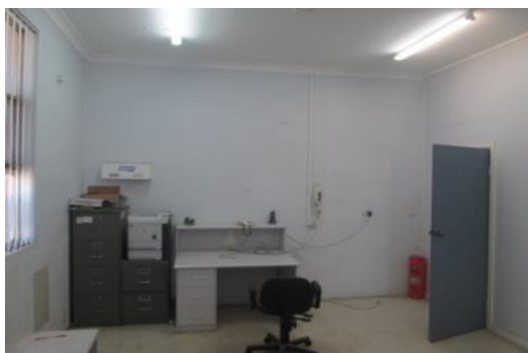
2.6.3	Walls	Painted rendered walls with flush vinyl skirting.	In fair overall condition.	Vinyl skirting has been removed. Allow to reinstate as part of refurbishment works.	R&M	2		\$	360.00		\$	360.00

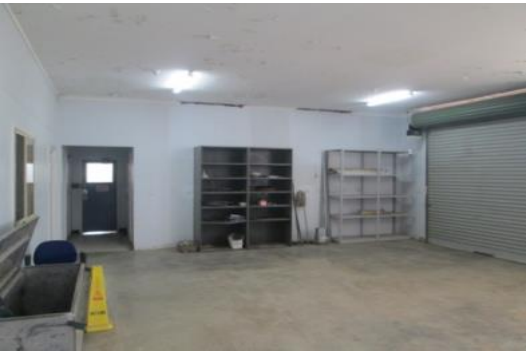
2.7.3	Walls	Painted rendered walls and partitions.	In fair overall condition.	Allow to repaint wall surfaces.	R&M	2		\$ 1,241.00			\$ 1,241.00

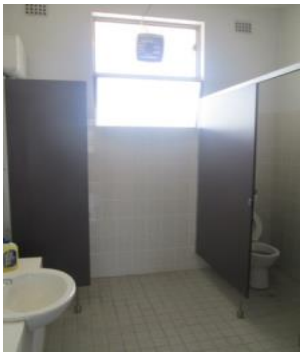
2.8.2	Walls	Painted masonry walls.	In fair overall condition.	Allow to repaint wall surfaces.	R&M	2		\$ 340.00			\$ 340.00	
2.8.3	Walls	Tiled splashback walls.	In fair to good overall condition.	No action required, ongoing maintenance as required.	CAP	4					\$ -

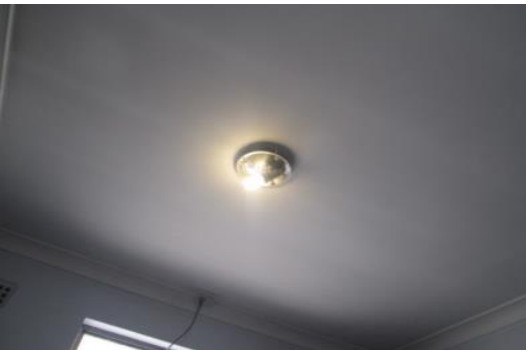
2.8.7	Lighting	Surface mounted fluorescent lights.	In poor overall condition.	Lighting inadequate and missing diffusers and / or not working. Allow for replacement of all lights ensuring IP rated within bathroom as part of the refurbishment in the short term.	R&M	2		\$ 500.00			\$ 500.00

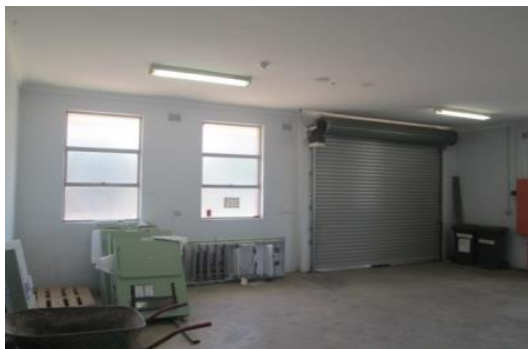
2.9.3	Walls	Painted rendered walls and partitions.	In fair overall condition.	Allow to repaint wall surfaces.	R&M	2		\$	1,938.00		\$	1,938.00

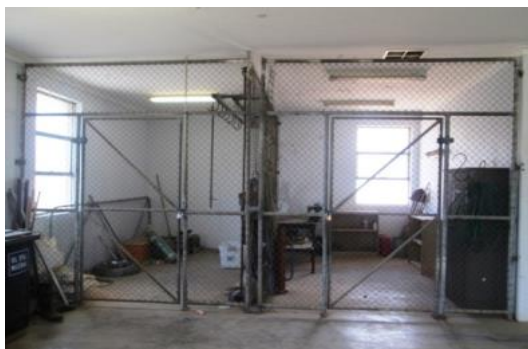
2.9.4	Walls - Storage Cages	Metal post and wire mesh partitions and doors.	In fair overall condition.	No action required, ongoing maintenance as required.	CAP	4					\$	-

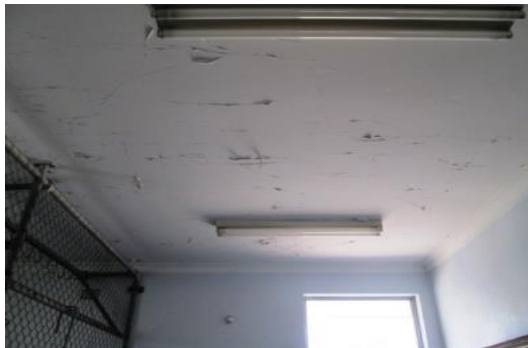
2.9.7	Lighting	Surface mounted strip lights.	In poor to fair overall condition.	2no lights not working. Replace tubes not working.	R&M	2		\$	50.00		\$	50.00

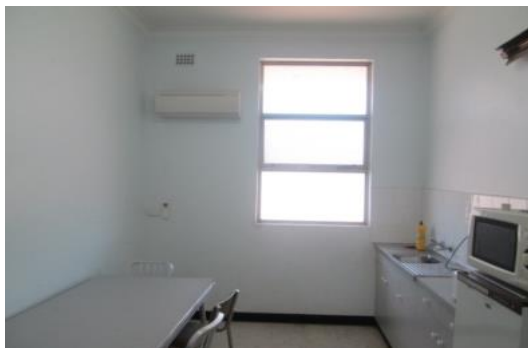
2.10.2	Walls	Painted rendered walls with flush vinyl skirting.	In fair overall condition.	Allow to repaint wall surfaces.	R&M	2		\$	680.00		\$	680.00

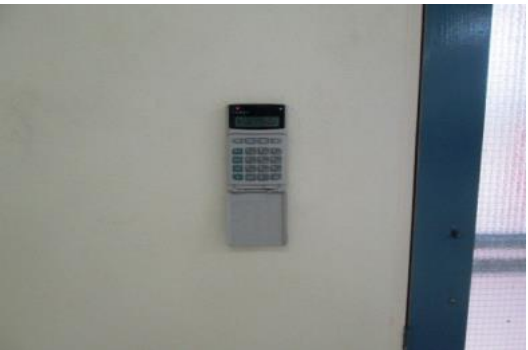
3.1	Building Services Generally	Access control system and sensors.	In fair to good overall condition.	We don't envisage any major replacement works in the reporting period. Maintain annually.	R&M	2	\$ 1,500.00	\$ 3,000.00	\$ 4,500.00	\$ 7,500.00	\$ 16,500.00

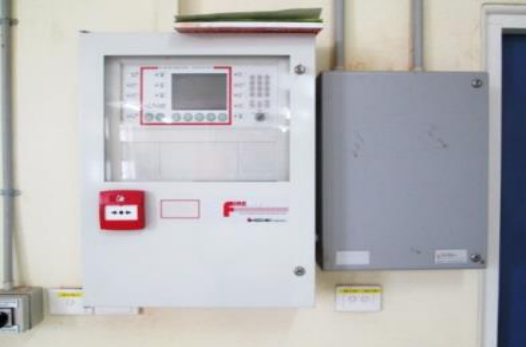
3.4	Building Services Generally	Fire indicator panel - Digital	In fair to good overall condition.	We don't envisage any major replacement works in the reporting period. Maintain annually.	R&M	1	inc.	inc.	inc.	inc.	\$ -

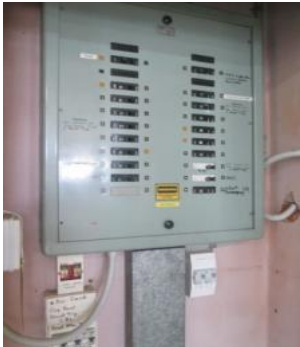
3.13	Building Services Generally	Mains Distribution board and switchboards.	In fair overall condition.	Aged but still performing. There are no RCDs on the lighting circuits and parts are becoming obsolete. Allow for short to medium term replacement of the boards.	CAP	2		\$ 10,000.00			\$ 10,000.00
