# AusNet

## Instrument Transformers

Asset Management Strategy

| Document number: | AMS 10-64 |

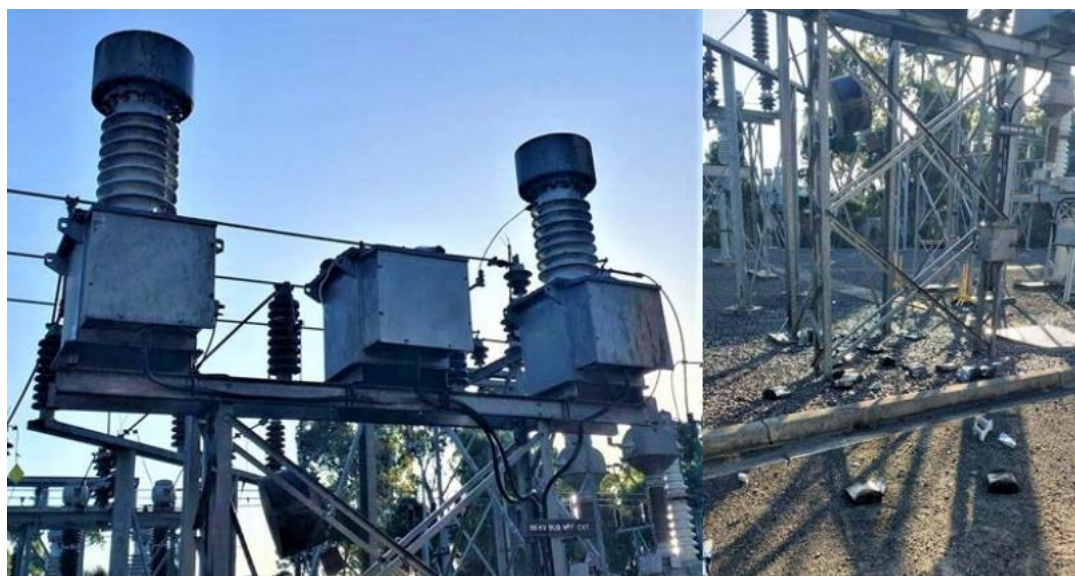
On 31 December 2022, a fault occurred on the 66kV FDR line at Lilydale Zone Substation (LDL), leading to the failure of a [ C.I.C ] CVT (see Figure 19 below) that was, at the time, not included in the CAMS scheme. The failure led to the catastrophic rupture of the CVT's porcelain insulator, causing porcelain fragments to be dispersed across an approximate 10-meter radius. The incident was further compounded by an accompanying fire, which caused localized damage to nearby assets situated within a five-meter vicinity of the failed unit. The nature of the failure highlights the inherent risks associated with aging porcelain-housed instrument transformers, particularly under fault conditions.

Figure 19: [ C.I.C ] CVT failure in 2022
