# AusNet

## Transmission Line Insulators

Asset Management Strategy

**Document number:** AMS 10-75

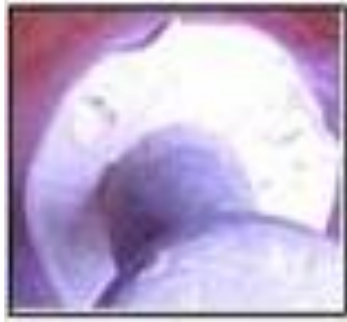
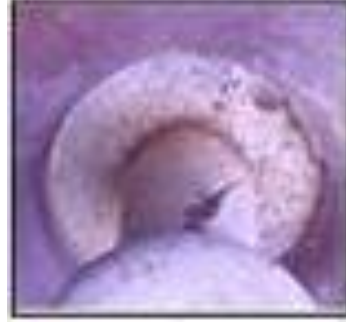
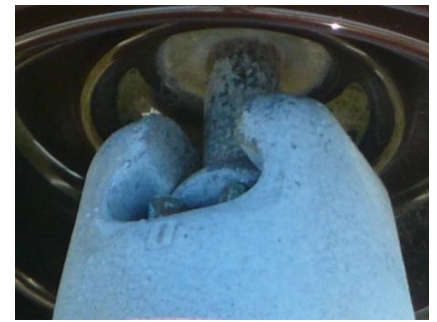
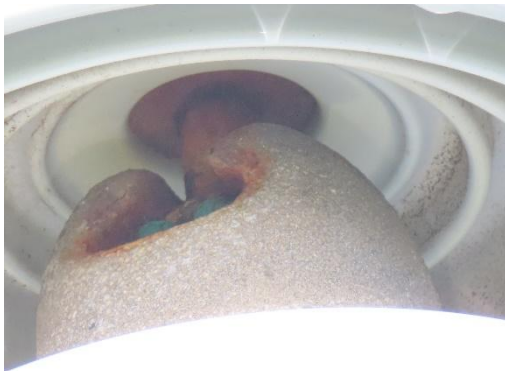
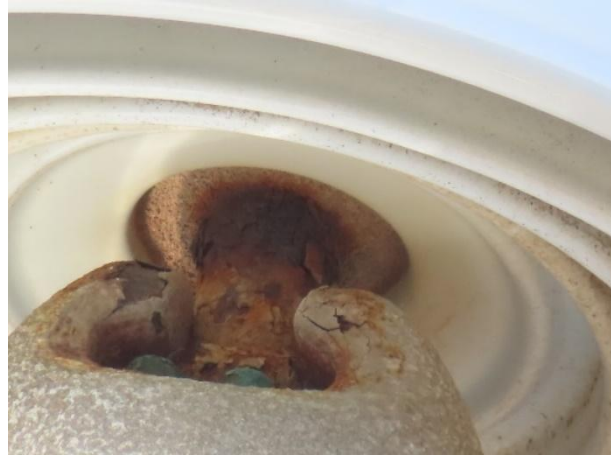
| CONDITION SCORE | CONDITION DESCRIPTION | PORCELAIN & GLASS DISC | POLYMERIC LONG ROD | REMAINING LIFE |
|---|---|---|---|---|
| C5 | Very Poor | Extensive surface rust of <20% wear or minor chips or minor flash/arcing damage | Minor tracking damage to sheath, Sheds split or torn up to sheath, Pellets embedded in sheath Flashed with no evidence of damage to end seals Animal attack, <10% of sheds lost, Flaking rust | <15% |

Table 11: C1 to C5 Insulator Pins
