Jemena Electricity Networks (Vic) Ltd

2026-31 Electricity Distribution Price Review - Revised Regulatory Proposal

Replace BLTS 22kV Switchgear - Business Case

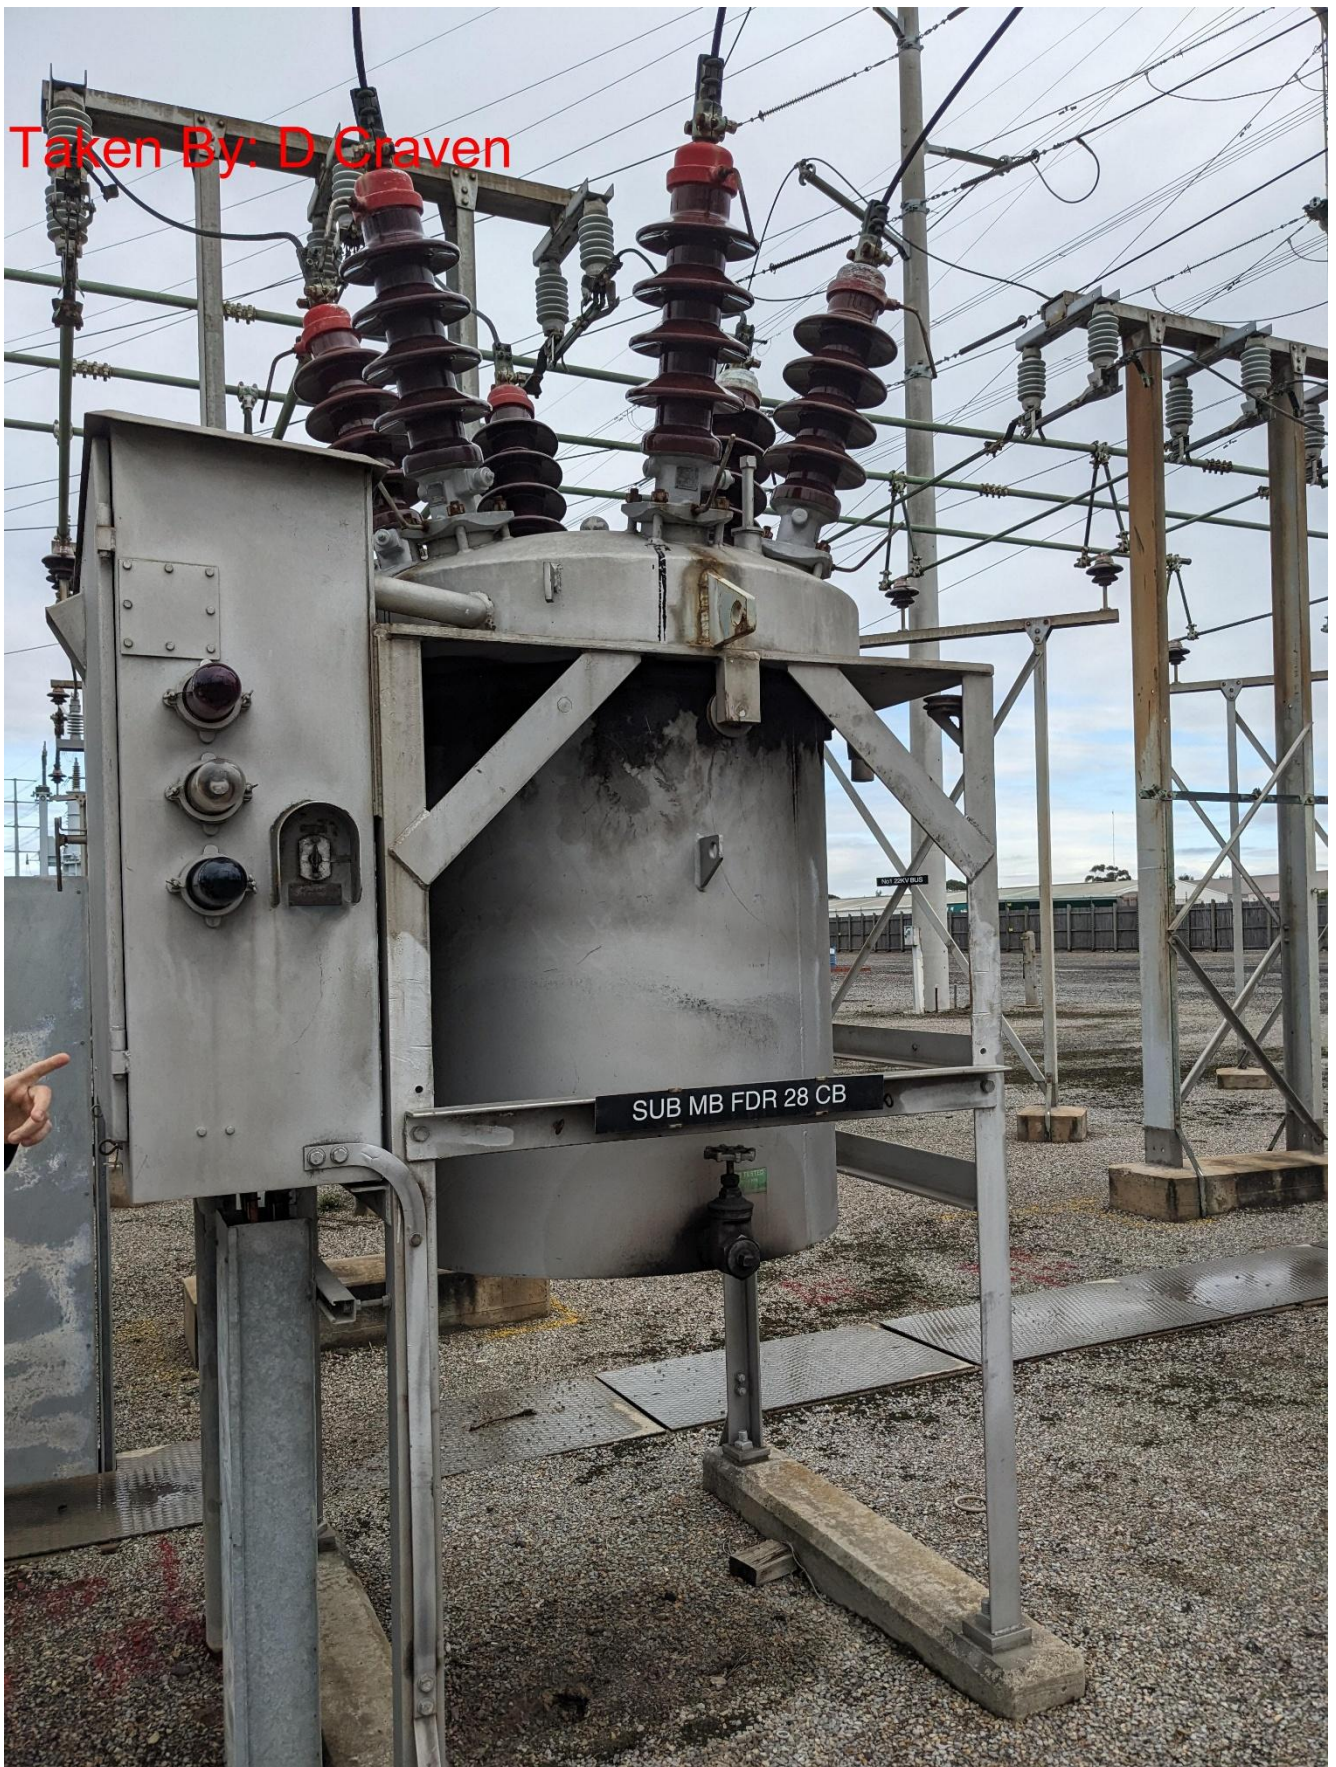
The 345GC CBs are outdoor dead tank bulk oil CBs. The load break mechanism is via heavy copper contacts that are suspended via wood pull rods. The 345GC CBs are also installed at zone substations AW (Airport West), BD (Broadmeadows) and CN (Coburg North).

Figure 2-1: 22kV Oil Filled Circuit Breaker EMAIL/WR 345GC Type (MB28)

Historically, the 345GC CBs suffer from several issues, the predominant issue being bushing defects. The bushings sometimes leak pitch. A program was initiated to refurbish all bushings on the 345GC CBs on the JEN. In more recent years the main contact pull rods have experienced failures. These pull rods were made from Permalloy wood, which is no longer available. In 2014 a project was initiated to replace pull rods with fibre glass pull rods on all transformer and cap bank CBs on JEN.

There has been multiple recorded defects associated with the Email 345GC 22kV switchgear. 26 recorded defects have occurred at ZSS CN (Coburg North) 32 defects have occurred at ZSS AW (Airport West) and 24 defects have been reported for ZSS BD (Broadmeadows). AW, BD and CN all have the Email 345GC switchgear on the JEN Network.

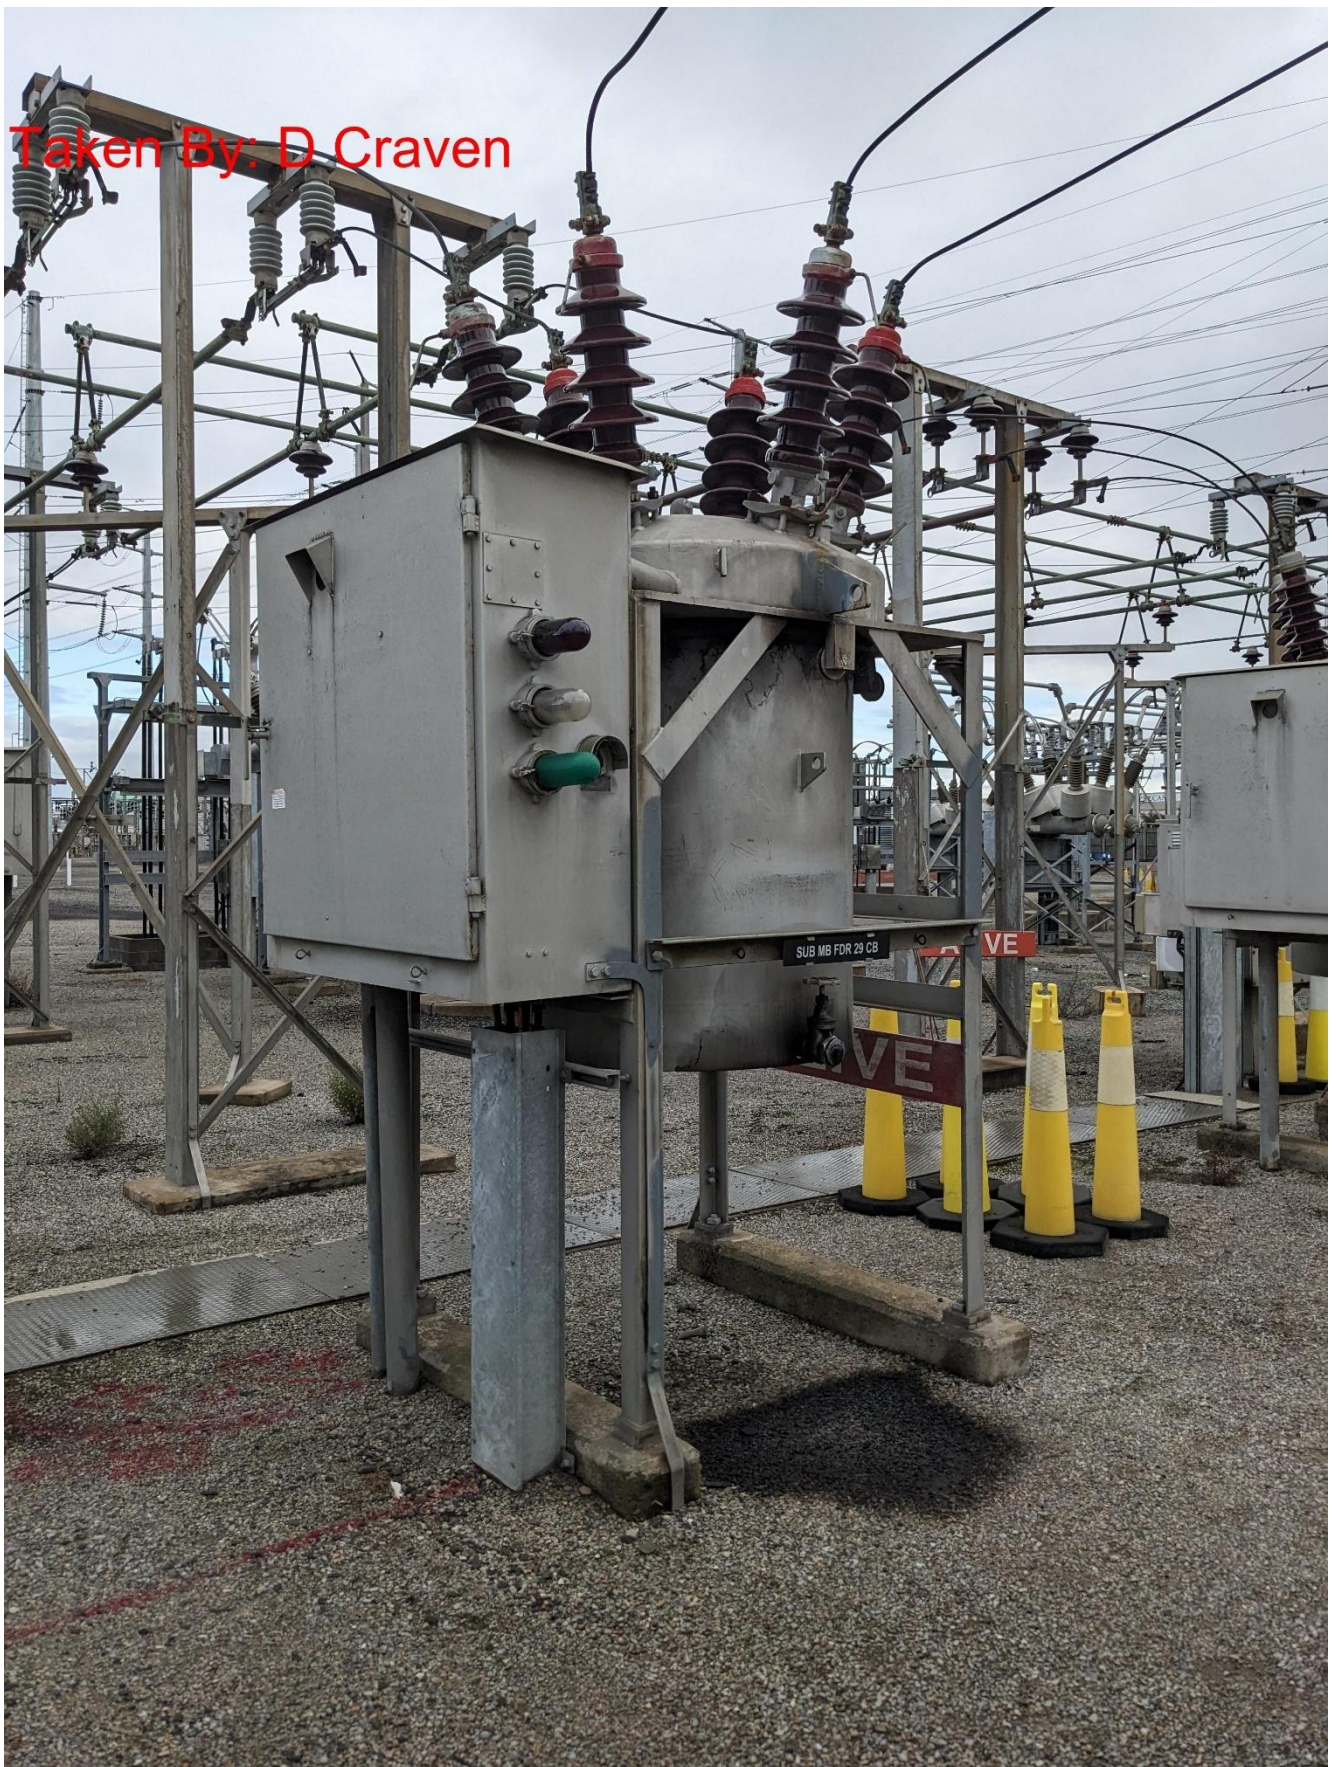
Figure 2-2: 22kV Oil Filled Circuit Breaker EMAIL/WR 345GC Type (MB29)
