# Jemena Electricity Networks (Vic) Ltd

## 2026-31 Electricity Distribution Price Review - Revised Regulatory Proposal

Supporting justification document

Compliance Switchgear Replacement - Business Case

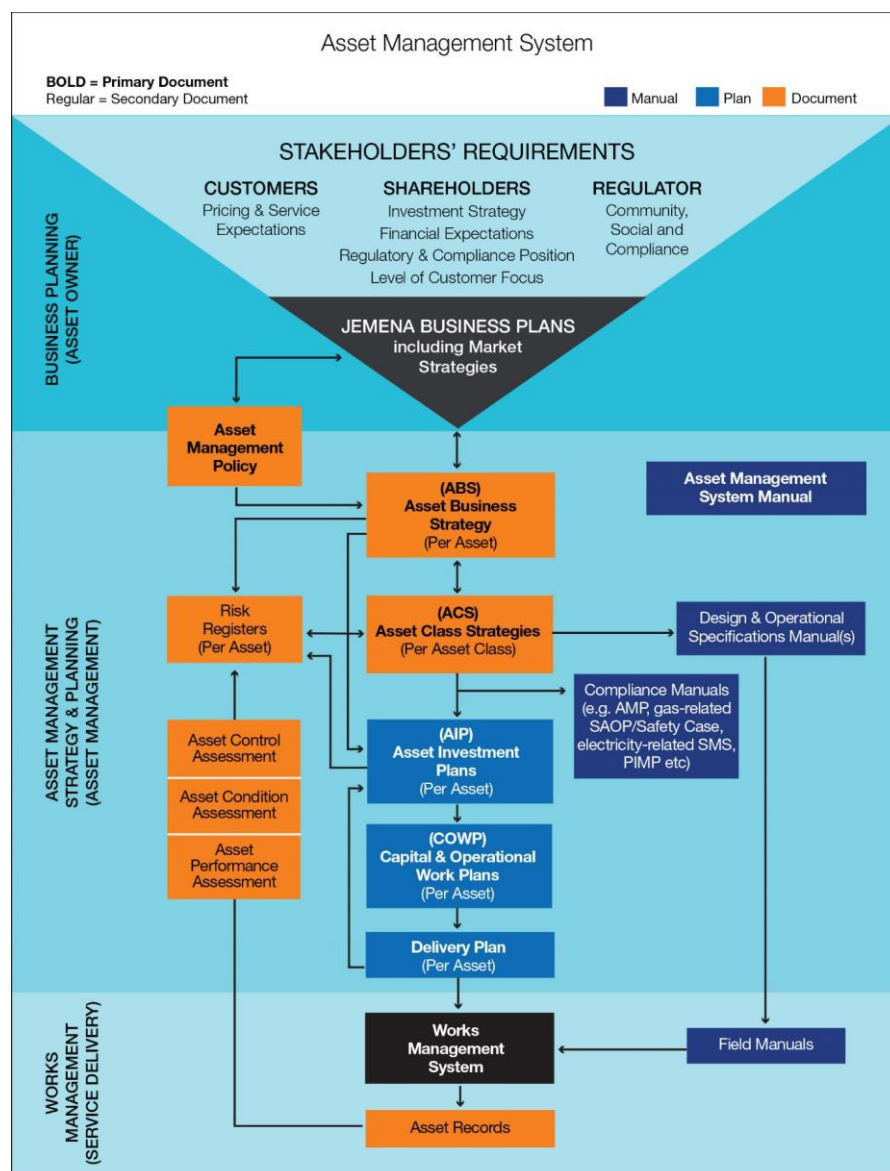
Figure 1: The Jemena Asset Management System

Figure 1 outlines the JEN asset management system and where the Asset Management Plan (AMP) is positioned within it. The AMP covers the creation, maintenance and disposal of assets including investment planned to augment network capacity to meet increasing demand and to replace degraded assets to maintain reliability of supply to meet Jemena Business Plan requirements.

This strategic framework facilitates the planning and identification of business needs that require network investment documented via business cases.

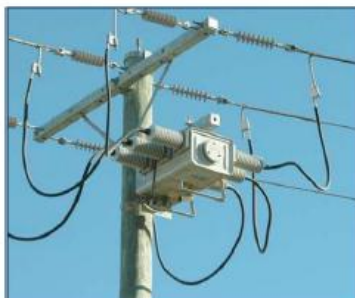
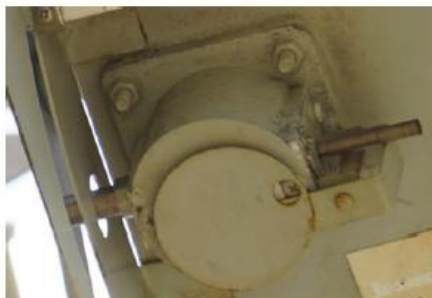
1. Overhead ILJIN SF6 Gas Load Break Switches are now not to be operated until further notice.
2. Overhead ILJIN SF6 Gas Load Break Switches are not to be used as isolation points until further notice.
3. The JEN Control Room has applied INOP tags to switches of this type, effective immediately.
4. The JEN Assets & Operations Electricity Team is preparing to implement an inspection program to verify the condition of the interlocking mechanism on the existing fleet of Overhead ILJIN SF6 Gas Load Break Switches installed on the JEN.

- ILJIN and HV overhead GFB switches are suffering from galvanic corrosion of the low gas lockout mechanism failure.
- Our approach has identified a prudent, cost-effective program of proactive replacements to ensure that we replace the most at-risk defective assets, to maintain network performance and address JEN compliance requirements.
