## Electricity Distribution Price Review FY2027 to FY2031

Business case: Benalla 11 – High Voltage Feeder

Document number: 0002

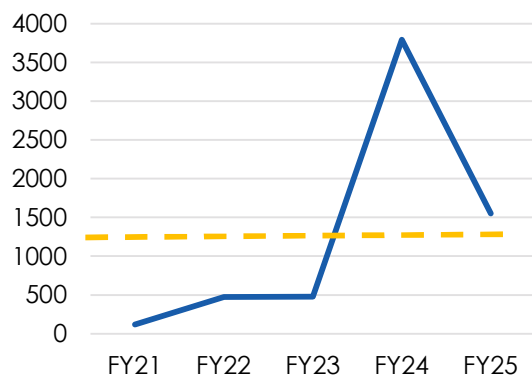
**Feeder SAIDI**

The following graphs show a rolling 12-month reliability summary for both frequency (SAIFI) and duration (SAIDI) of normalised unplanned sustained outages. This performance is compared against a performance threshold<sup>2</sup>.

As it can be seen from the above graphs, this feeder became poor performing during FY24 due to both duration of outages and number of outages. It remained poor performing for FY25 due to outage duration.

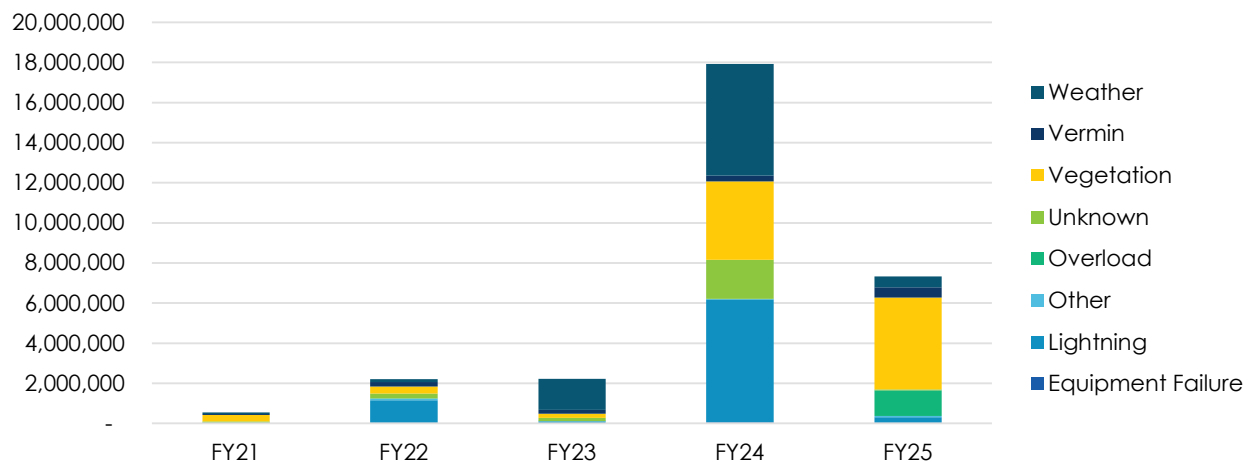
**Figure 1 – Feeder outage duration contribution by cause**

The variability of the performance of this feeder is due to weather related impacts (both storm and lightning), and due to vegetation impacts.

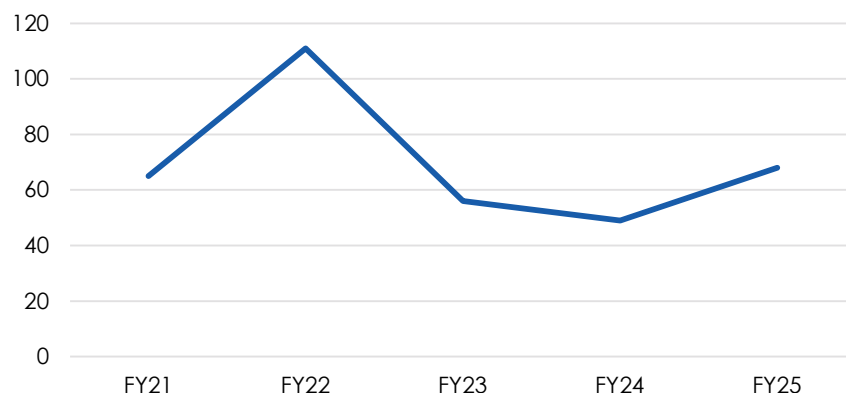
The following graph shows the number of momentary outages on the feeder. On average the feeder experiences approximately 70 outages a year (1.3 per week).

**Figure 2 - Momentary Outages on BN11**

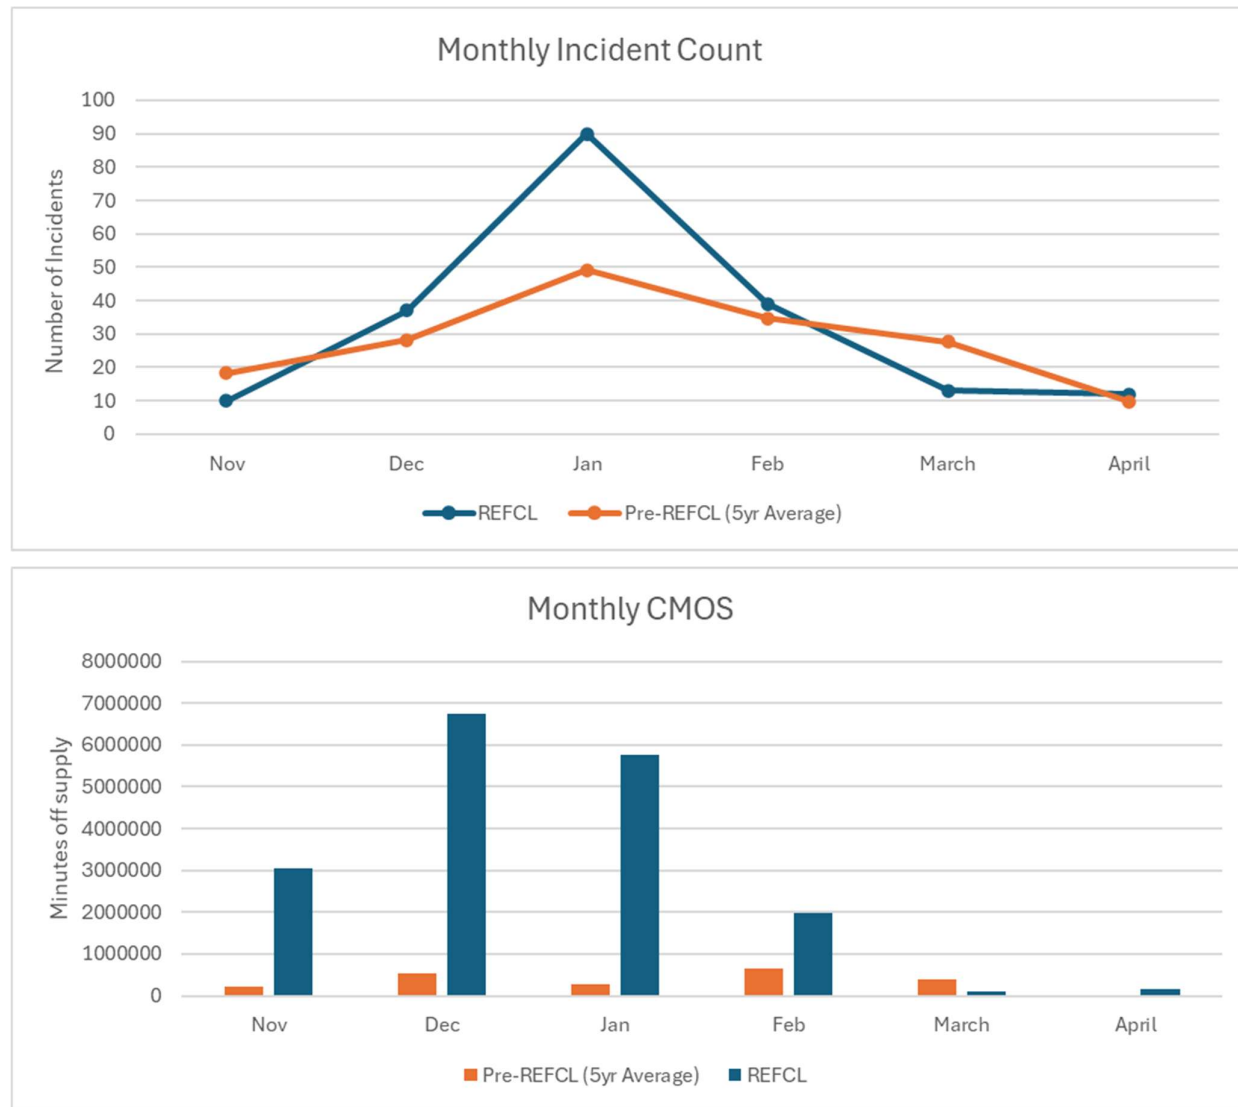
Since the commissioning of the BNVT remote REFCL in 2023, has seen a deterioration in the performance of BN11. The monthly incident count has increased over the summer months, as expected (once in two-year biennial trend). The increase in CMOS is well above biennial trend and has occurred since the commissioning of the BNVT Remote REFCL.

Toward the end of the fire season, the incident count and CMOS has trended down which is reflective off previous years and the addition of several targeted reliability measures

Figure 3a and Figure 3b – Graphs showing the impact of REFCL commissioning on reliability performance

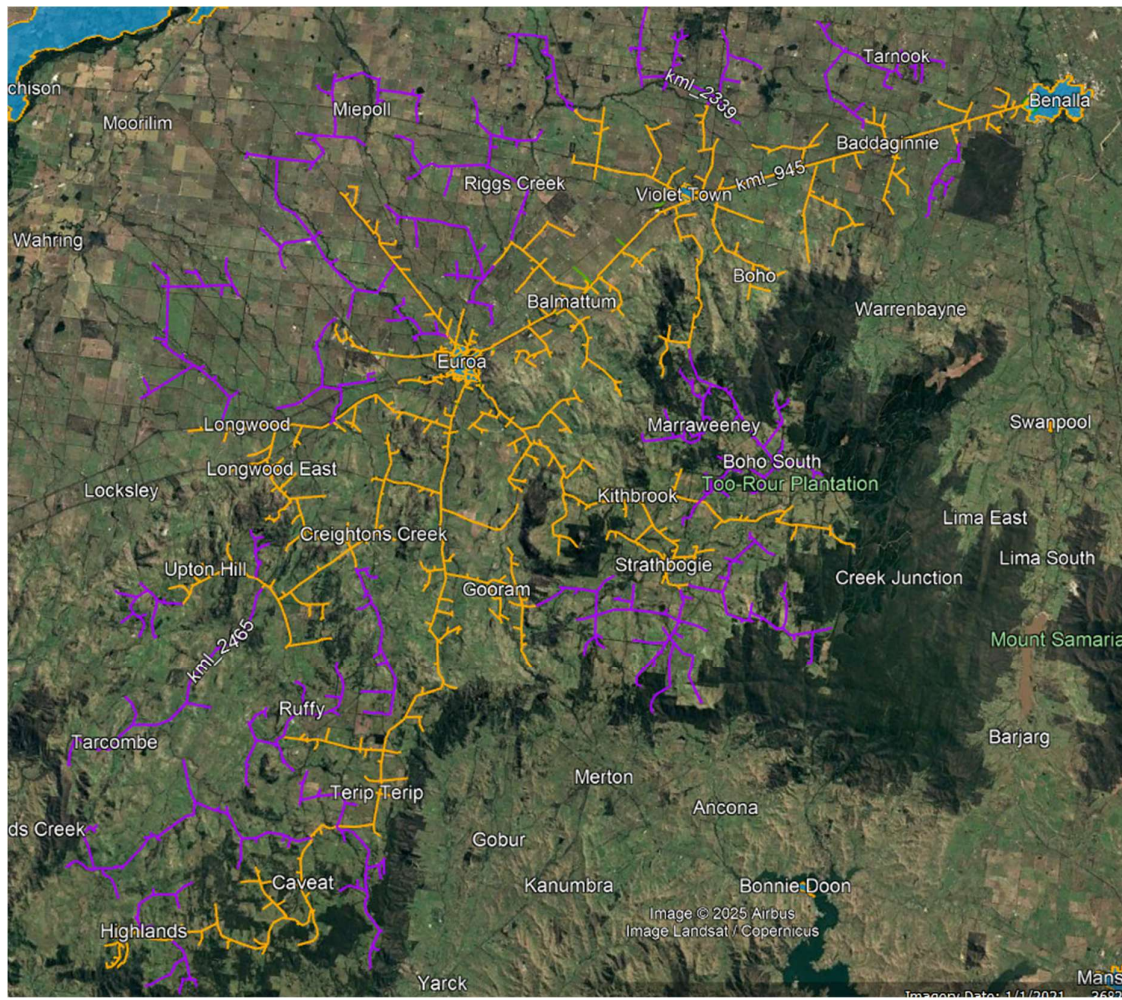
Figure 5: Map view of the BN11 feeder (Orange: 22kV, Purple: 12.7kV)
