## Feeder Reliability Investment Case

Business case: Reliability Program – MSD1

Document number: 0001

The document outlines a business case for intervention investments as they relate to improving the reliability and resilience of Mansfield distribution feeder MSD1.

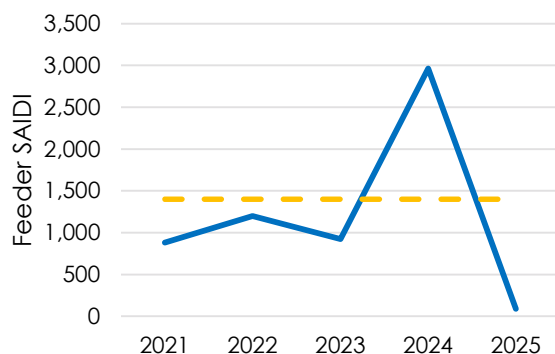
**Feeder SAIDI**

The following graphs show a rolling 12-month reliability summary for both frequency (SAIFI) and duration (SAIDI) of normalised unplanned sustained outages. This performance is compared against a performance threshold<sup>1</sup>.

As it can be seen from the above graphs, this feeder became poor performing during 2024 due to the major event day on 13<sup>th</sup> February which spanned over two days affecting the whole feeder. This event contributed 2395 to the feeder SAIDI. Excluding this event in 2024 would bring the feeder SAIDI down to 569, which is well below the limit for a long rural feeder. The feeder has been performing well against SAIFI during this time.

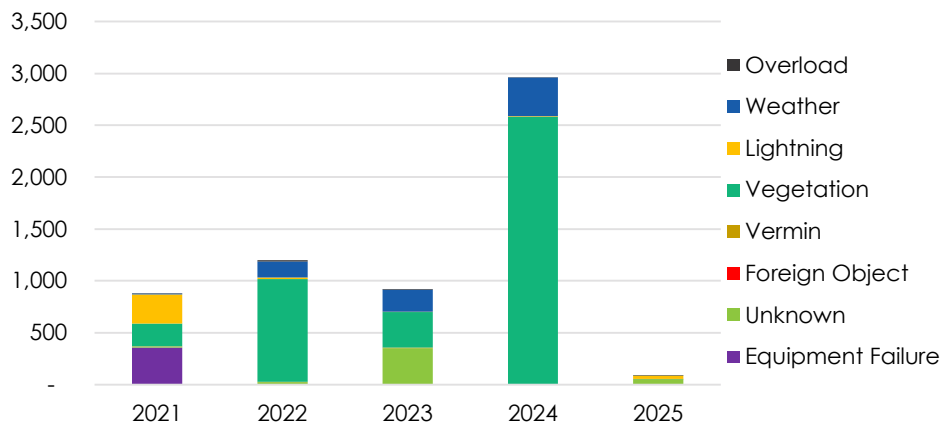
**Figure 1 – Feeder performance due to cause**

As it can be seen from the above table, the feeder experiences an average of 35 sustained interruptions per year, with an average contribution of 2.8 million customer minutes. The predominate causes of incidents on this feeder are:
