Feeder Reliability Investment Case

Business case: Reliability Program - WYK13

The document outlines a business case for intervention investments as they relate to improving the reliability and resilience of Woori Yallock distribution feeder WYK13.

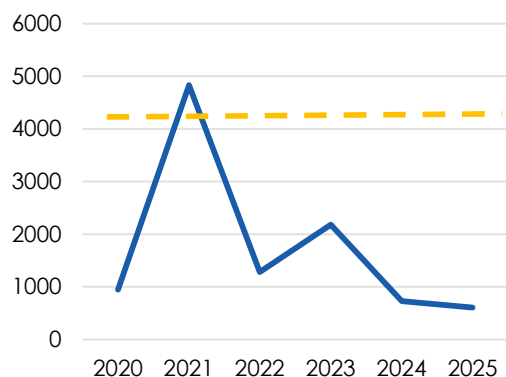
Feeder SAIDI

The following graphs show a rolling 12-month reliability summary for both frequency (SAIFI) and duration (SAIDI) of normalised unplanned sustained outages. This performance is compared against a performance threshold¹.

As it can be seen from the above graphs, this feeder became poor performing during 2023 due to duration of outages. The feeder has been performing well against SAIDI and SAIFI during this time.

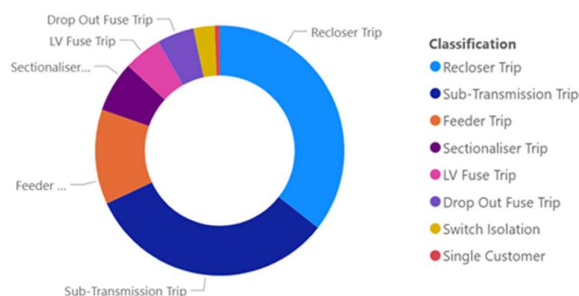
Figure 1 Unplanned Outage SAIDI by fault classification

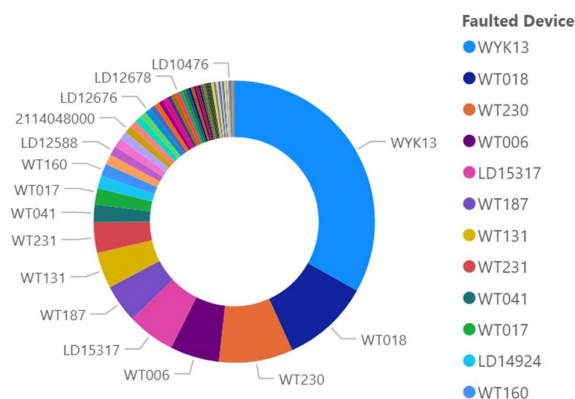
Figure 2 Unplanned Outage USAIDI by Faulted Device

The most impacted devices in terms of overall USAIDI are the circuit breaker (32.72%), WT018 (9.94%), WT230 (8.46%), and WT006 (5.62%), as highlighted in the single-line diagram and geographic map. This suggests that the key areas for reliability improvement are the Don Valley spur line, as well as the Millgrove and Warburton sections.

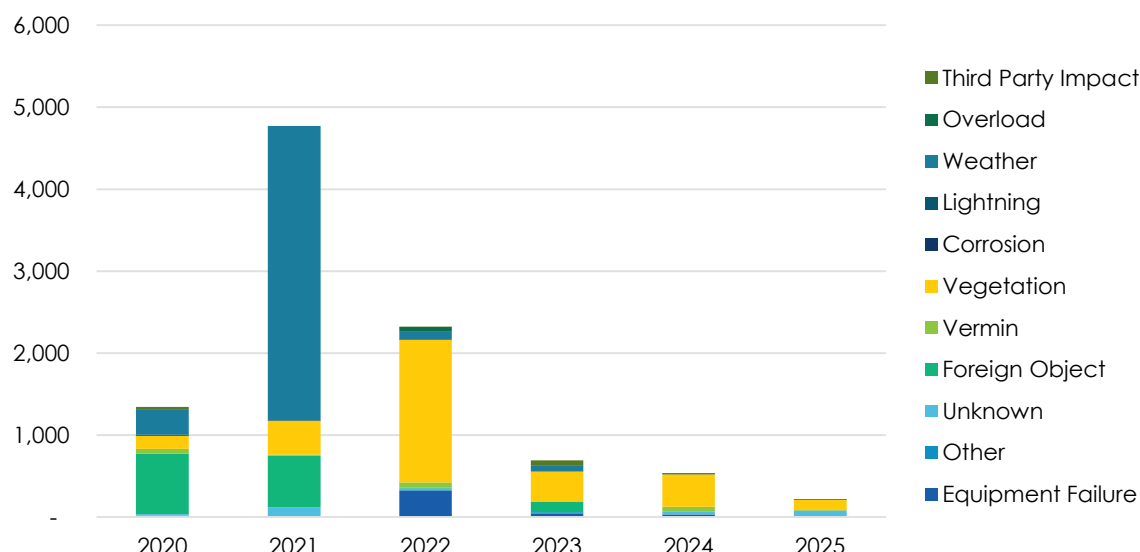
Figure 3 – Feeder performance due to cause

With reference to Figure 3 below, it can be seen that the variability of the feeder's performance can be attributed to 'weather' and 'vegetation' impacts, as it can be seen in calendar years 2021 and 2022

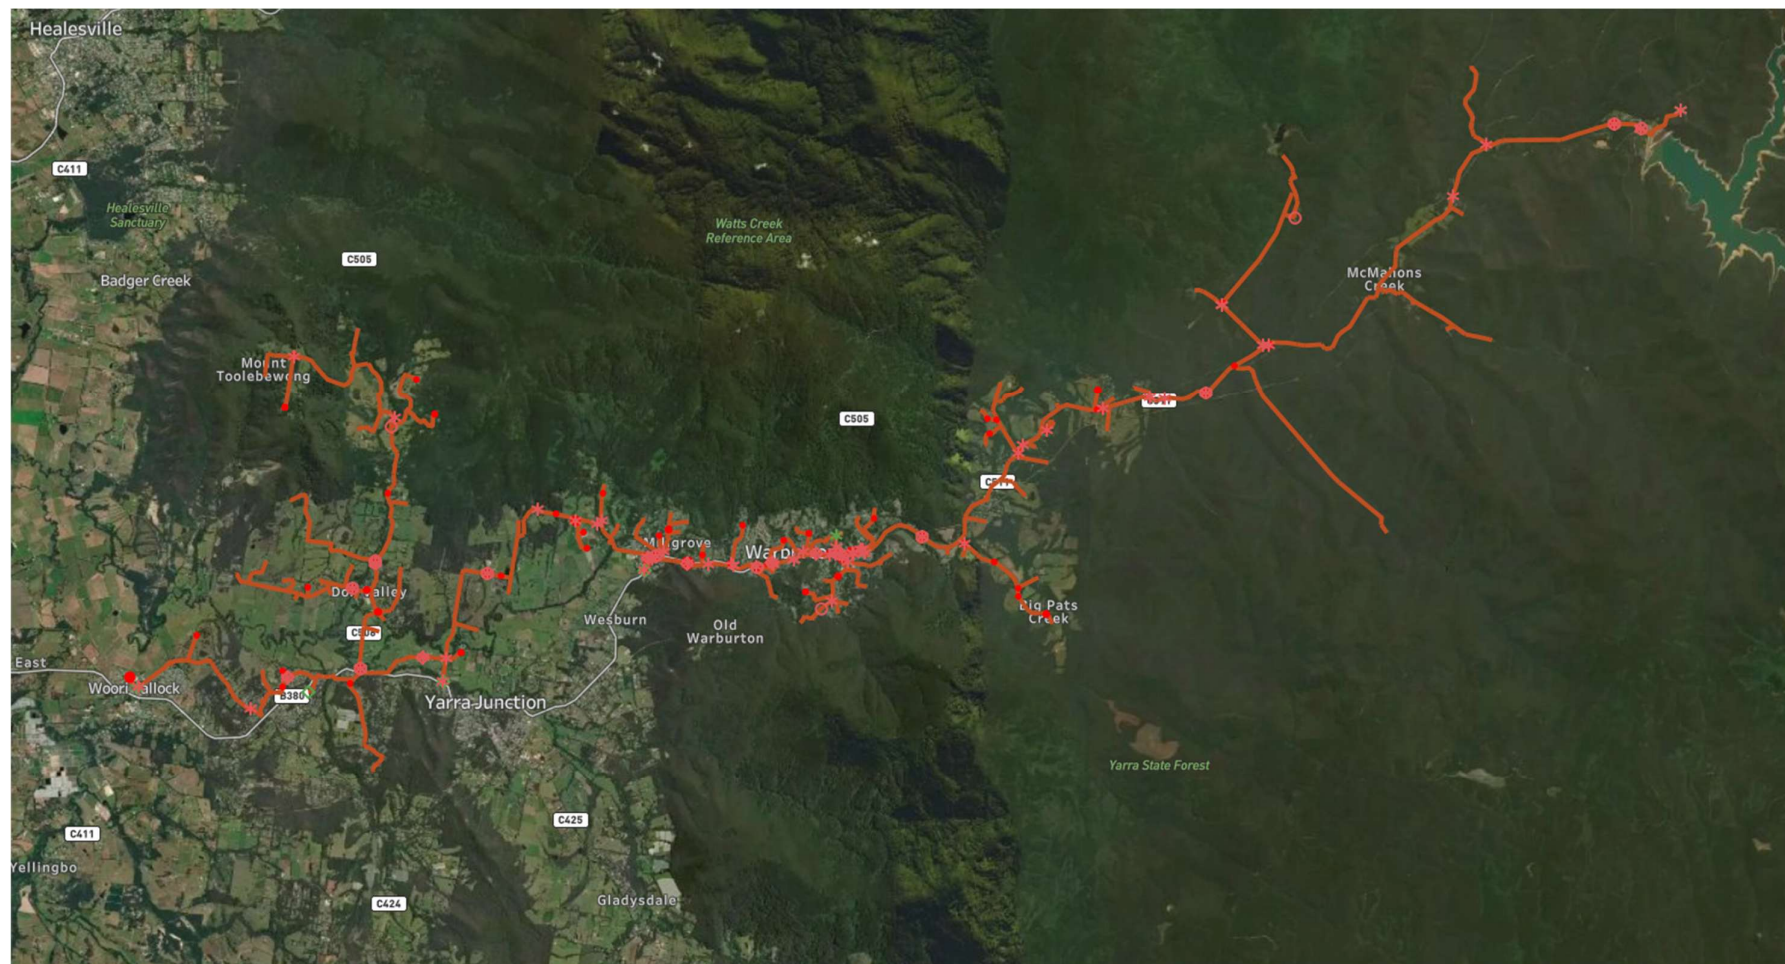
4.8. Appendix 8- Geographic Location of Feeder

Figure 3: Map view of the WYK13 feeder

The WYK13 feeder is approximately 128 km and traverses through the Yarra Ranges, with more than 80% of its medium-voltage network constructed as overhead lines in heavily vegetated terrain. This exposure makes the feeder highly susceptible to outages caused by severe weather events that frequently affect surrounding vegetation.
