# AusNet

## Disconnectors and Earth Switches

Asset Management Strategy

**Document number:** AMS 10-59

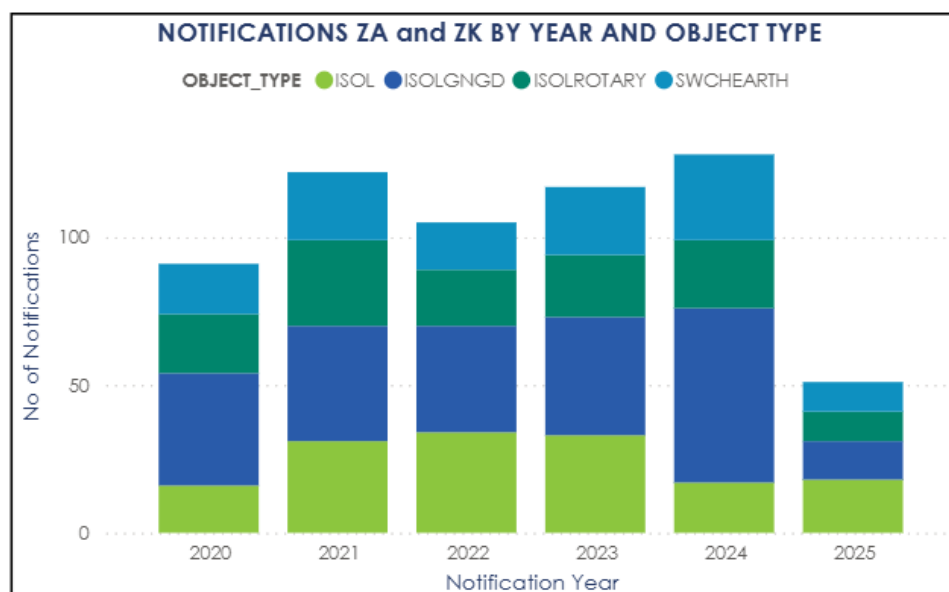
Figure 5: ZA and ZK Notification by object type of Switches - 2020-mid 2025

Figure 5 above shows notification trends for four object types of Disconnectors (ISOL, ISOLNGND, ISOLROTARY) and Earth Switch (SWC EARTH) from 2020 to mid-2025. Notification volumes were relatively lower during 2020 to 2022, likely influenced by the COVID-19 pandemic, which may have affected inspection schedules, reporting practices, and asset access. From 2023 onward, there's a clear upward trend, with 2024 showing the highest number of notifications across all object types particularly ISOL and ISOLNGND suggesting increased asset stress or improved detection. ISOLROTARY and SWC EARTH also saw noticeable rises in 2024, indicating emerging reliability concerns. While 2025 shows a decline, the data only covers the first half of the year, so full-year trends remain uncertain.

The following observations were derived from Figures 5, 6, 7, 8, and 9:

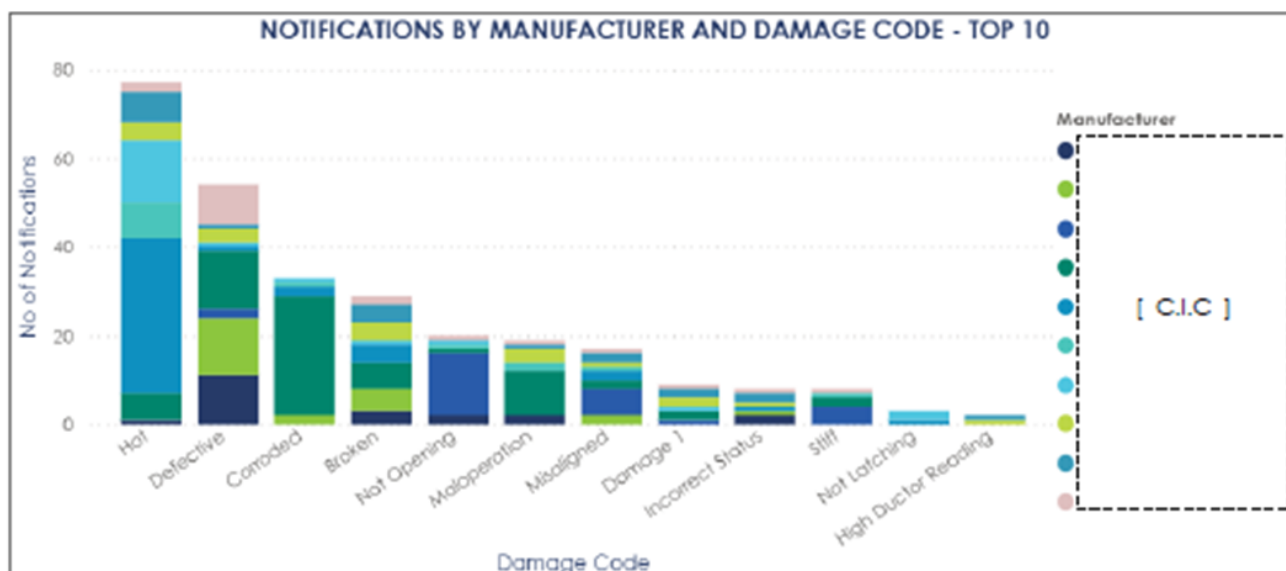
Figure 9: ZA and ZK Notification by Defect - 2020- mid 2025 (top 10 manufacturer by noti counts)

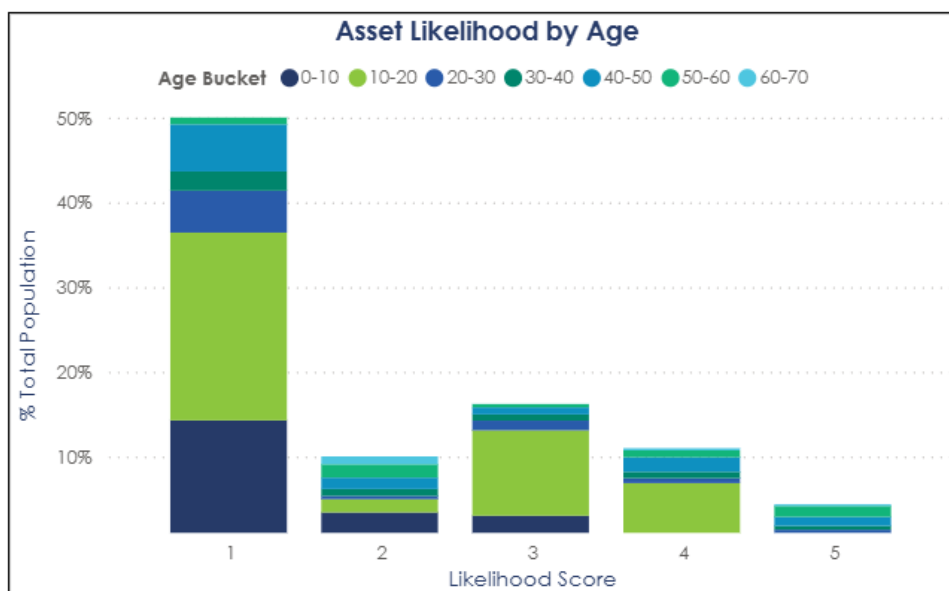
Figure 12: Disconnectors and Earth Switches Likelihood Score by Age Profile

**Key Findings on Asset Health Conditions Derived from the Figures above:**
