AusNet

Instrument Transformers

Asset Management Strategy

Document number: AMS 10-64

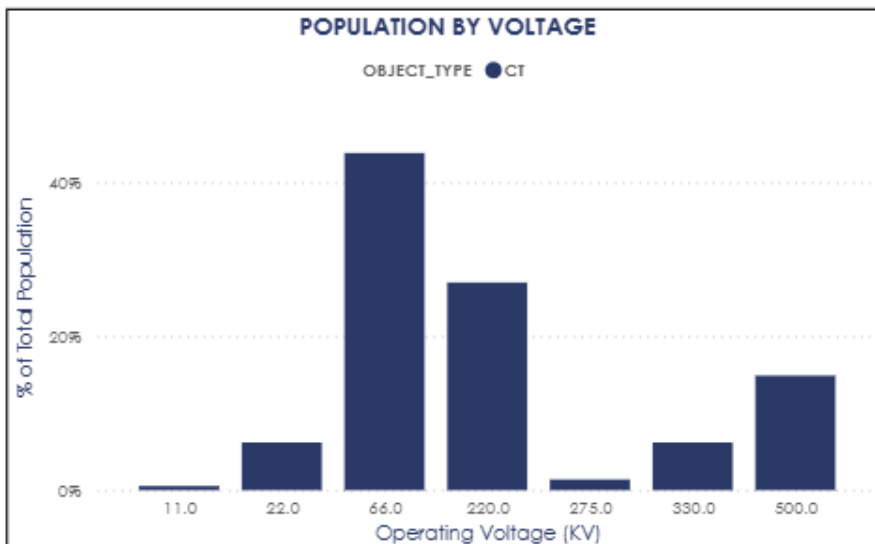
Figure 1 below provides the CT population by voltage. Approximately 75% of the total population are at 66kV and 220kV, followed by 15% at 500kV. The number of post-type high-voltage insulated CTs at 66kV and 220kV is steadily declining due to the transition to dead tank circuit breakers equipped with integral low-voltage insulated CTs. This transition offers advantages such as reduced maintenance requirements and a smaller physical footprint.

Figure 1: CT Population by voltage

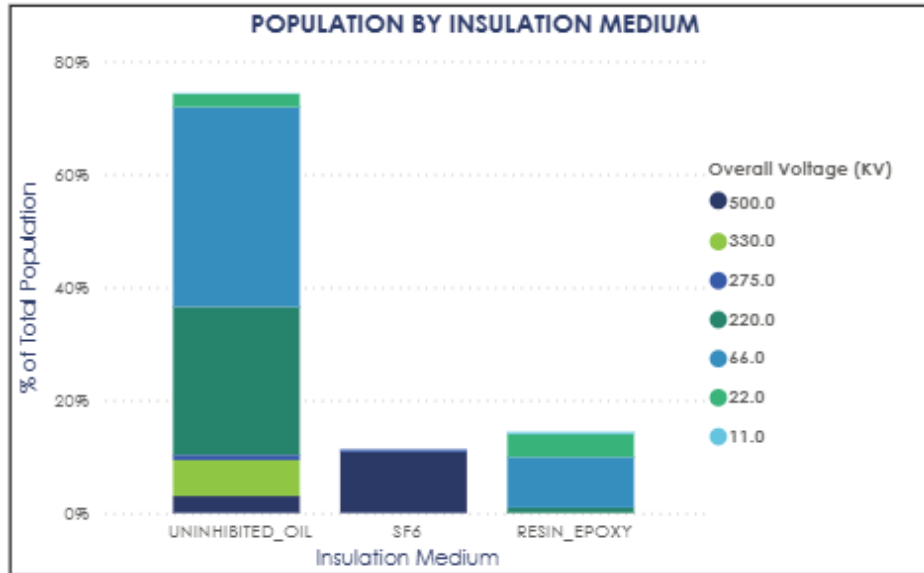
Figure 2 provides the CT population by insulation medium. It is observed that approximately 75% of the population comprise of oil filled current transformers, SF6 insulated (11%), and the remaining population is solid type epoxy or cast resin type used for protection and measurements and at capacitor banks. The use of SF6 and polymer housing for 500 kV CT is a policy decision aimed at reducing potential safety risks.

Figure 2: CT Population by Insulation Medium

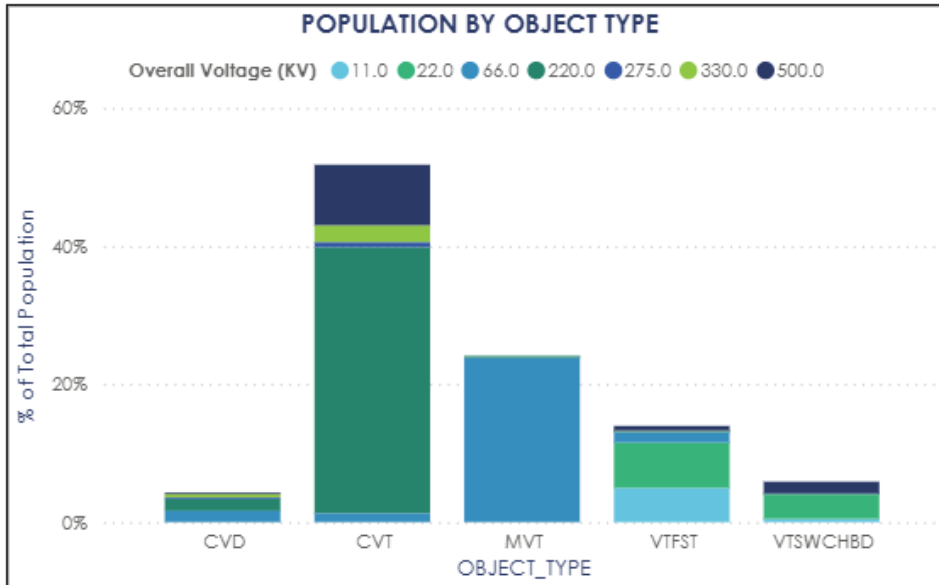
Figure 4 below provides the VT population by Object Type. Approximately 60.4% of the total 11kV - 500kV Voltage transformer population consist of CVT (56.1%) and CVDs (4.3%). CVTs are mainly at 220kV (38.5%) and 500kV (8.8%) of the total voltage transformer population. MVT and VTFST are mainly located at 66kV system (25%). Indoor types are those shown as VTSWCHBD and mainly at lower voltages.

Figure 4: VT Population by Object type

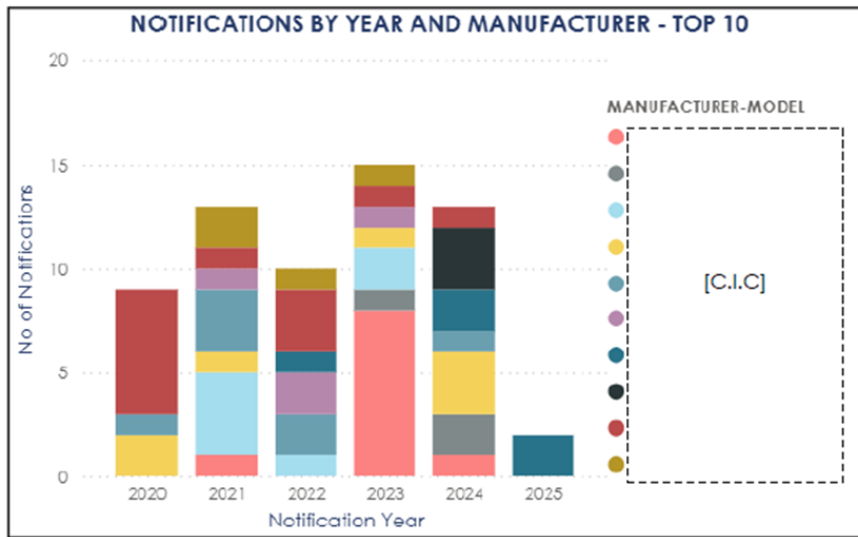
Figure 16 provides the Number of ZA and ZK Notifications per VT manufacturer model during the period 2020-2025.

Figure 16: Number of ZA and ZK Notifications per VT Manufacturer 2020 – mid 2025 (top 10)

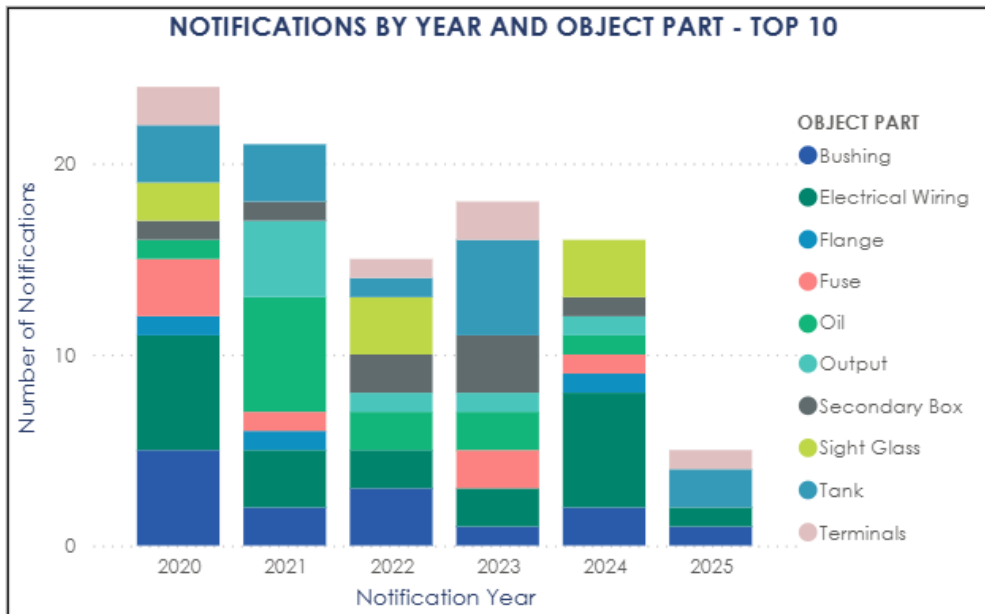
Figure 18 provides the Number of VT ZA and ZK Notifications Vs Object Part for the period 2020 - mid 2025. Issues in electrical wiring contributed to 17% of total ZA and ZK notifications during the period. Other key affected object parts are Insulator bushings (12%), tank (12%), Oil insulation medium (10%) during the last 5-year period.

Figure 18: Number of VT ZA and ZK Notifications vs Object Part affected 2020 – mid 2025 (top 10)

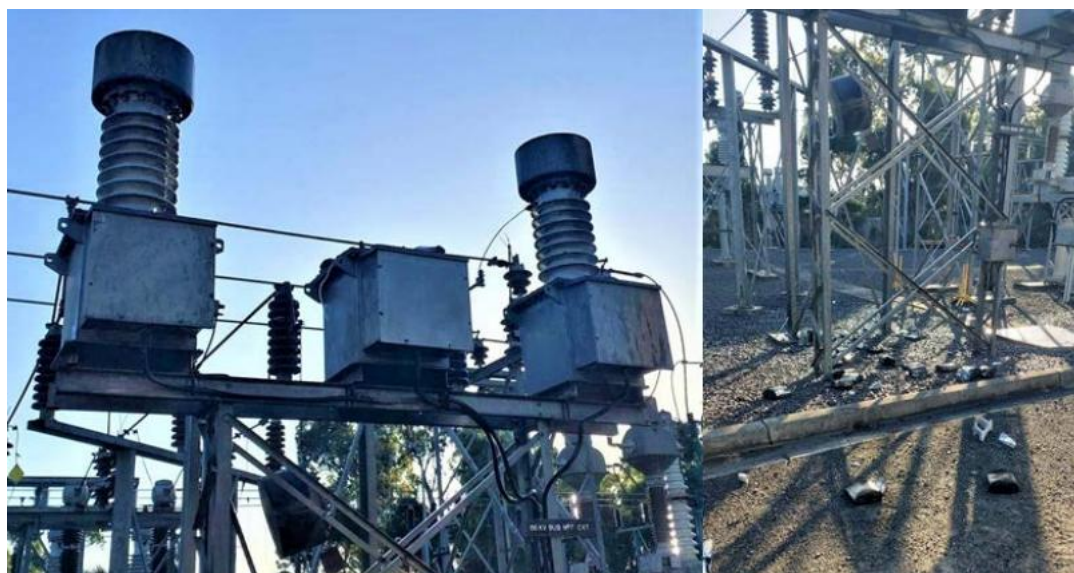
On 31 December 2022, a fault occurred on the 66kV FDR line at Lilydale Zone Substation (LDL), leading to the failure of a [C.I.C] CVT (see Figure 19 below) that was, at the time, not included in the CAMS scheme. The failure led to the catastrophic rupture of the CVT's porcelain insulator, causing porcelain fragments to be dispersed across an approximate 10-meter radius. The incident was further compounded by an accompanying fire, which caused localized damage to nearby assets situated within a five-meter vicinity of the failed unit. The nature of the failure highlights the inherent risks associated with aging porcelain-housed instrument transformers, particularly under fault conditions.

Figure 19: [C.I.C] CVT failure in 2022

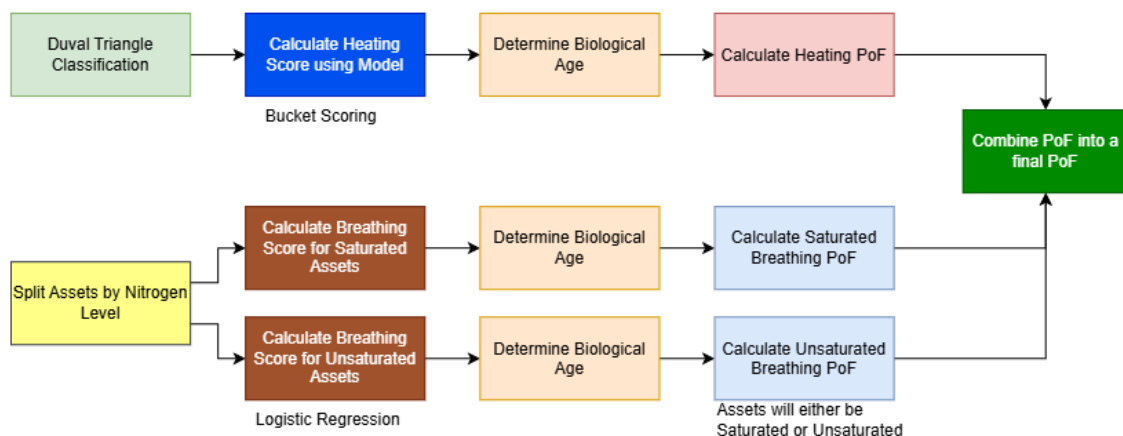
The overall PoF for CT is determined by integrating the breathing and heating PoF components, as illustrated in the block diagram below. The model also estimates the asset's biological age based on conditional PoF. Future PoF projections are calculated using a Weibull distribution model, in accordance with the methodology outlined in AMS 01-09.

Figure 24 - Block Diagram for Combined Probability of Failure

Heating gas analysis will be done by analysing the five key gases: Hydrogen, Methane, Ethane, Acetylene and Ethylene. Duval Triangle method has been used to identify heating gas events within CTs. The Duval Triangle uses three of the heating gases (Methane, Acetylene and Ethylene) to classify a CT into heating event classifications. Unlike the IEC method, the Duval Triangle is a closed system, meaning all assets will be classified.
