**MANAGEMENT PLAN 2011**

**GROUND MOUNTED SUBSTATIONS**

DOCUMENT NUMBER: NW-#30160765-V6

DATE: 8 MAY 2011

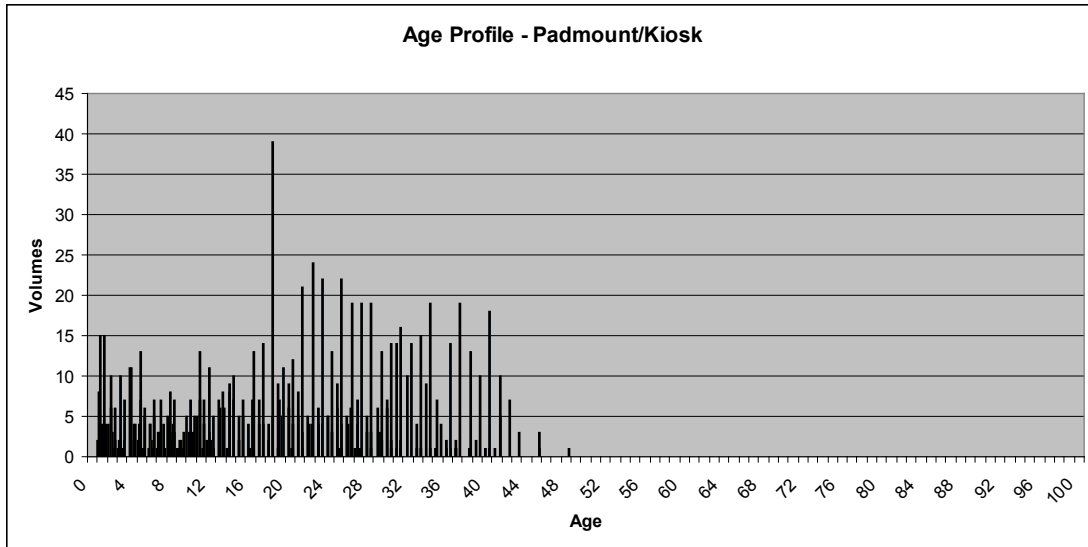
**Figure 2: Padmount and kiosk age profile in the distribution system as at August 2010**

The large concentration of assets volumes with an age between 20 and 40 above the average volume is partly due to Tasmanian Housing Department development in urban residential subdivisions that supported underground electrical infrastructure during the late 1970s. A strong focus on the south of Tasmania resulted in large numbers of 11 kV padmount and general ground mounted substations being installed which can be demonstrated in the large step change in volumes.

Assets with an age less than the average life across the whole asset class of twenty four are predominantly within padmount/kiosk type substations as shown in Figure 2.

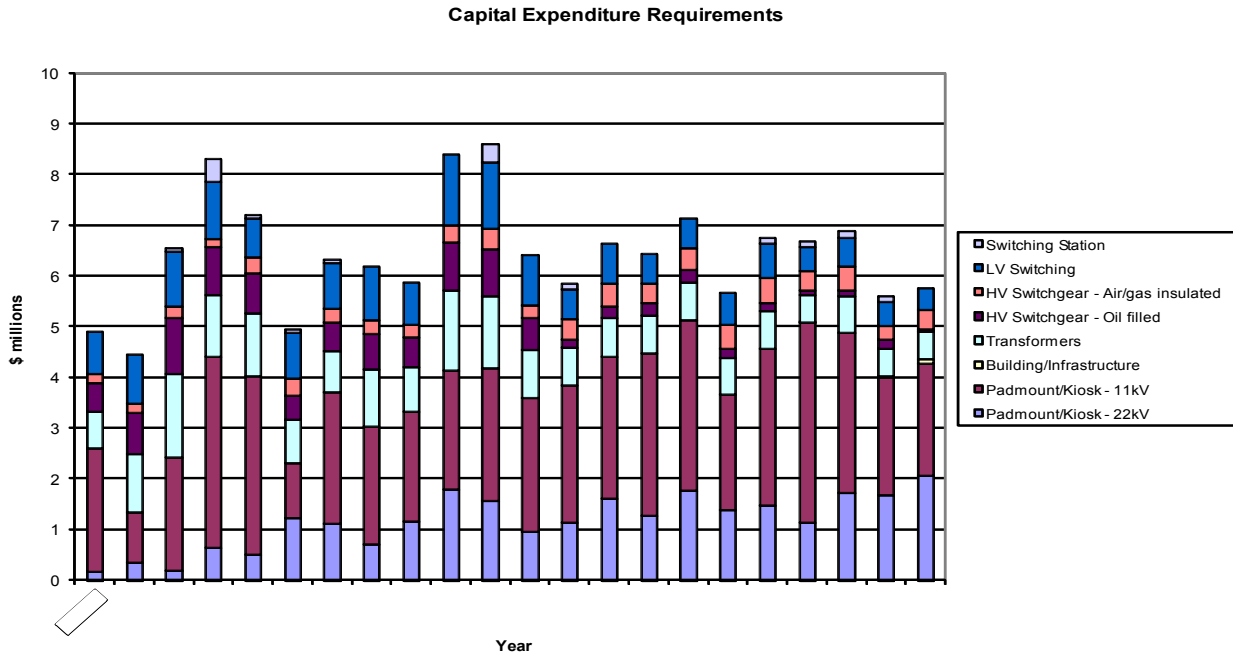
Figure 5: Forecast capital expenditure based on age profile information

Figure 5 shows the outputs of Aurora’s capital expenditure model for the ground mounted substations, taking into account condition, risk and age. The model forecasts capital investment of \$25.5m over the next regulatory period however, the values used for age are higher than those proposed by the regulator. A total CAPEX of \$33.3m would be anticipated if the regulated life expectancy was used.

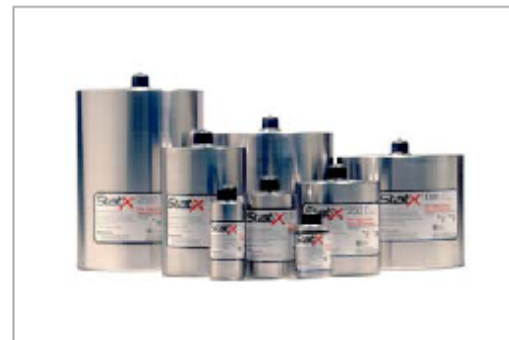
Upon detection of a fire, **StatX** generators can be activated either manually or automatically from a suitable electrical releasing device. Upon activation, the generators produce an exceptionally effective, ultra-fine, potassium based aerosol. Unlike gaseous systems, **StatX** aerosol generators are very cost effective to install and maintain - as they do not require the pressure vessels, piping or expensive installation costs associated with other extinguishing systems. Space and weight requirements are minimal. On an agent weight basis, **StatX** aerosol is ten times more effective than gaseous agent alternatives. The **StatX** generator's effectiveness is a function of its patented design, aerosol composition, and ultra-fine particle size. Fire suppression is rapidly achieved through interference between the ultra-fine aerosol particulate and the flame's free radicals - terminating propagation of the fire. **StatX** aerosol generators are virtually maintenance free and have a service life of over 10 years. The low installation cost also makes them an extremely cost effective fire protection solution.
