**MANAGEMENT PLAN**

**BUSHFIRE MITIGATION**  
**(ASSET PROGRAMS)**

DOCUMENT NUMBER: NW-#30043347-V4

DATE: 9 MAY 2011

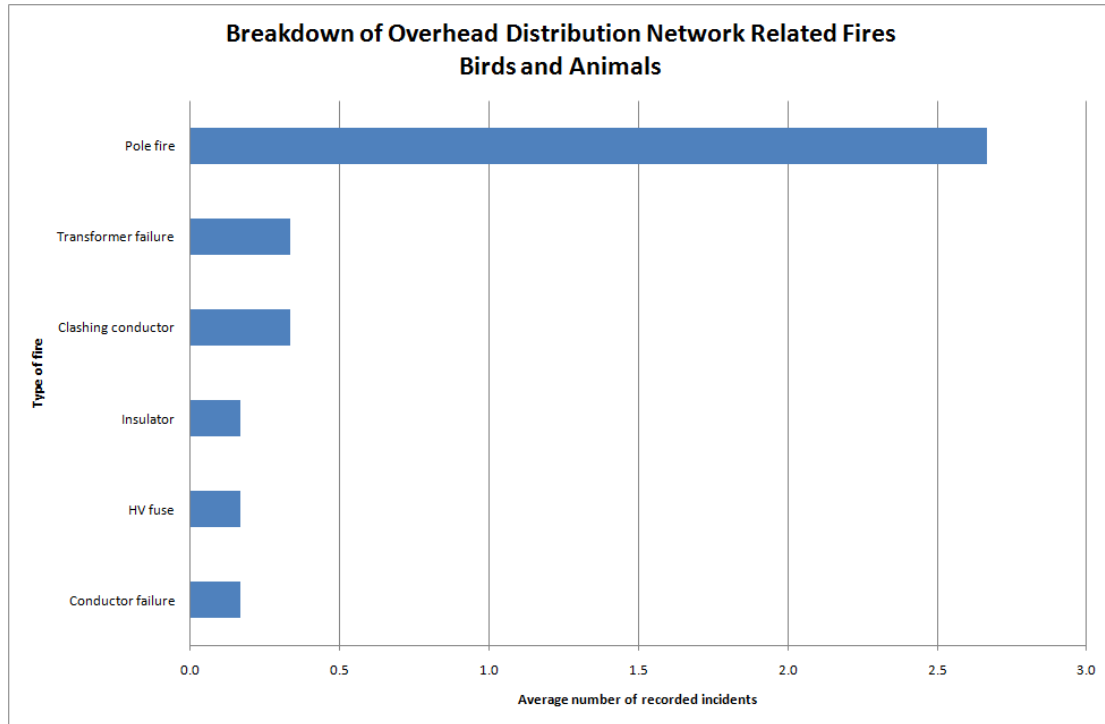
Figure 7 shows the breakdown of fires caused by birds and animals.

**Figure 7: Breakdown of Overhead Distribution Network Related Fires caused by Birds and Animals**
