Planning Proposal

WR1236790 Hermit Park Substation
Refurbishment
Ergon Energy
2020-25
January 2019

Hermit Park Zone Substation (HEPA) is an Ergon Energy zone substation located in Townsville. HEPA was established in the late 1970s with the majority of the primary plant assets manufactured between 1978 and 1979. The substation distributes electricity to 7,200 customers including major retail centres and private hospitals and supplies 28MVA to numerous inner suburbs of Townsville via nine outgoing 11kV circuits.

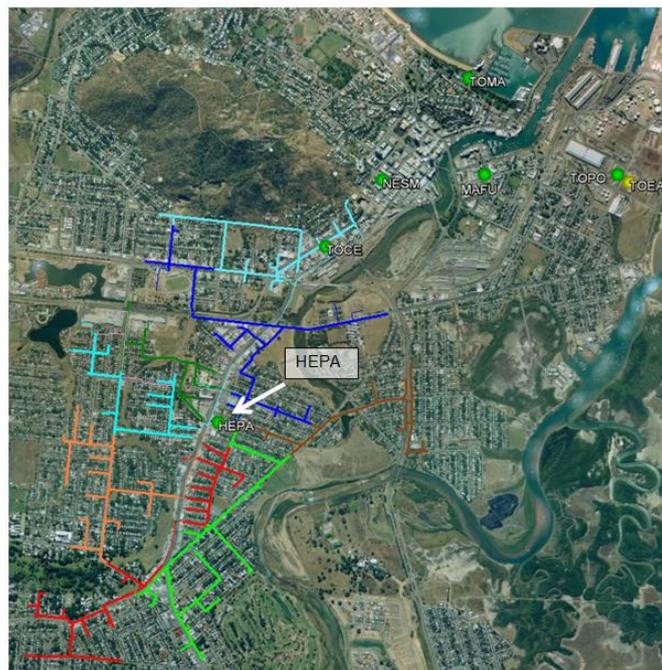
The HEPA electrical distribution network is shown in the diagram below.

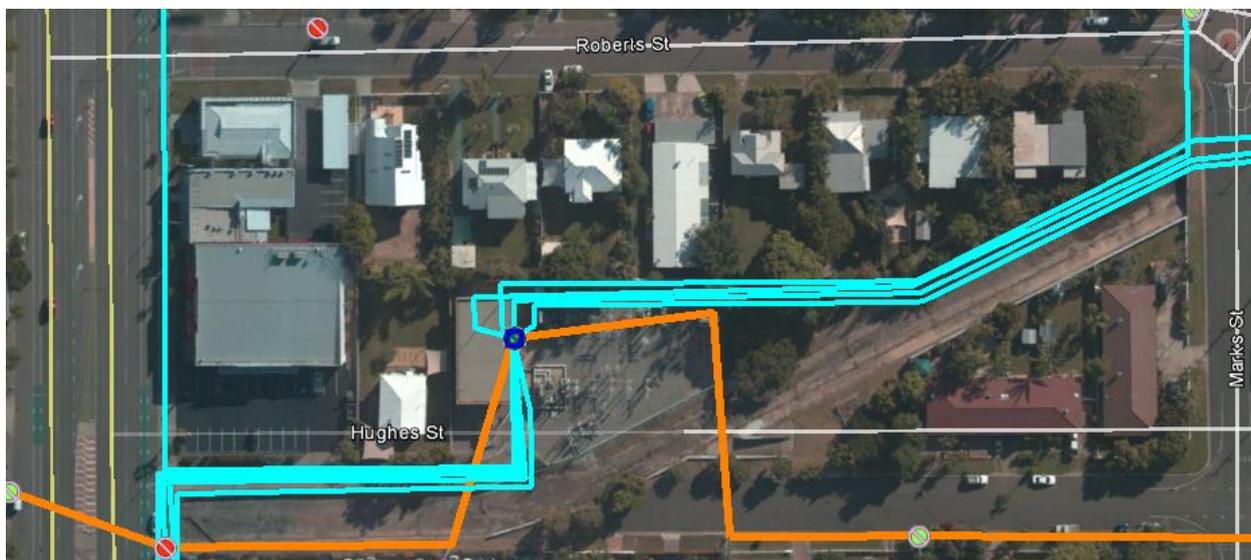
Figure 1: 66 kV (Orange) and 11 kV Feeders (Blue)

The two power transformers that are situated in HEPA ZS are 25 MVA General Electric Company (GEC) that were manufactured in 1979. The ZS is enclosed by Hughes Street, Marks Street, Roberts Street and Charters Towers Road; a six-lane road that is governed by the Department of Main Roads. The feeder exits are split into two main banks; one group that runs under the heavy vehicle access road (Charters Towers Road) and the other that runs under a concrete drain culvert to Marks St, a residential street (as shown in Figure 1: 66 kV (Orange) and 11 kV Feeders (Blue)).

The zone substation is connected to Garbutt ZS and Oonoonba ZS on the 66 kV sub transmission network (refer to Figure 1: 66 kV (Orange) and 11 kV Feeders (Blue)). In the Safety Net document for Hermit Park, it outlines that there is 3.5 MVA capacity of load transfer via the distribution network in a N – 1 Scheme. This would need to be reviewed in the next Safety Net revision. The maximum load recorded in 2017 is 28.3 MVA and the forecast load for medium growth in 2026 is estimated to be 26 MVA.

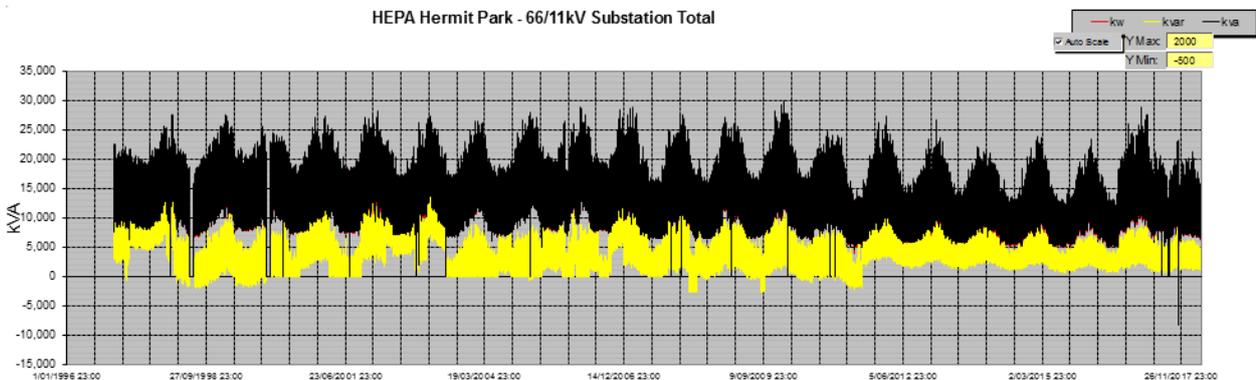
Graph 3: Hermit Park ZS loading 01/01/1996 - 19/04/2018 (VERSION 4.3 OF SMDB PROFILER)

Graph 3 outlines the load demands for HEPA ZS. The Statistical Metering Data Base (SMDB) profile graph for Hermit Park's substation shows a cyclic pattern in load demand. However, the graph shows that the peak of each cycle is lower than the cycles in the years prior to 2009. The graph shows that the maximum peak in 2017[#] is similar to the peaks that were recorded in the years previous to 2009.

[#]**Note:** The maximum peak load in 2017 was 29 MVA but this is still below the LTEC loading of 31.5 MVA.

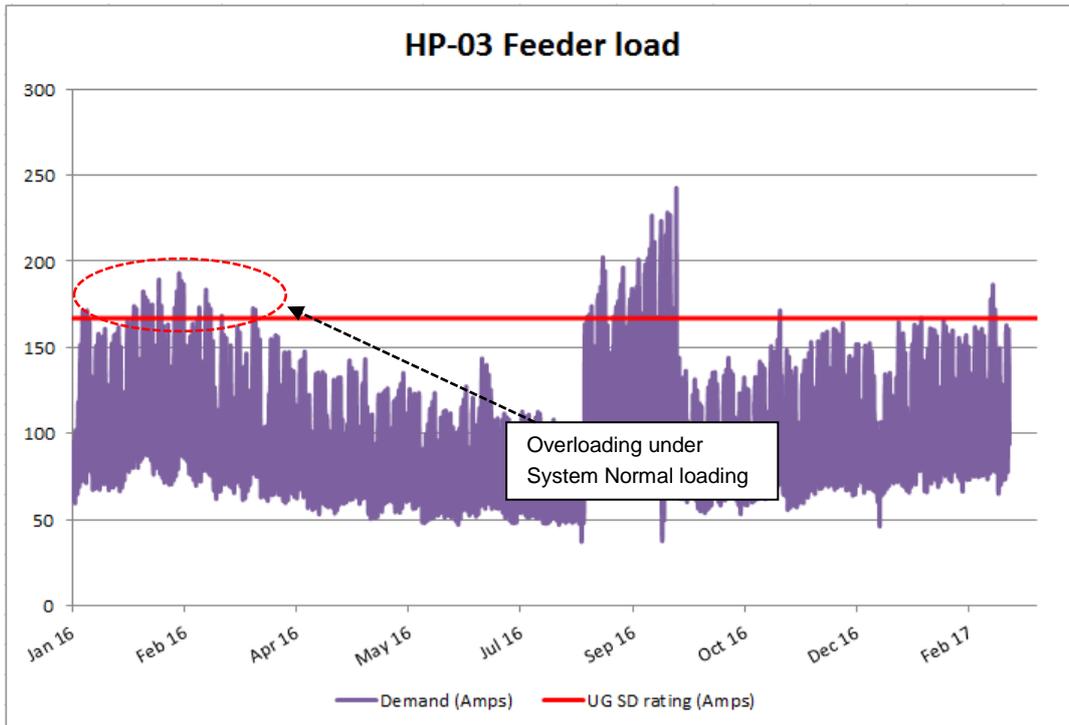
Graph 4: HP - 03 Feeder Load (VERSION 4.3 OF SMDB PROFILER)

- Hermit Park No.3 Feeder (HP-03) is currently overloaded (111%) [109%] under system normal conditions.
- Hermit Park No.4 Feeder (HP-04) is currently overloaded (127%) [108%] under system normal conditions.
- Hermit Park No.6 Feeder (HP-06) is currently overloaded (148%) [125%] under system normal conditions.

Graph 4 to 6 as shown below outlines the loading on the feeders described above.

As it can be seen from a loading perspective, the thermal ratings on the HP-03, HP-04 and HP-06 would need to be increased or the feeder unloaded to alleviate the constraint.

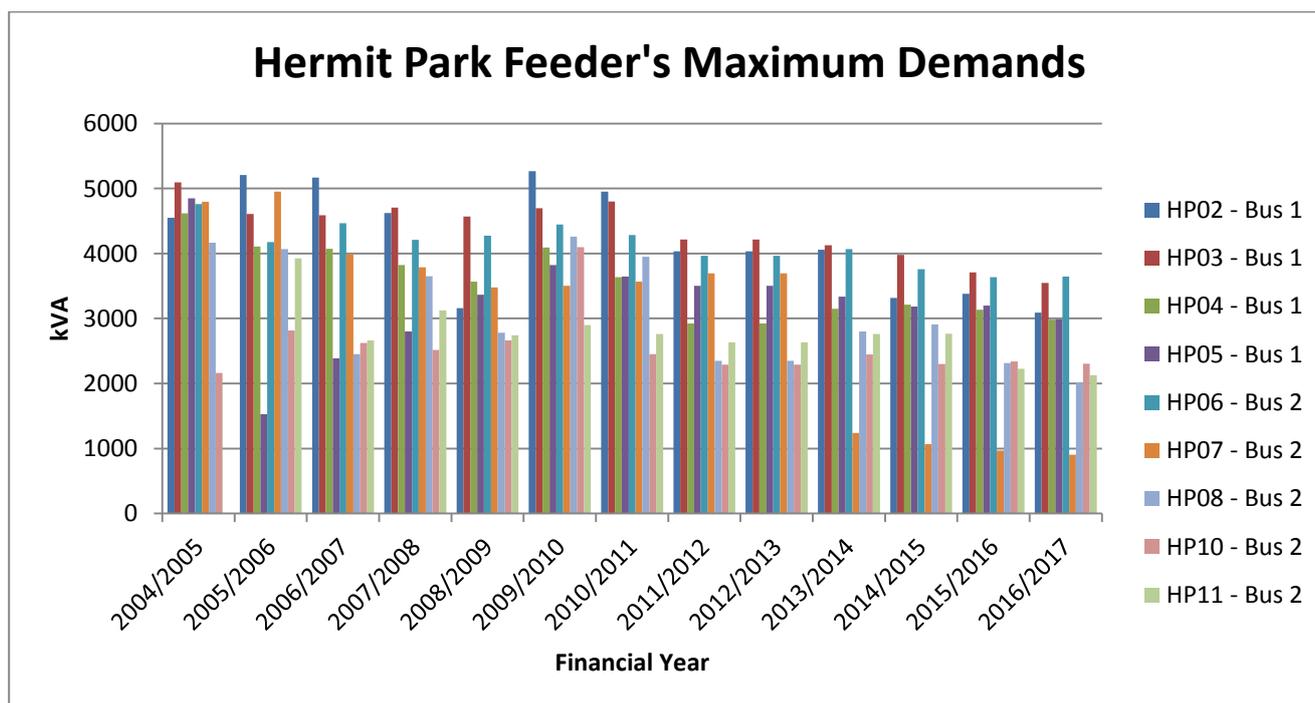
Graph 7: Hermit Park Feeders' Maximum Demand (DFD)

Graph 5 shows the maximum demand for Hermit Park's feeders from the financial years of 2004/05 to 2016/17. The graph also shows that the maximum demands of these feeders have decreased since 2011/12. There was a load transfer that was done in 2013 from Railway Ave No. 2 switch (HP-07 to Oonoomba Feeder No. 08 or OONN-08). It can be seen that HP-02, HP-03 and HP-06 typically have a higher demand in comparison to the other feeders.

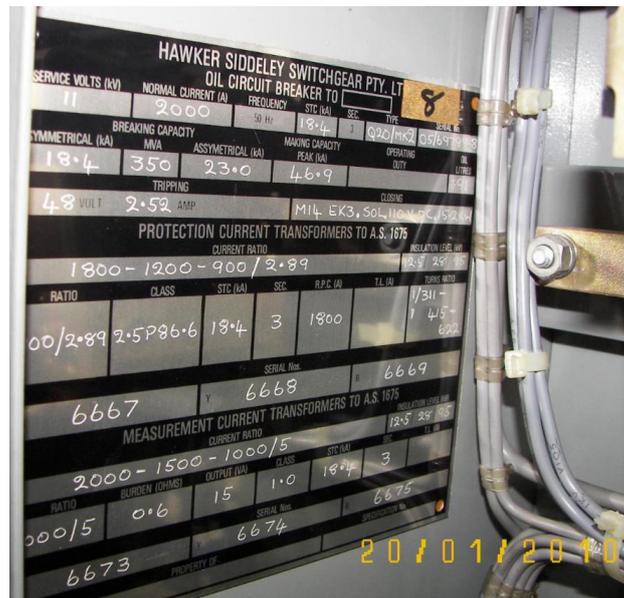
Figure 5: HEPA 11 kV T2 Nameplate Rating (Asymmetrical Rating is the same 23.0 kA for the Feeder Circuit Breakers)

There are potential risks of losing 11 kV circuit break LV closing coil supply to both bus sections whilst either T1 or T2 is out of service (e.g. replacement of T1 or T2). Whilst this risk is small, the occurrence has occurred on occasions (refer Figure 5), particularly for long-duration plant outages.

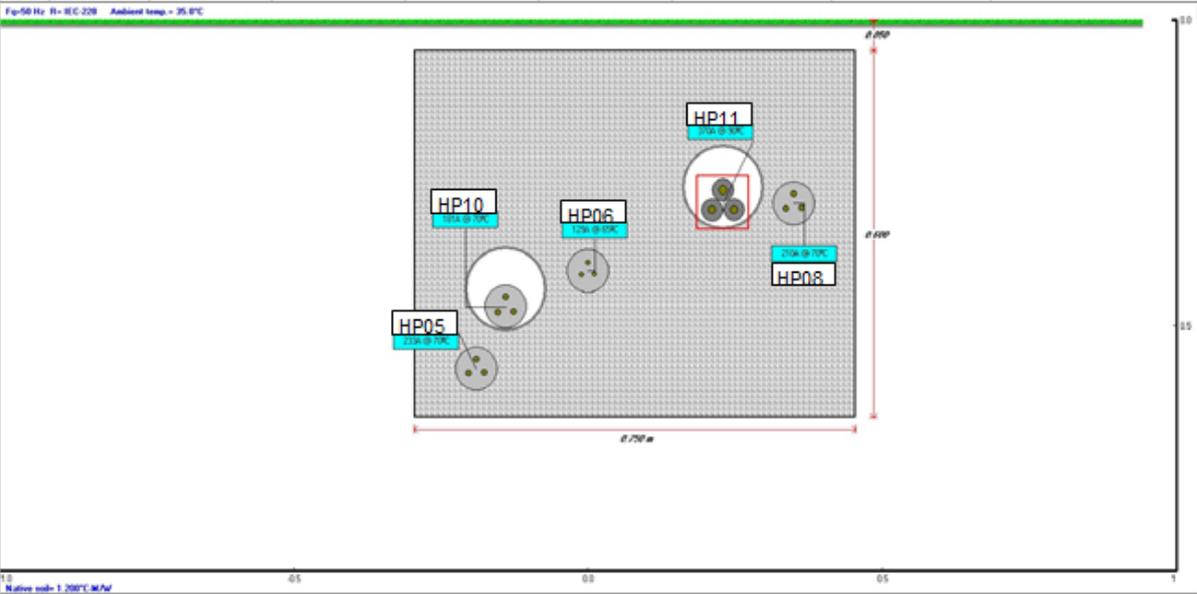
Study: HEPA-CharterTowers RD feeder exits
Execution: HP 6/10/5/8/11 - TR3.0/35deg/LFset/WP6R_trenchsect1
Date: 9/04/2013
Frequency: 50 Hz
Conductor Resistances: IEC-228
Fraction of conductor current returning through sheath for single phase cables: 0

Installation Type: Multiple Duct Banks Backfills							
Parameter						Unit	Value
Ambient Soil Temperature at Installation Depth						°C	35
Thermal Resistivity of Native Soil						°C.m/W	1.2
Layers		Dimensions [m]				Type	Thermal Resistivity [°C.m/W]
No.	Name	X Center	Y Center	Width	Height		
1	NSTD DB1	0.08	0.35	0.75	0.6	Non-Standard ductbank	3

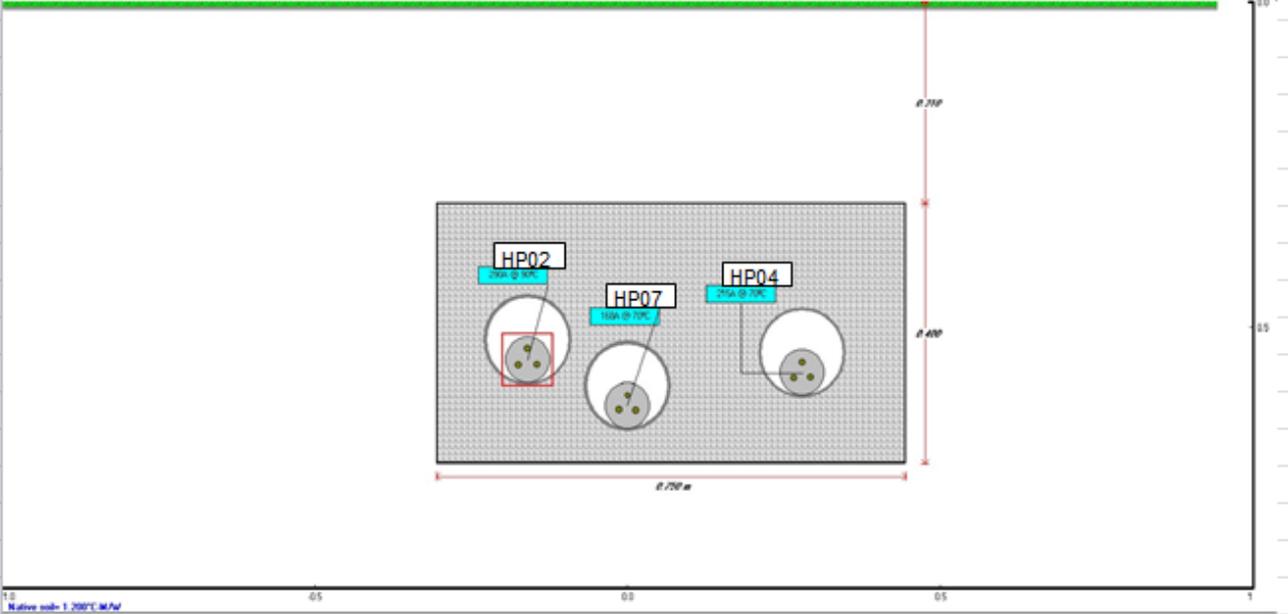
Study: HEPA-Mark St feeder exits temp solution
Execution: HP4/7/2 - TR3.0/35deg/LFset/MID Rd Mark ST-R_trench1
Date: 12/04/2013
Frequency: 50 Hz
Conductor Resistances: IEC-228
Fraction of conductor current returning through sheath for single phase cables: 0

Parameter						Unit	Value
Ambient Soil Temperature at Installation Depth						°C	35
Thermal Resistivity of Native Soil						°C.m/W	1.2
Layers		Dimensions [m]				Type	Thermal Resistivity [°C.m/W]
No.	Name	X Center	Y Center	Width	Height		
1	NSTD DB1	0.07	0.51	0.75	0.4	Non-Standard ductbank	3

Fig-58 Hz R= IEC-228 Ambient temp = 35.0°C

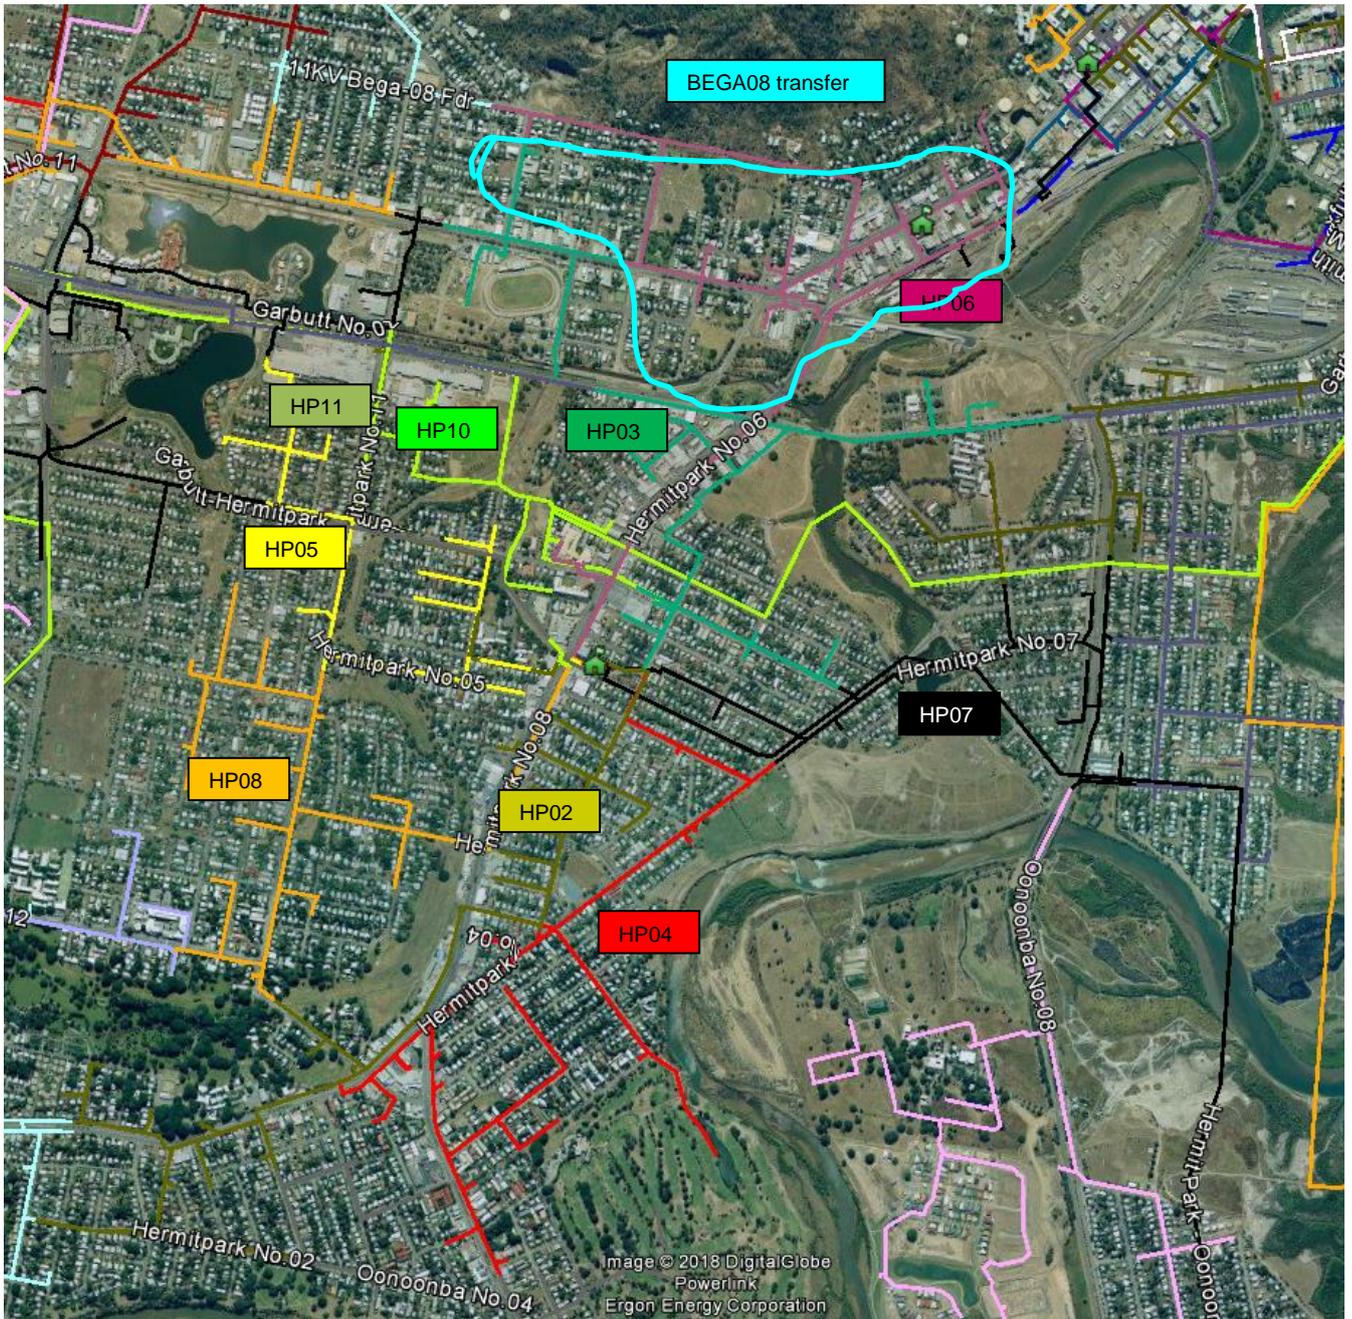
Figure 8: HEPA 11 kV network configuration (PROPOSED STATE)

Upgrade stay /streetlight ecorp ID pole 82627508 to 11 kV term. pole- term. Ex-HP04 cable

Install new 240Cu. 3C XLPE or 400 Al. triplex to HP04 term. pole ecorp ID 81444586
