MANAGEMENT PLAN 2012

PUBLIC LIGHTING

DOCUMENT NUMBER: NW#-30148124-V6A

DATE: 10 JANUARY 2012

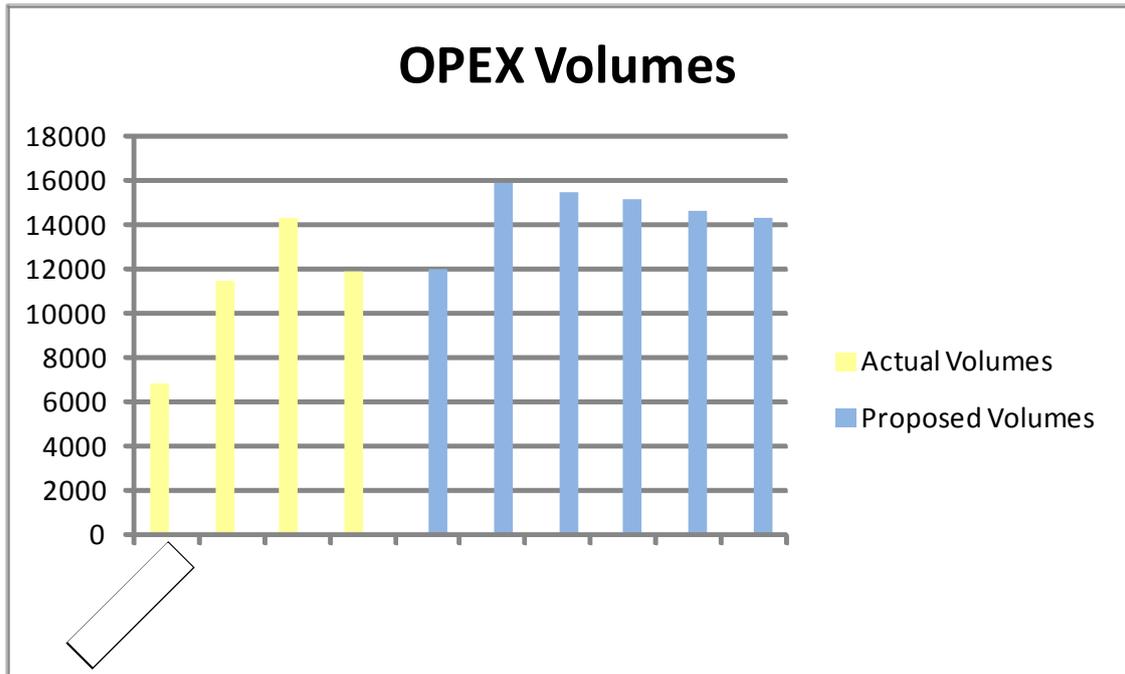
Figure 1: Public Lighting OPEX (Actual and Proposed)

The reduction of OPEX for the Bulk Lamp Replacement (BLR) program in the financial years of 2010/2011 and 2011/2012 was due to business financial pressures. This saw OPEX cut across the business, including the work program of RLBLR. As a result, the four yearly cycle of bulk lamp replacement has fallen behind. Year 4 of Cycle 1 of the BLR program was due to be completed in 2011/2012. It is now proposed to be completed over a seven year period – beginning in the first year of the next pricing period. Year 3 of Cycle 1 of the BLR program is currently being completed in this financial year (2011/2012).

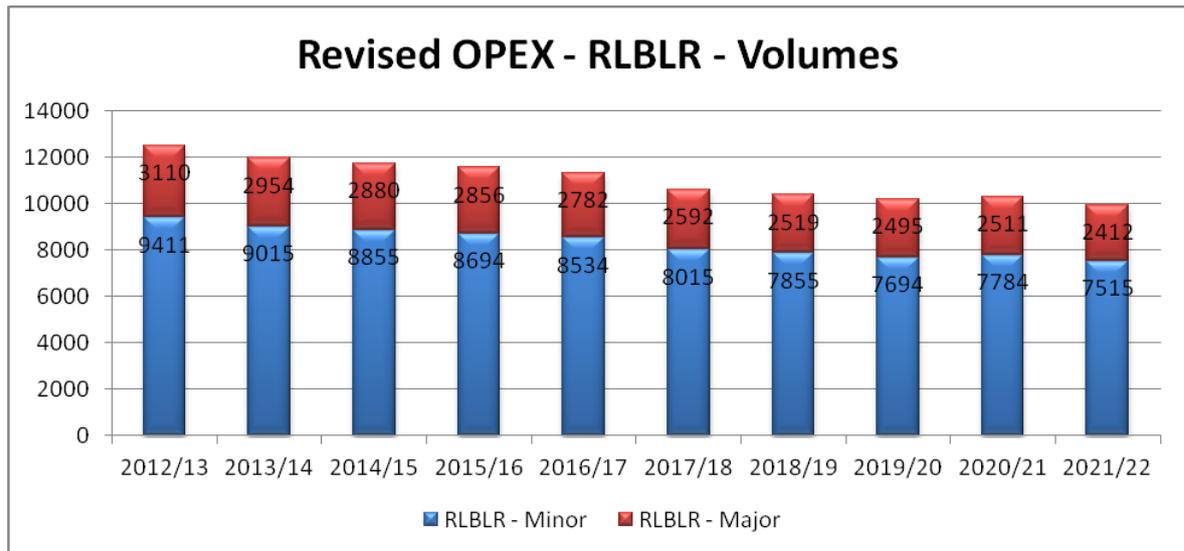
Figure 2: Volumes for major and minor bulk lamp replacement programs

Spreading the volumes and hence costs for the BLR program (for Cycle 1, Year 4) across the seven year period will significantly reduce the price impacts to our customers with no large spikes in prices. This is shown in Figure 2. It shows a gradual reduction of OPEX BLR program volumes from 2012/13 to 2018/19 (seven year period). At this point forward (2019/20) the BLR program gets back to be a true four yearly replacement program.

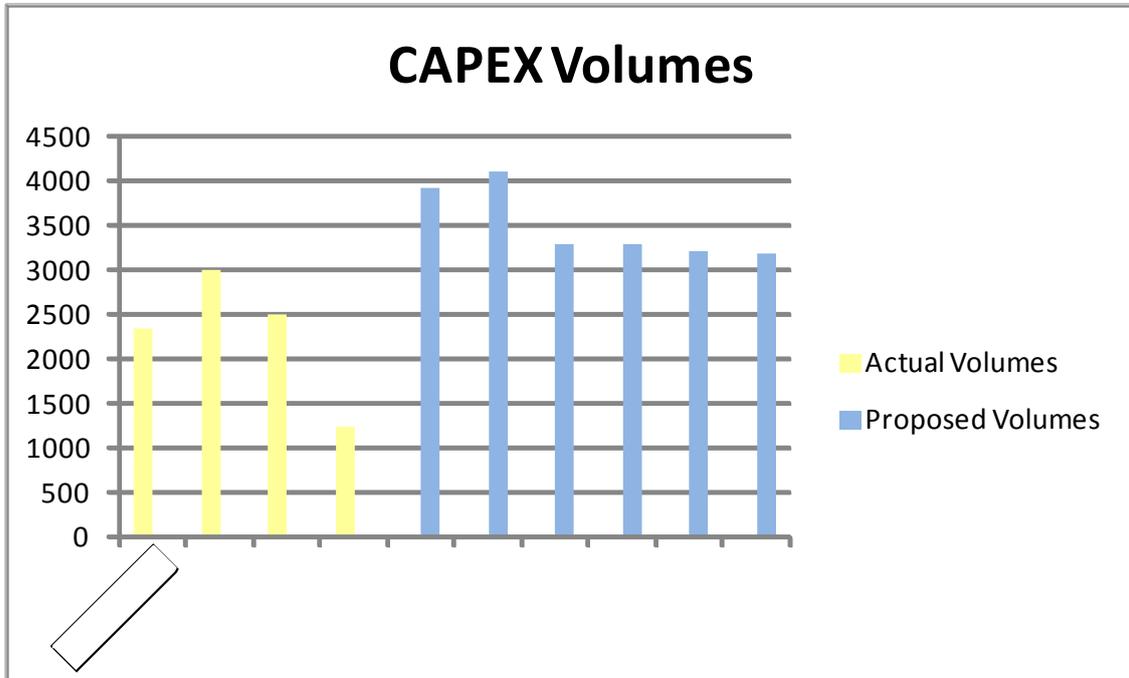
Figure 3: Public Lighting CAPEX Volumes (Actual and Proposed)

The increase in volumes is due to a change to the reporting methodology for the Replace Luminaires - Minor public lighting (Bulk Replacement) (RLMAJ) and Replace Luminaires - Major public lighting (Bulk Replacement) (RLMIN) programs. Previously these items in the program of work were reported as single items for each program. The program of work now reports volumes for specific tasks programmed. This has increased the volumes by approximately 3,200 for the 2012/13 financial year and 2,300 for years 2013/14 to 2016/17.

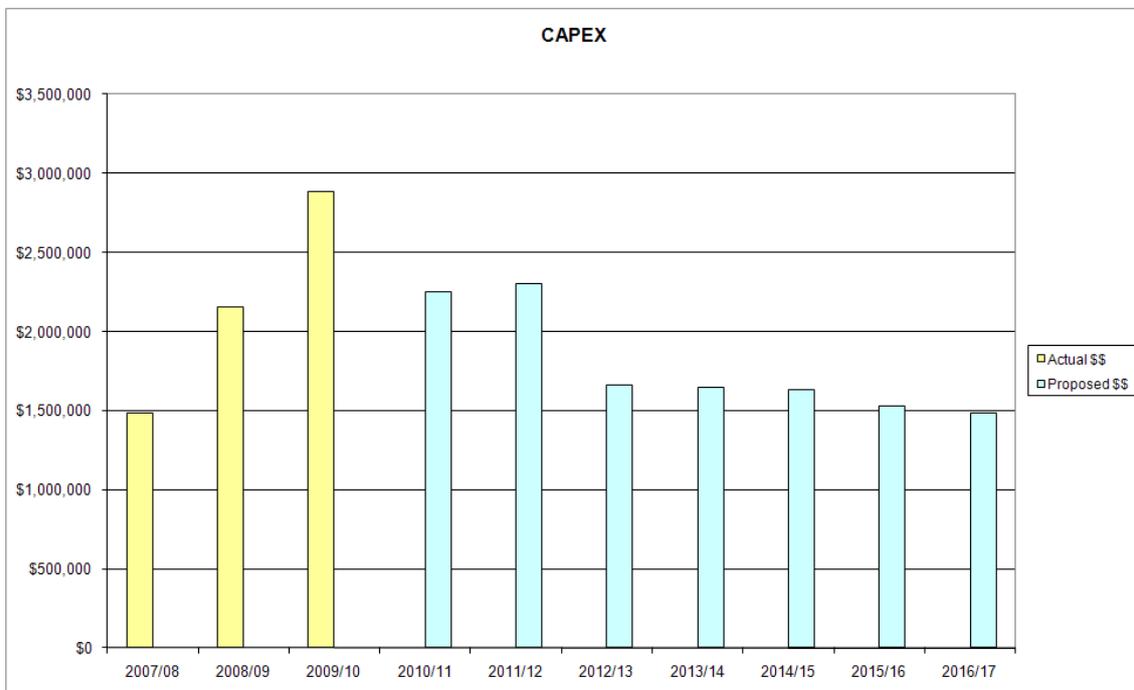
Figure 4: Public Lighting CAPEX Expenditure (Actual and Proposed)

The reductions in capital expenditure are attributed to two factors:
