## **Revised Regulatory Proposal**

### **Supporting Information: HV Underground Cables (REUGC)**

### **Aurora response to the AER's Draft Distribution Determination**

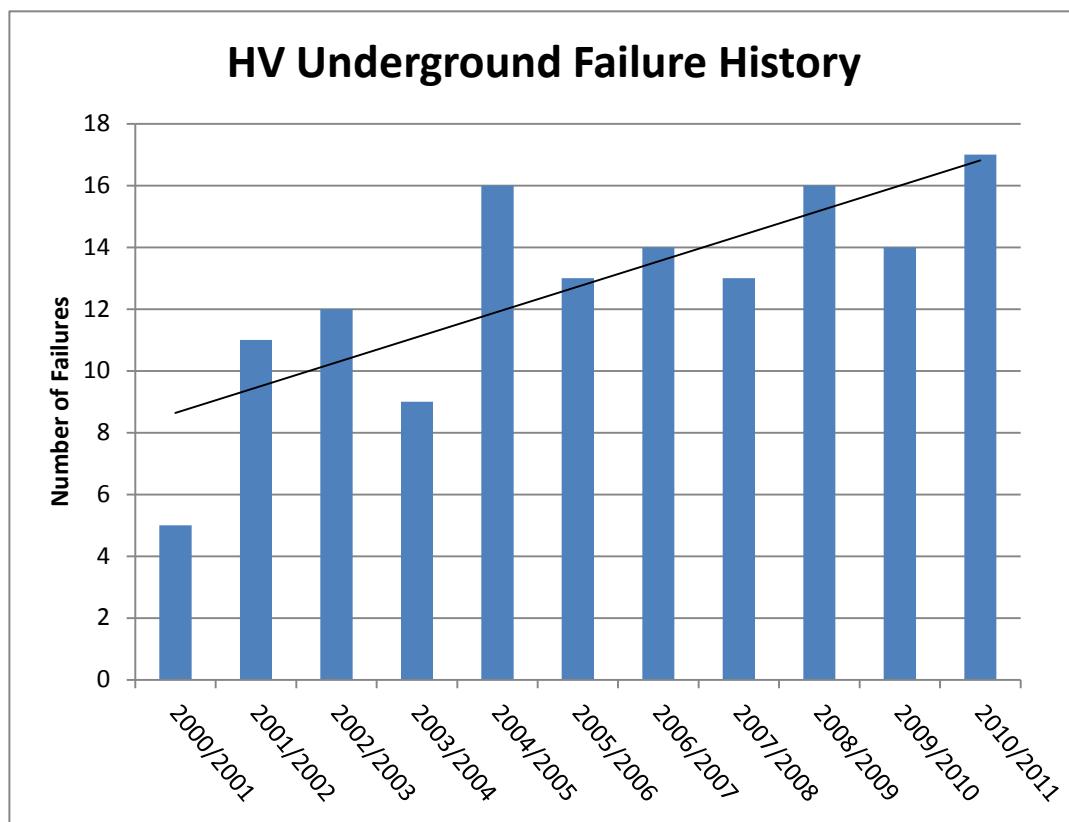
**Figure 1: Aurora's HV Underground Cable Failure History**

It can be seen in Figure 1 that there is a clear upward trend in underground cable failures over the past 10 years, with Aurora recording the most underground cable failures in 2010/11. It can be assumed that this trend will continue due to the ageing cable asset base shown in Chapter 3, given Aurora's current population consists of over 700km of underground cable between 30 and 80 years old.

Aurora has a history of cable failures on both underground and submarine cable assets. The mode of failure is a combination of failures at midspan, joints and terminations. Aurora's records of historical failures can be categorised by the type of protection that operated as a result of such failure, therefore allowing HV failures to be separated and analysed. The graph in figure 1 shows the number of underground cable historical failures that resulted in HV protection operating.

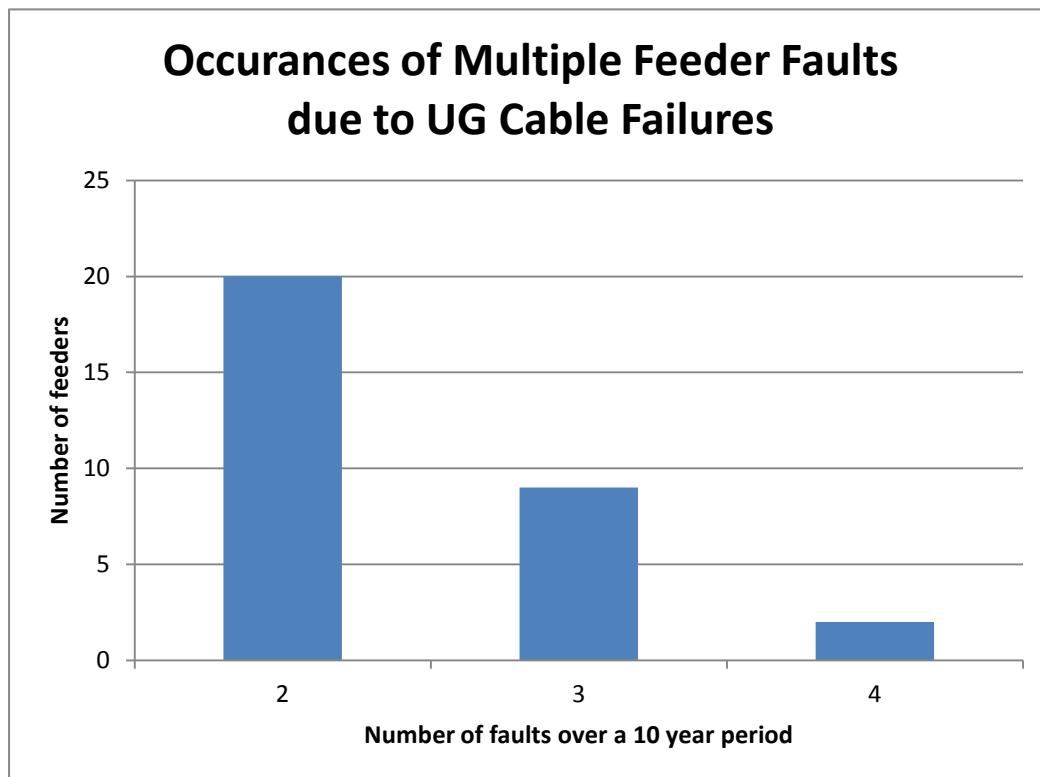
**Figure 2: Occurrences of Multiple Feeder Faults**

As an example, there are 20 feeders which have experienced 2 recorded faults due to underground cable failures, over a 10 year period. In instances where more than one fault has occurred on older assets, proactive replacement will be considered to ensure that the current trend of failures will not increase to a level that significantly affects customer supply. This is because the majority of areas which have experienced multiple failures are urban and therefore a significant number of customers are affected by the resultant feeder outages.

Further analysis of HV underground cable failures determines the feeders on which multiple cable failures have occurred. The results are shown in figure 2.
