# Program of Works

## 2017 – 2022

### Transformer Bushings Replacement (PUBLIC VERSION)

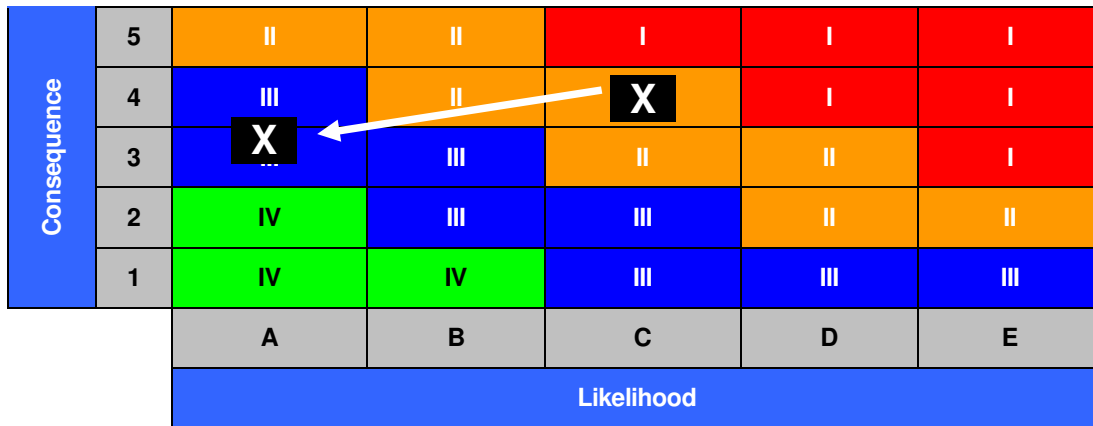
Figure 1 – Risk Matrix

This high voltage bushing replacement program (chosen option – Option 3) will reduce the likelihood of those bushings failures from moderate to rare and consequences from major to moderate as shown in the risk matrix in following Figure 1 below.

The consequences become moderate as a result of the bushings being replaced with resin impregnated paper (RIP) non-porcelain bushings. These bushings will not result in porcelain projectiles during explosive failures and therefore will mitigate the health and safety risk to the personal working onsite and risk of collateral damage to other plant in the switchyard. Replacement of the bushings will reduce the failure risk from a score of II to III on the AusNet Services corporate risk matrix. Figure 1 displays the expected improvement in risks achieved through replacement of bushings.
