AMS – Victorian Electricity Transmission Network

Circuit Breakers (PUBLIC VERSION)

Document number	AMS 10-54
Issue number	9
Status	Approved
Approver	J. Dyer
Date of approval	22/07/2015

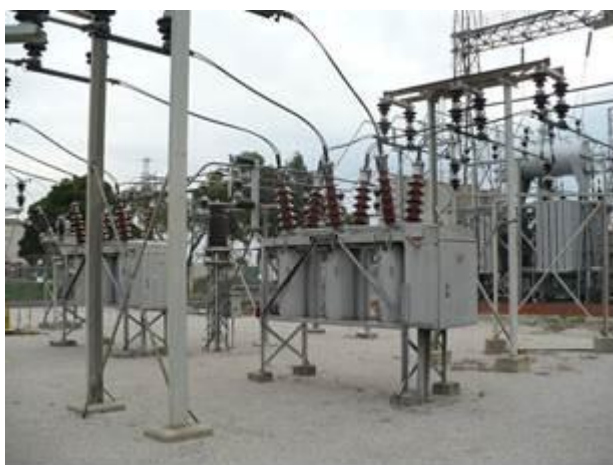
Figure 1 – 66 kV Bulk oil CB

Some of the common types of circuit breakers available in the network are; Bulk oil, Minimum oil, SF₆ and Vacuum. Figure 1 below illustrates a bulk oil 66 kV circuit breaker typical of a technology which is now nearing the end of its useful service life. Figure 2 below illustrates a modern 220 kV SF₆ gas insulated dead tank circuit breaker featuring toroidal CTs in the base of each bushing. Circuit breakers of this type are expected to provide more than 40 years reliable service.

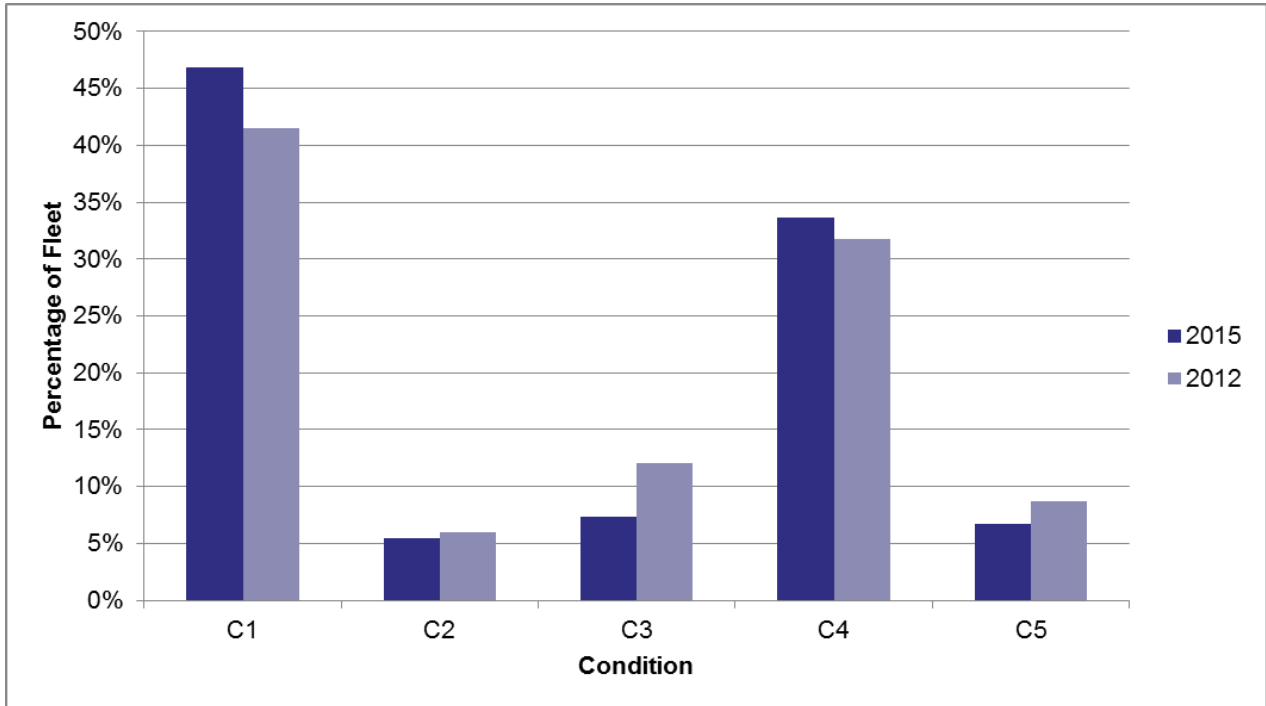
Figure 8 – Circuit Breaker Condition Comparison 2012 and 2015

Figure 8 illustrates a comparison between 2015 and 2012 circuit breaker condition profiles. It is evident that circuit breaker replacements during past three years were sufficient to maintain the circuit breaker condition profile.

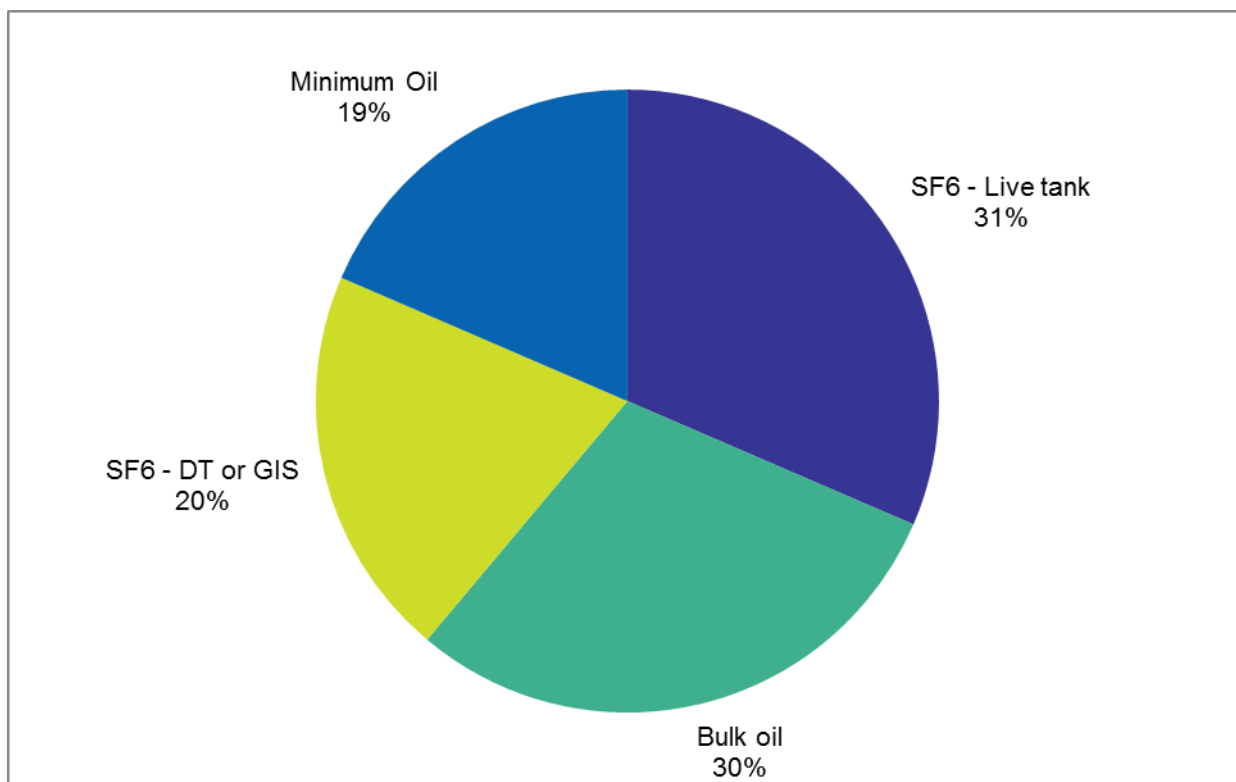
Figure 9 – Significant Defect and Failure History by Technology: 1997 to 2014

Figure 9 depicts the significant defects and failures experienced from 1997 to 2014 by CB technology.

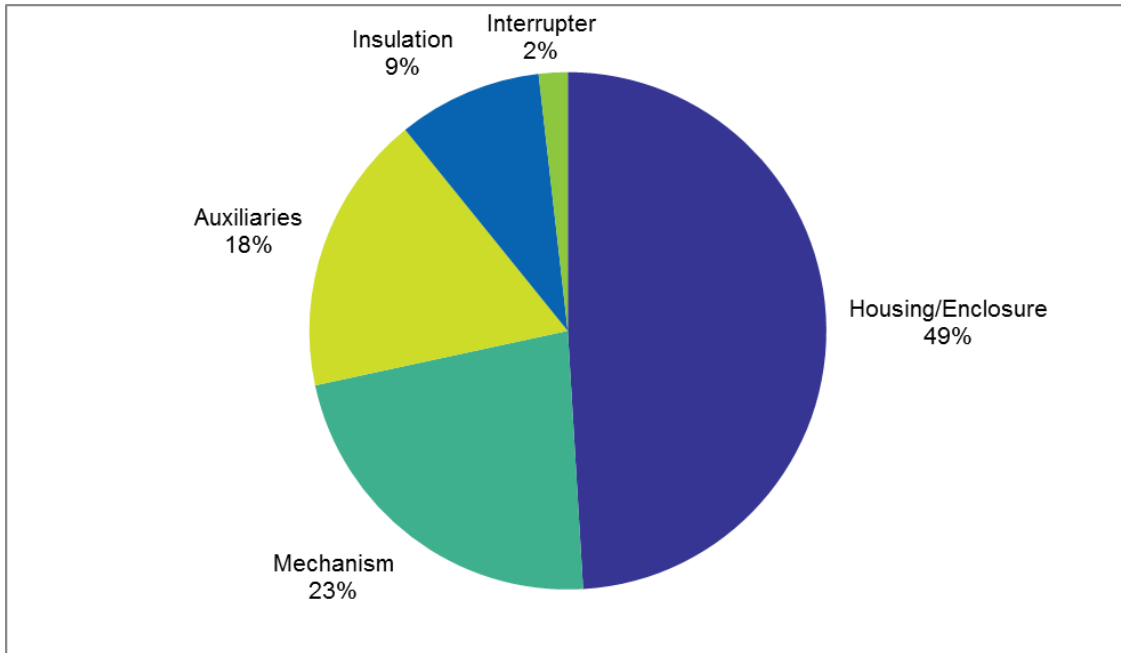
Figure 12 – Annual Work Order History by Circuit Breaker Component

Figure 12 depicts the percentage of CM work orders categorised according to circuit breaker components. The main issue evident is the increasing number of SF₆ gas leaks presented by the circuit breaker population captured in housing/enclosure. This is partly contributed by more than 62% of SF₆ type circuit breaker population. In addition, there has been a recent increase in work orders associated with circuit breaker mechanisms.

Auxiliary systems include cubicle heaters, cyclometers, Amp meters, oil gauges, breathers and SF₆ gas density monitors required for the correct functionality of circuit breakers.

As shown by the Work Order analysis in section 3.4.2, leaks from ageing seals and corroding equipment are a continuing issue for older SF₆ CBs. Asset works programs have been developed to address these fleet issues.
