AMS – Victoria Electricity Transmission Network

Fire Detection and Suppression

Document number	AMS 10-61
Issue number	9
Status	Approved
Approver	J. Dyer
Date of approval	17/09/2015

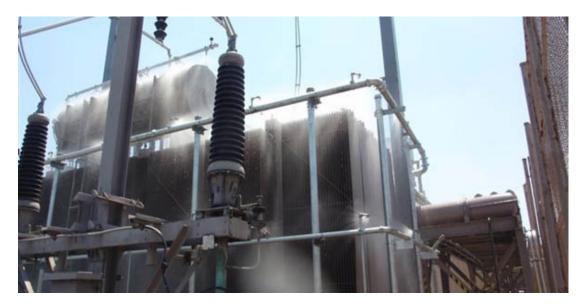
Figure 3 – Water deluge system operating on a power transformer

In switchyards, fire walls and FHSs are installed to provide fire protection to power transformers and buildings (from outside). WDSs provide fire suppression for power transformers, when there is no other fire containment measure. Figure 3 illustrates an example of a WDS operating on a station transformer.
