AMS – Victorian Electricity Transmission Network

Gas Insulated Switchgear

Document number	AMS 10-62
Issue number	9
Status	Approved
Approver	J. Dyer
Date of approval	14/10/2015

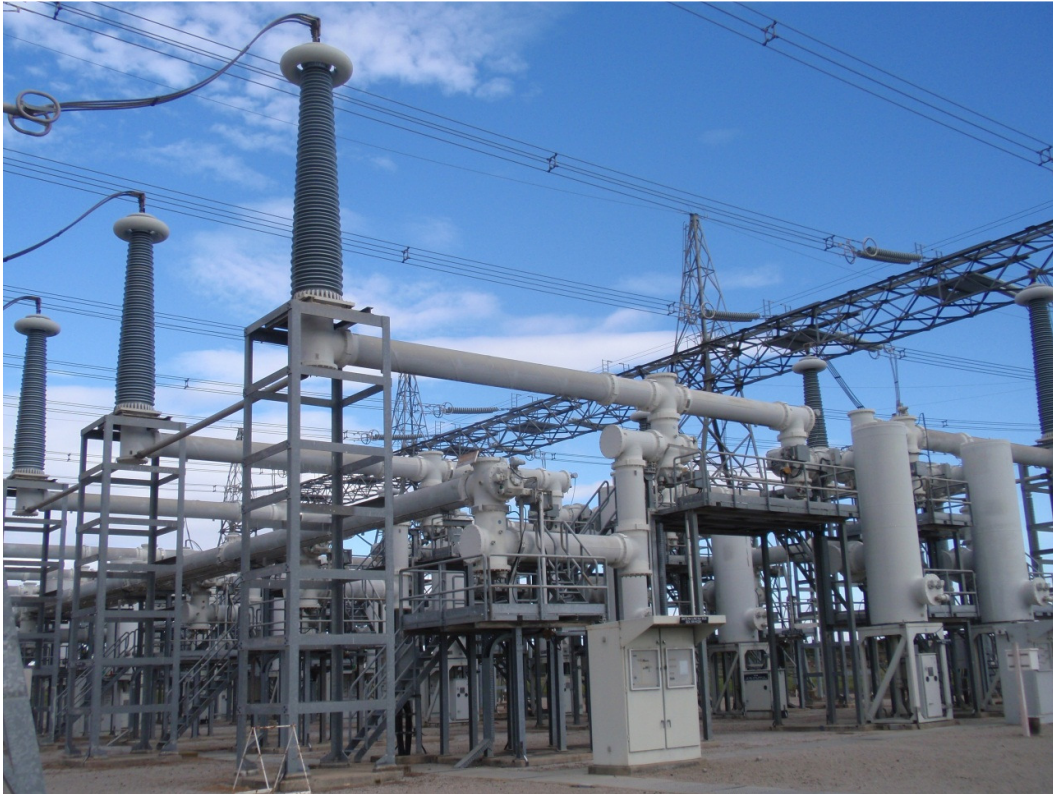
Figure 1 – GIS Equipment at SYTS

Gas Insulated Switchgear (GIS) is an alternative construction technique to Air Insulated Switchgear (AIS). It encloses all live parts within an SF₆ filled metal enclosure. It is typically used when a compact layout is required as shown below in Figure 1. The use of GIS is limited as the cost of GIS is significantly higher compared to AIS.

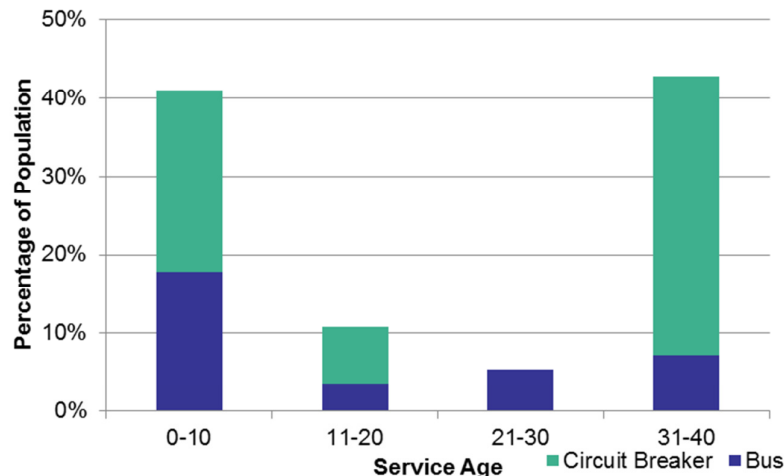
Figure 3 – Age Distribution of GIS Equipment

The GIS equipment population falls into two distinctive categories as shown by the age profile in Figure 3. The majority of GIS equipment operates at 500 kV with a service age between 31 to 40 years. The second age category consists of 22 kV and 500 kV GIS equipment that has a service age between one to ten years.

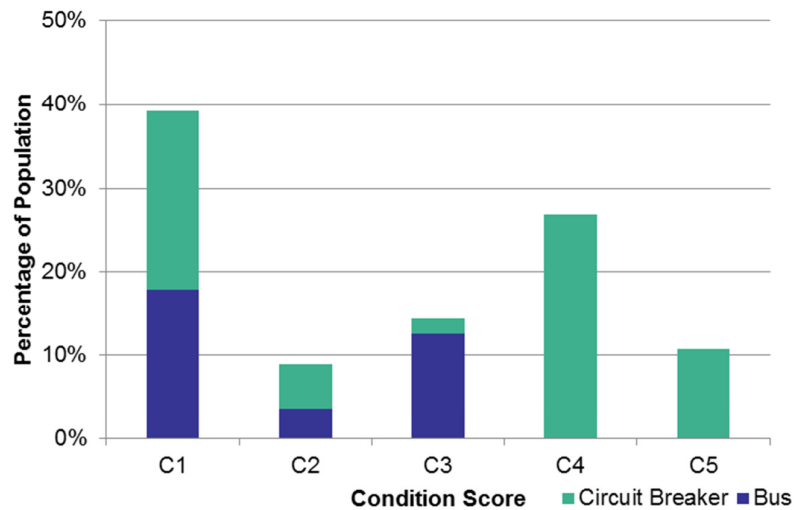
Figure 4 – Condition of GIS Equipment

A condition score of C1 to C3 corresponds to an acceptable condition where no additional action (apart from continued routine maintenance and condition monitoring) is proposed. However, a condition score of C4 or C5 corresponds to GIS with high to very high failure risk requiring remedial action in a relatively short timeframe. Figure 4 shows the condition of the GIS equipment in the transmission network.

The condition of approximately 40% of the GIS equipment population is C1 (Very good). Approximately 27% of the population are in condition C4 (Poor) and there are 11% in condition C5 (Very Poor).

GIS equipment that is in poor and very poor condition is located at SMTS, SYTS and WMTS. The principal issue associated with these assets are SF6 gas leaks. At SYTS, there is moisture in SF6, hydraulic leaks and loose components, however, upon completion of refurbishment works at SYTS, it is estimated the condition score will revert to C3. These issues are discussed further in Section 3.4.3.
