AMS – Victorian Electricity Transmission Network

Transmission Line Insulators (PUBLIC VERSION)

Document number	AMS 10-75
Issue number	9
Status	Approved
Approver	J. Dyer
Date of approval	14/08/2015

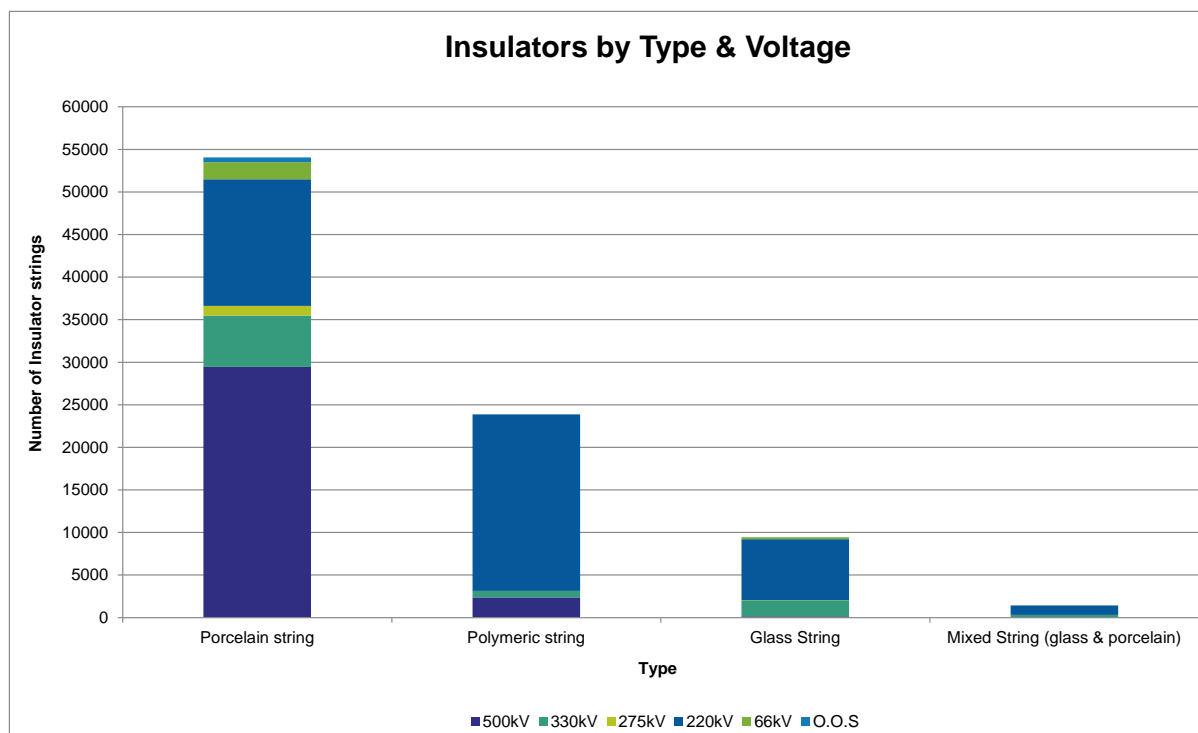
Figure 2, below is a graphical representation of the transmission line insulator fleet by type and voltage cohorts.

Figure 2 – Volumes of insulator strings by type and voltage

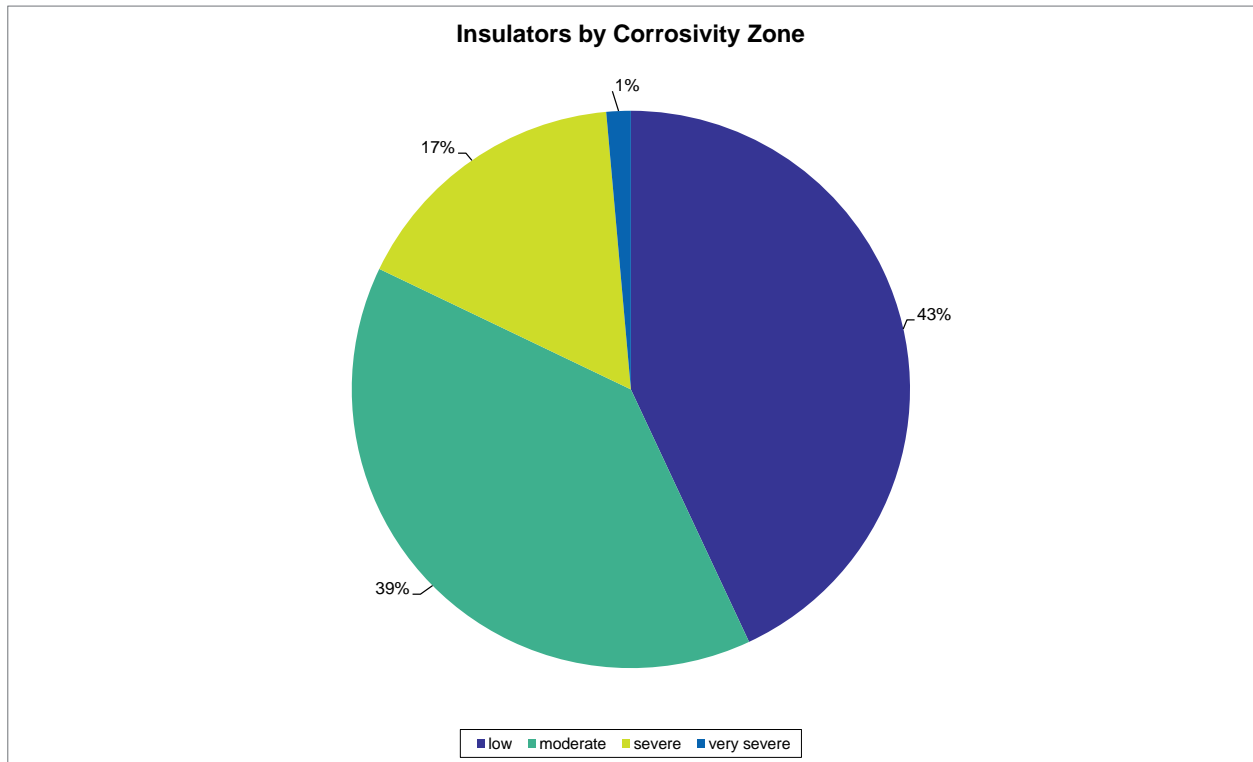
Figure 3 shows the proportion of transmission line insulators located in each of the four corrosivity zones. A map displaying a spatial view of transmission line assets within the four corrosivity zones is included in Appendix A. Almost half of the transmission line insulators are situated in the low corrosivity zone. The HYTS – APD 500 kV lines are situated in the very severe corrosivity zone. They supply power to an industrial plant situated at Portland on Victoria’s western coast. Heavy corrosion of porcelain insulators on these lines prompted their early replacement in 2010 after 29 years of service.

Figure 3 – Insulator strings by corrosivity zone

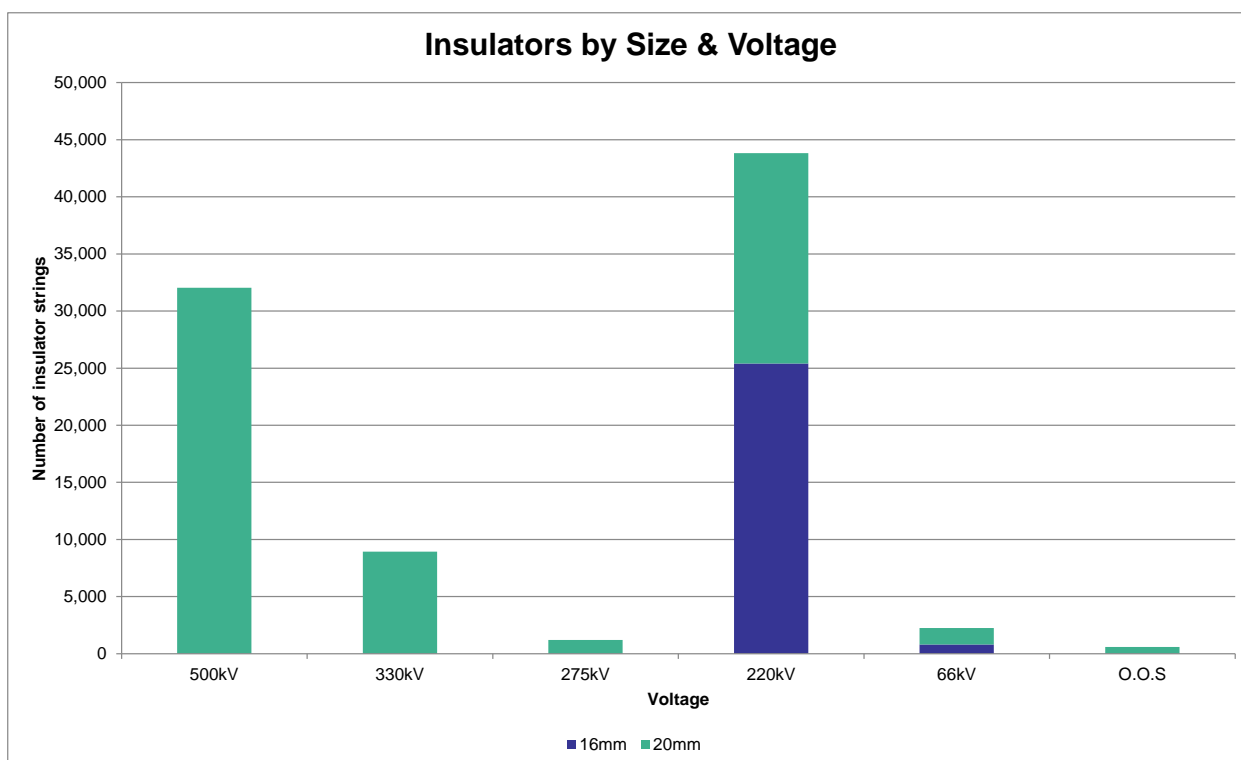
Figure 4 displays the volume of each insulator pin size against operating voltage. Seventy per cent of transmission line insulators have 20 mm pin sizes. Some 220 kV and 66 kV transmission lines have insulators with 16 mm pin sizes, equating to 30 per cent of the total insulator fleet respectively.

Figure 4 – Insulator strings by voltage and size of connection pin

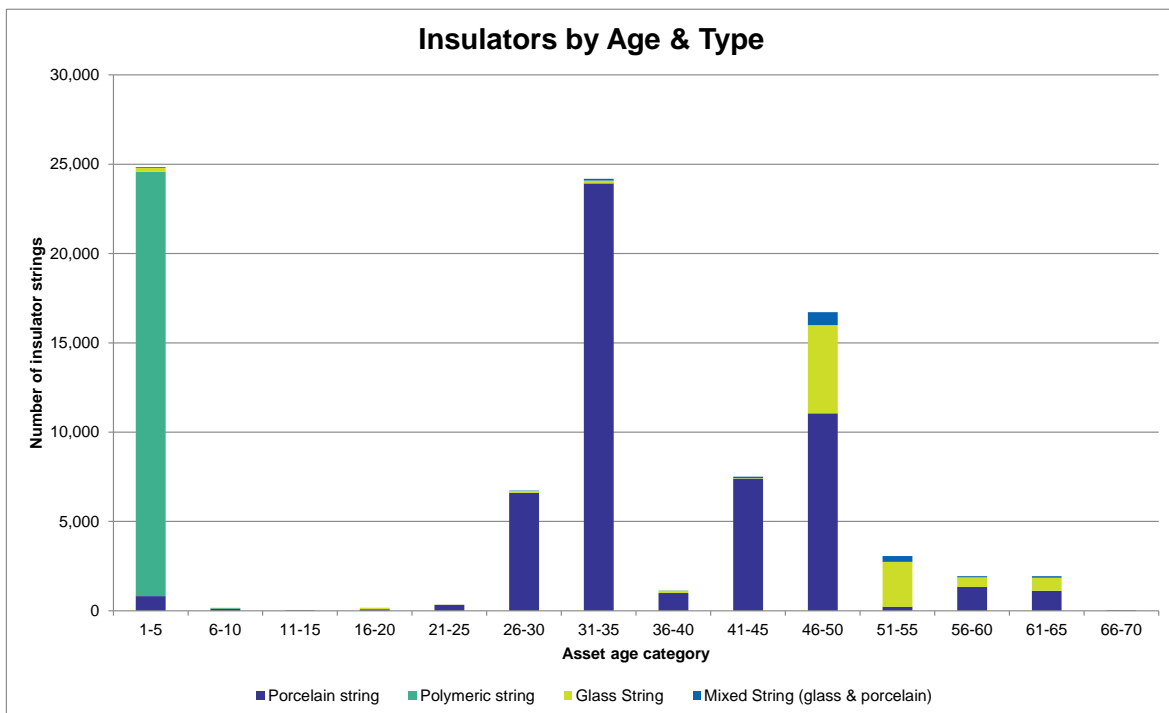
Figure 6 displays the age of the transmission line insulator population by type. The oldest transmission line insulators in the fleet are either the porcelain type or glass type or a mixture of both. Since the year 2000 the preferred type of transmission line insulator has been the polymeric type. The majority of insulator strings with an age of 15 years or less are polymeric types.

Figure 6 –Insulator Service Age by type (as at November 2014)

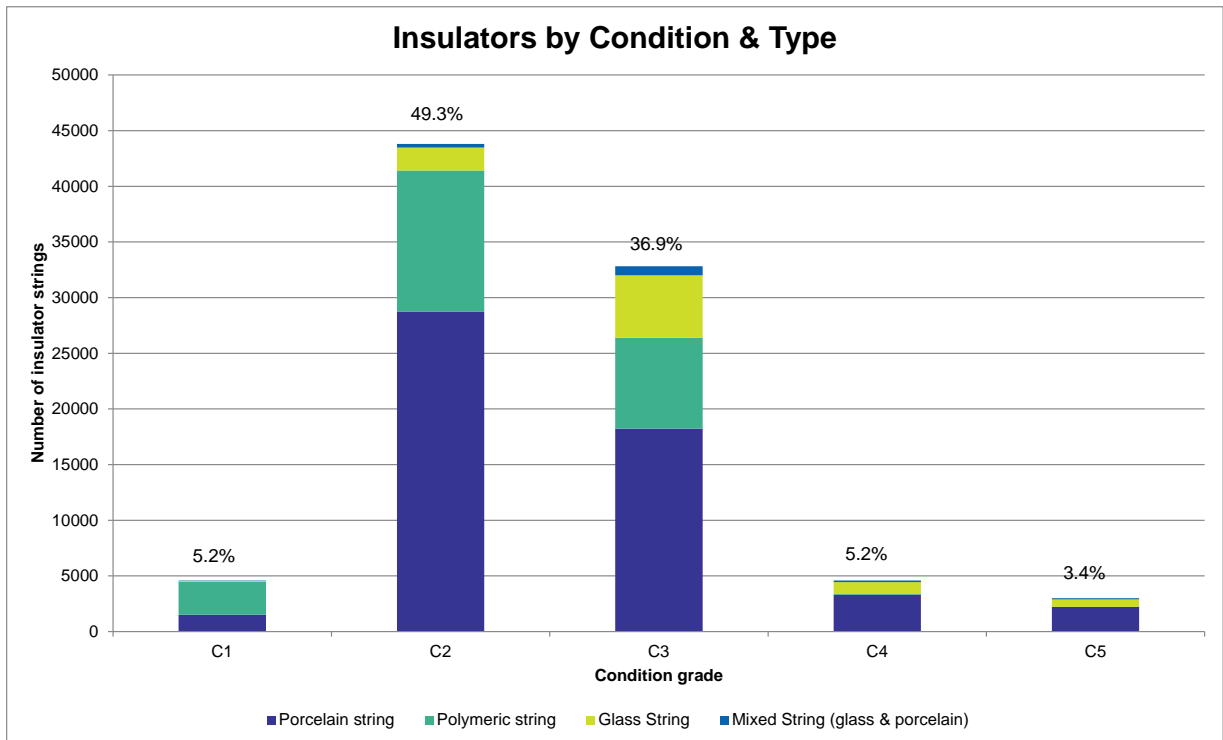
Figure 8 shows the condition of transmission line insulators by type. Fifty-four per cent of all insulator strings in service on the transmission network exhibit minimal fitting wear or light levels of rust in line with condition grades C1 or C2. A total of 3,009 insulator strings or 3.4 per cent of the total transmission insulator fleet currently exhibit levels of fitting wear or pin corrosion in line with condition grade C5.

Figure 8 –Insulator condition by type

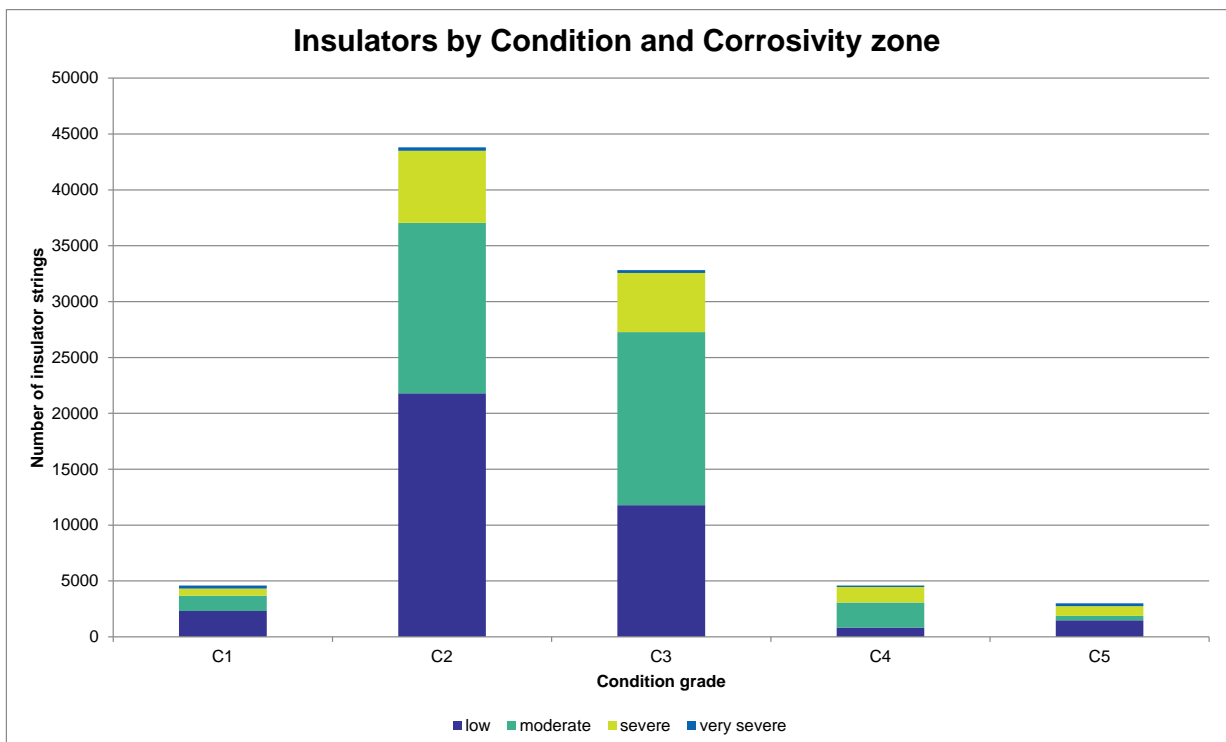
Figure 9 displays transmission line insulator condition by corrosivity zone. Only one per cent of transmission line insulators which are currently assessed as condition grade C5 are situated in the severe or very severe corrosivity zones.

Figure 9 –Insulator condition by corrosivity zone

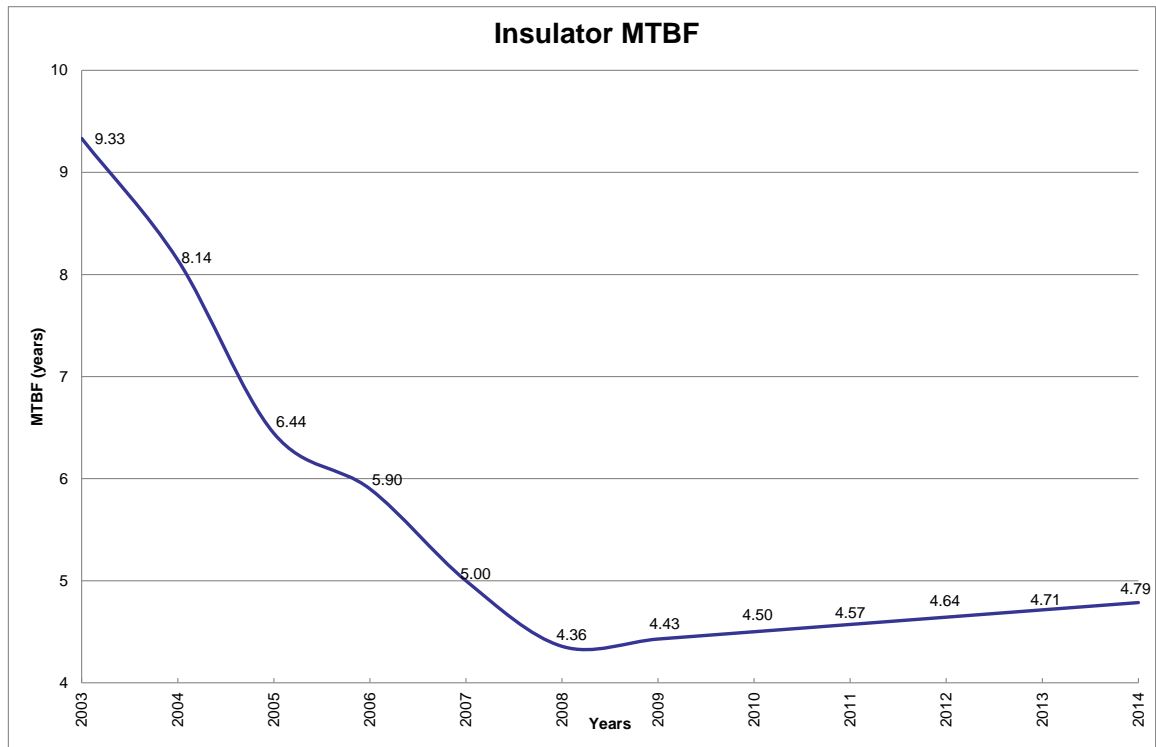
Reliability of the insulator fleet has improved since 2009 as a result of the replacement program commenced following the high concentration of failures experienced between 2003 and 2008. This planned insulator replacement program began in 2006 targeted insulators deemed to have high probabilities of failure based on condition, type and pin size. There have been no insulator functional failures since 2009. The Mean Time Before Failure (MTBF) of the fleet was approximately 4.79 years in 2014 improving slightly from 4.43 in 2009. This reflects a general increase in MTBF from its historically lowest point of 4.36 years in 2008. Figure 13 displays the change in insulator MTBF since 2003.

Figure 13 – Transmission line insulator MTBF

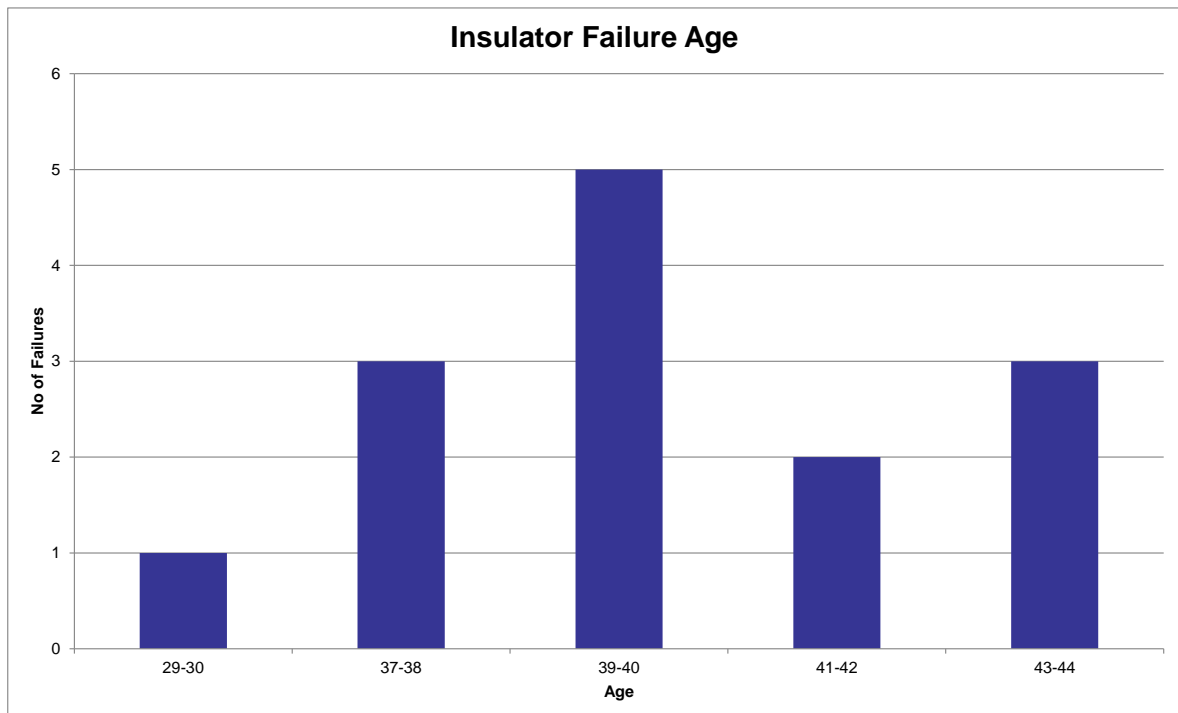
Fifty per cent of transmission line insulators which have failed have been from the porcelain cohort and 50% have been from the glass cohort. All 14 insulator functional failures occurred on insulators aged between 29 and 44 years with 36% of these failures occurring between the service age of 39 and 40 years. The mean service age at the time of failure for transmission line insulators is 39 years. Figure 14 shows the distribution of insulator ages at time of failure.

Figure 14 – Transmission line insulator age at time of failure
