AMS – Victorian Electricity Transmission Network

Transmission Line Structures

Document number	AMS 10-77
Issue number	2
Status	Approved
Approver	J. Dyer
Date of approval	28/08/2015

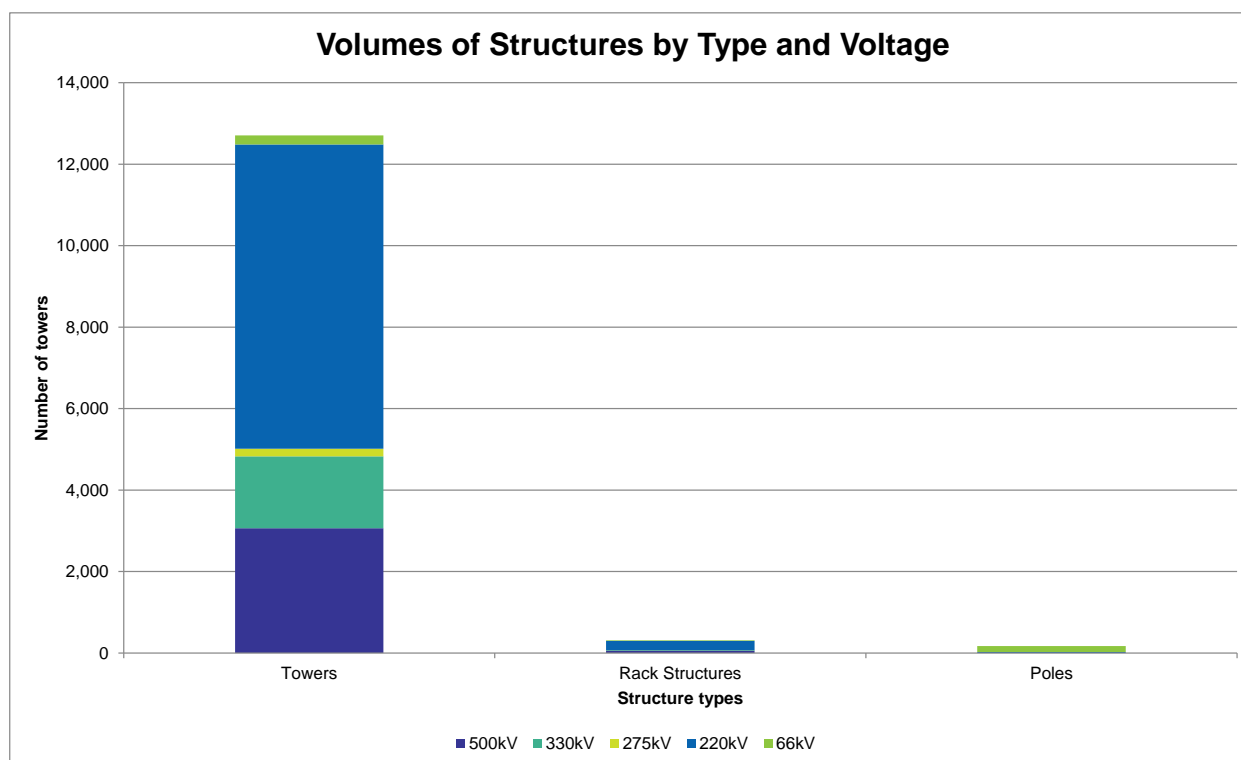
There are approximately 13,000 transmission line structures in service on the transmission network. Structures comprise all elements above 300 mm above ground-level, which support the conductors and ground wires. Different types of structures in service include steel lattice structures, poles, rack structures and ground wire masts. Figure 1 displays the number of different types of structures by operating voltage.

Figure 1 – Volumes of structures by type and voltage

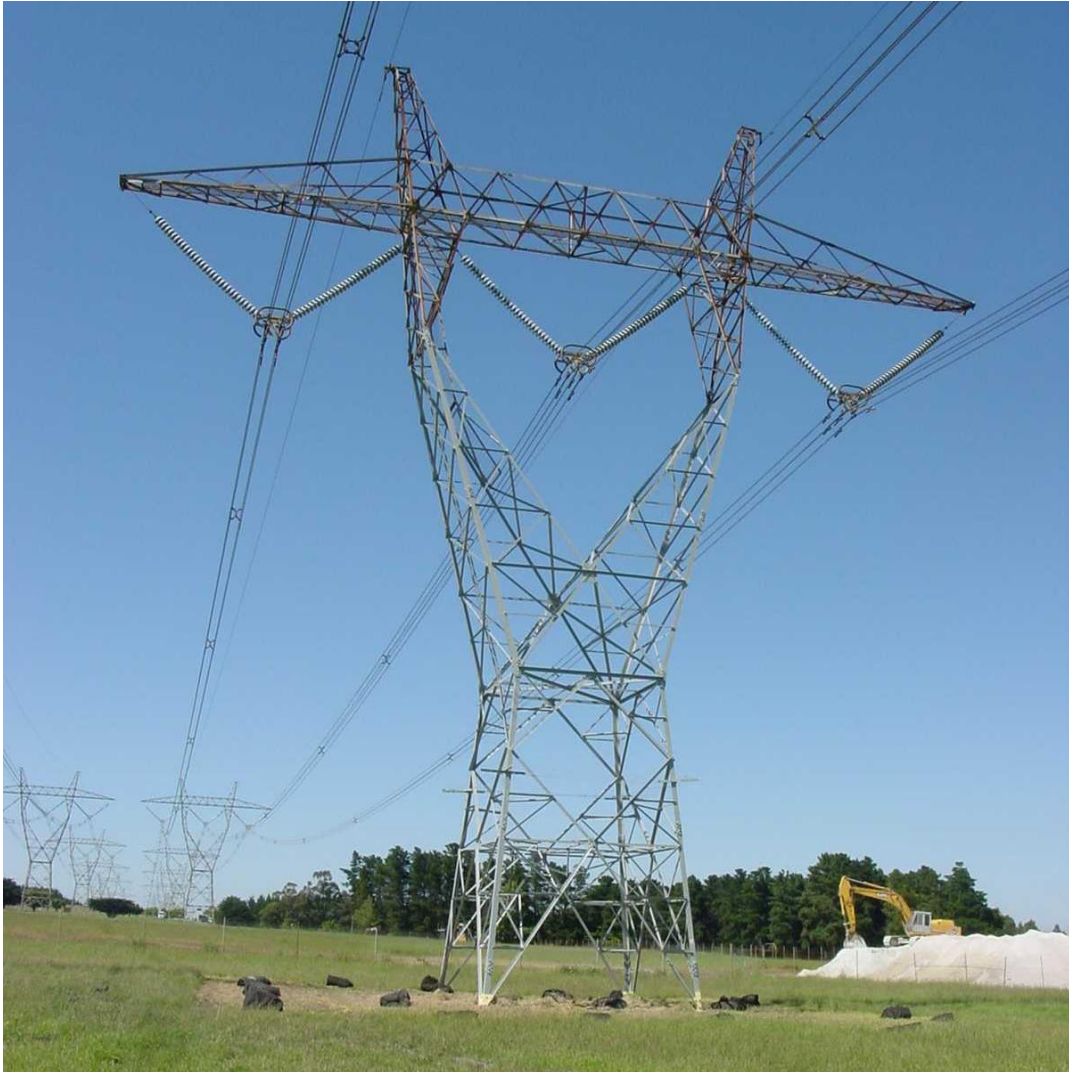
Steel lattice structures make up approximately 96 per cent of structure types on the transmission network. Lattice structures consist of angled galvanised steel members connected with bolts. These structures generally support either single-circuit or double-circuit lines including three different phase conductors⁴ per circuit. The phase conductors are protected from lightning strike by single or multiple ground wires⁵ situated on the peaks of the structures. Some structures support subsidiary distribution lines operating at 66 kV situated below the transmission circuit phase conductors. The structures are electrically insulated from the live conductors using insulators⁶. Figure 2 displays an image of a typical steel lattice structure (500 kV Delta Suspension).

Figure 2 – Transmission Line Structure

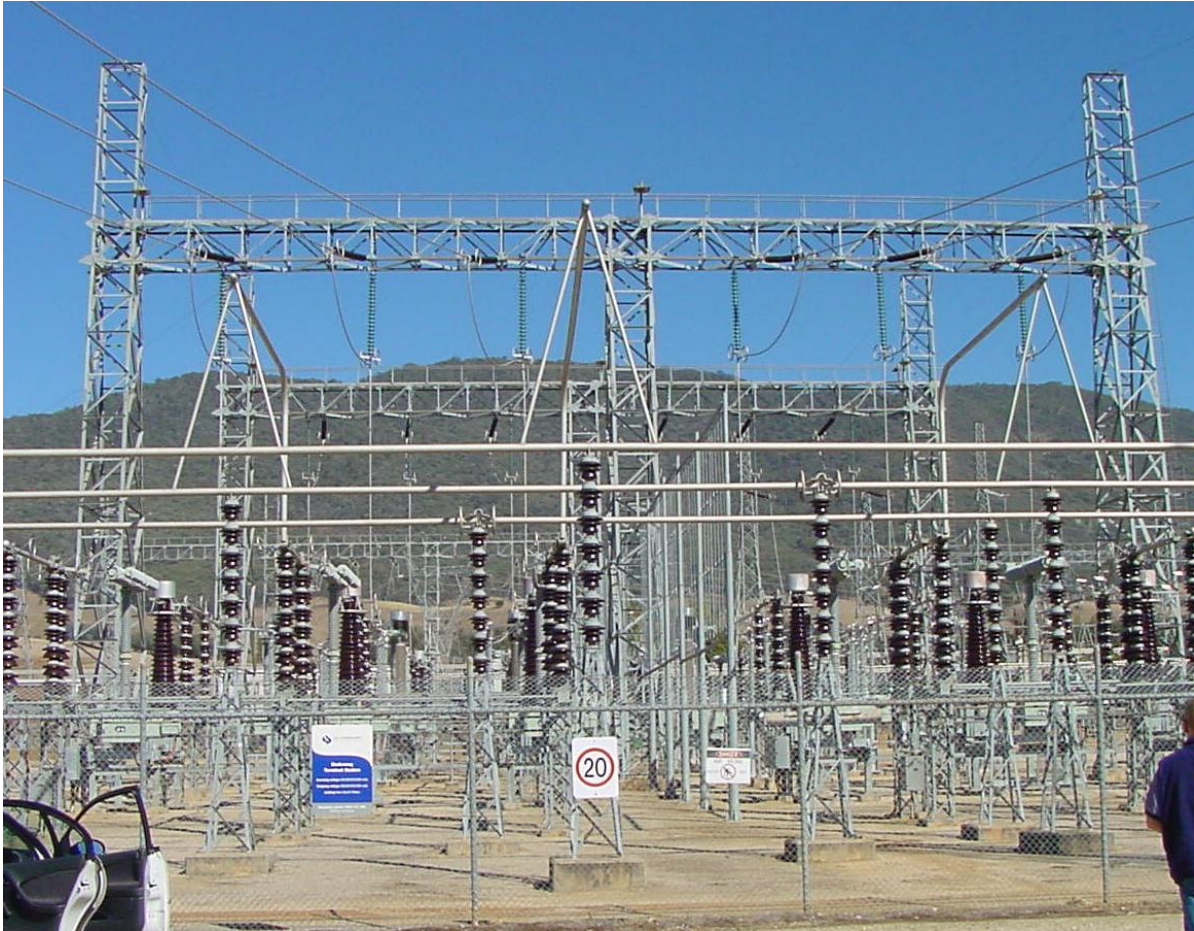
The primary function of rack structures is to facilitate the transition of phase conductors from line easement structures to electrical plant situated in terminal stations. Rack structures consist of steel lattice members connected by fasteners or tubular hollow sections bolted or welded together. The vast majority of rack structures are situated within terminal stations; however, there are a number of rack structures known as portal structures which are situated on line easements. Portal structures are designed to accommodate acute changes in line easement alignment such as 90 degree tee offs. Rack and portal structures make up two percent of the total structure population. Figure 3 displays a transmission line rack structure at Dederang Terminal Station (DDTS).

Figure 3 – Transmission Line Rack Structure

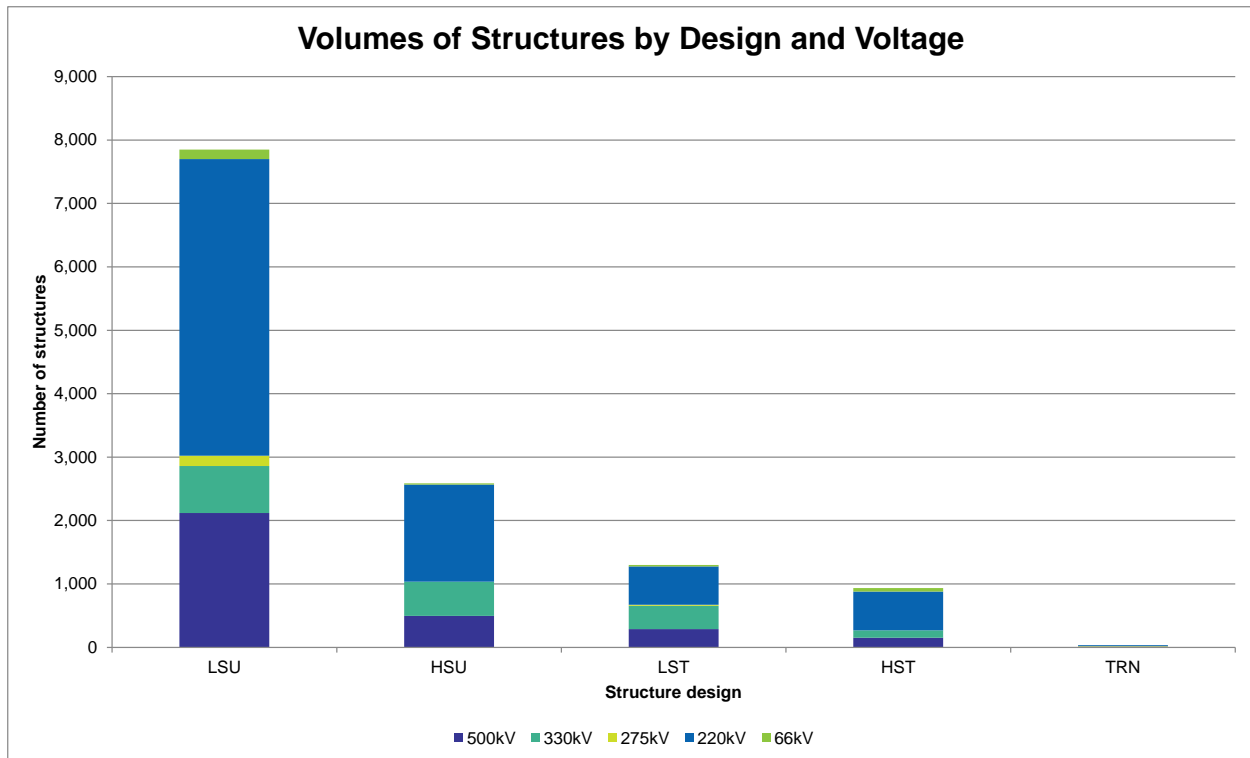
Transmission structures are further categorised based on design characteristics. The design characteristics determine what mechanical load the structure can support. There are five design categories including heavy strain (HST), light strain (LST), heavy suspension (HSU), light suspension (LSU) and transposition (TRN). Figure 4 displays the proportion of the structure fleet within each design category by operating voltage.

Figure 4 – Volumes of structures by design category and voltage

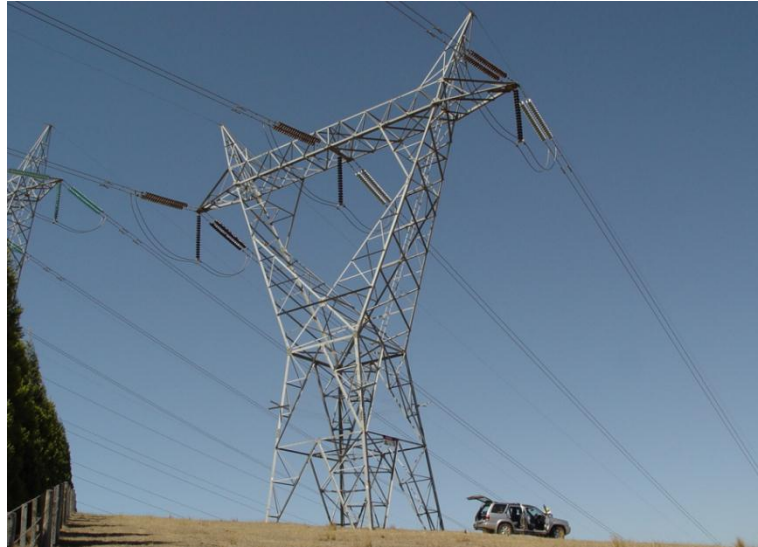
Figure 5 – DDTS-SMTS No. 1 330 kV strain tower

The 330 kV strain tower, 220 kV suspension tower and 500 kV transposition tower are shown in the following figures.

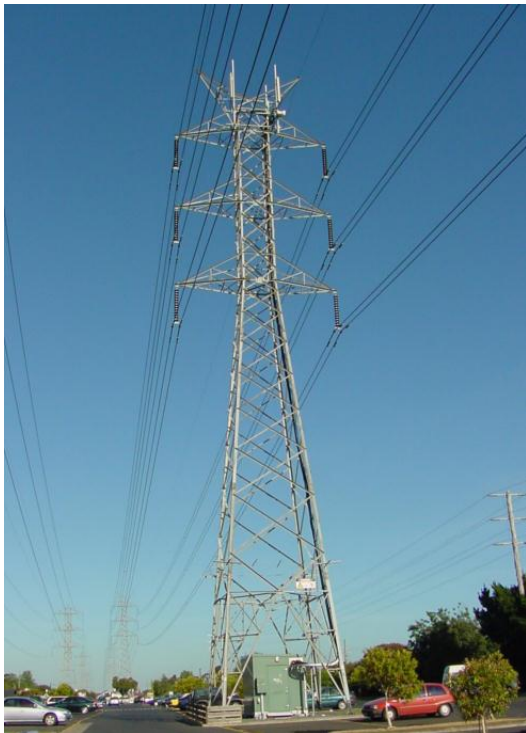
Figure 6 – ROTS-SVTS 220 kV suspension tower

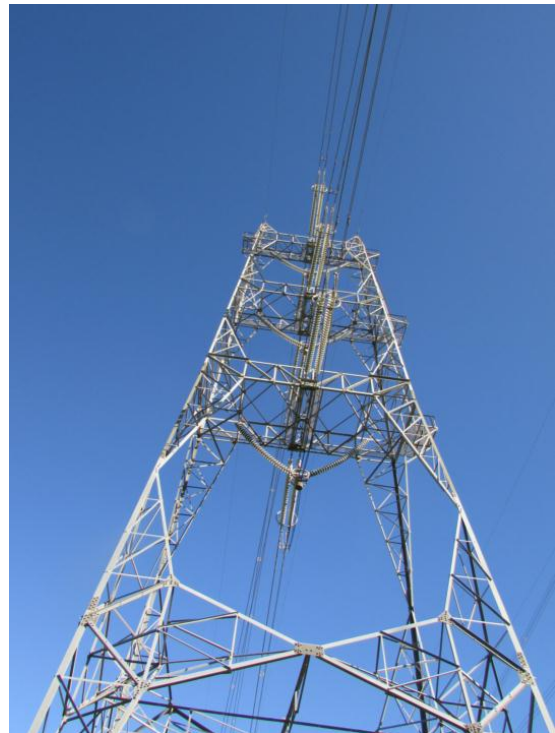
Figure 7 – HWTS-CBTS No. 4 500 kV transposition tower

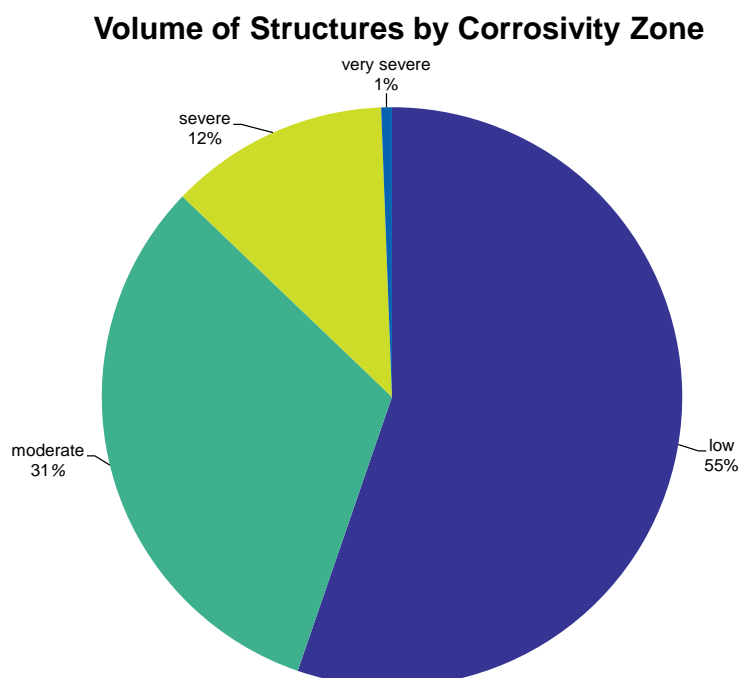
Figure 8 shows the percentage volume of transmission structures located in each of the four corrosivity zones. A map displaying a spatial view of transmission line assets within the four corrosivity zones is included in Appendix A. Fifty-five percent of structures are situated in the low corrosivity zone. The HYTS – APD 500 kV lines are situated in the very severe corrosivity zone as they supply power to an industrial plant situated at Portland on Victoria's western coast.

Figure 8 – Volume of structures by corrosivity zone

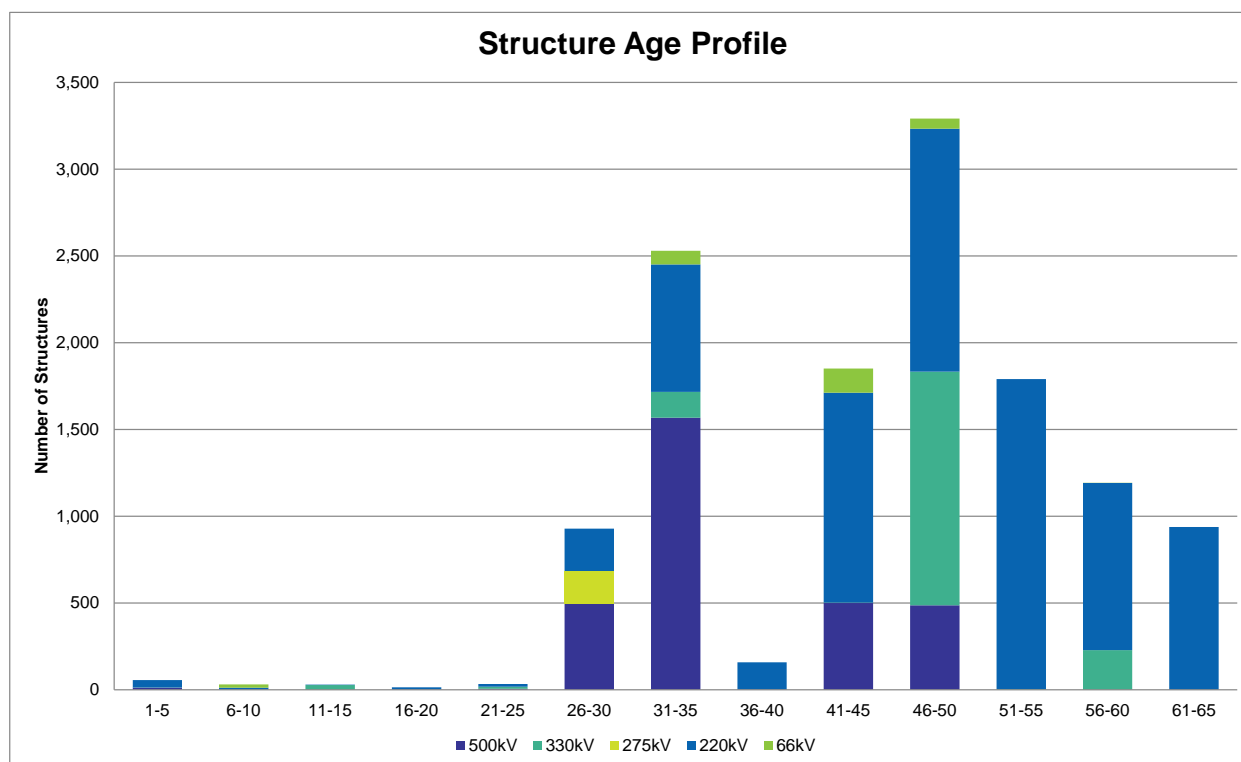
Figure 9 displays the service age profile of transmission line structures by voltage class. The structure service age profile roughly reflects that of a normal distribution with a mean age of approximately 45 years. The expected service life of AusNet Services' towers is 70 years.

Figure 9 – Structure Service Age Profile

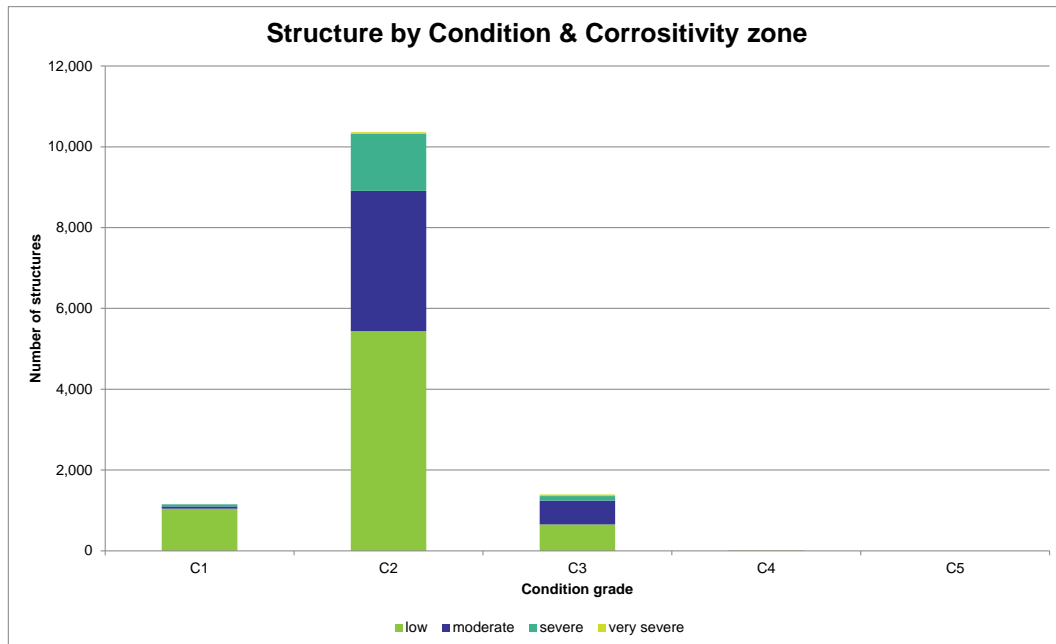
Figure 10 shows the overall condition grades of transmission line structures. Eighty-nine per cent of structures are exhibiting condition grades of C1 or C2 indicating that they are in very good or good condition. The remaining 11 per cent of structures have been assessed at C3. Less than one percent of the transmission line structures have been assessed at C4 and none are assessed as C5.

Figure 10 – Structure Condition Profile

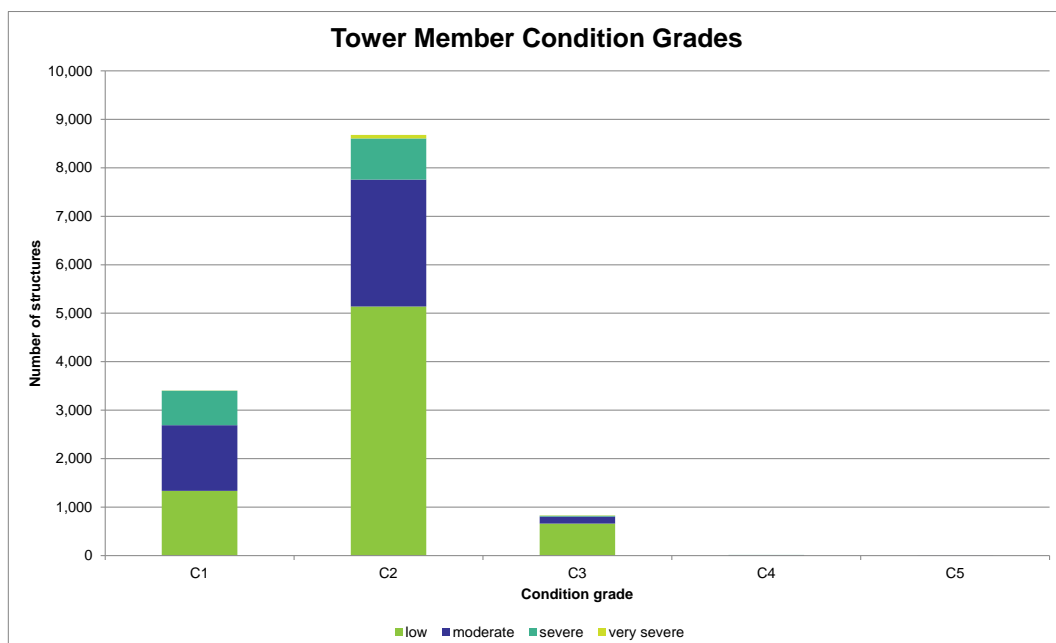
Figure 11 shows the condition of structure members. Ninety-four per cent of structures contain members which are exhibiting condition grades of C1 or C2 indicating that members are in very good or good condition. The remaining six per cent of structures have been assessed at C3. Condition grades C3, C4 and C5 have been assigned to members on 828, 9 and 1 structures respectively.

Figure 11 – Structure Member Condition Profile

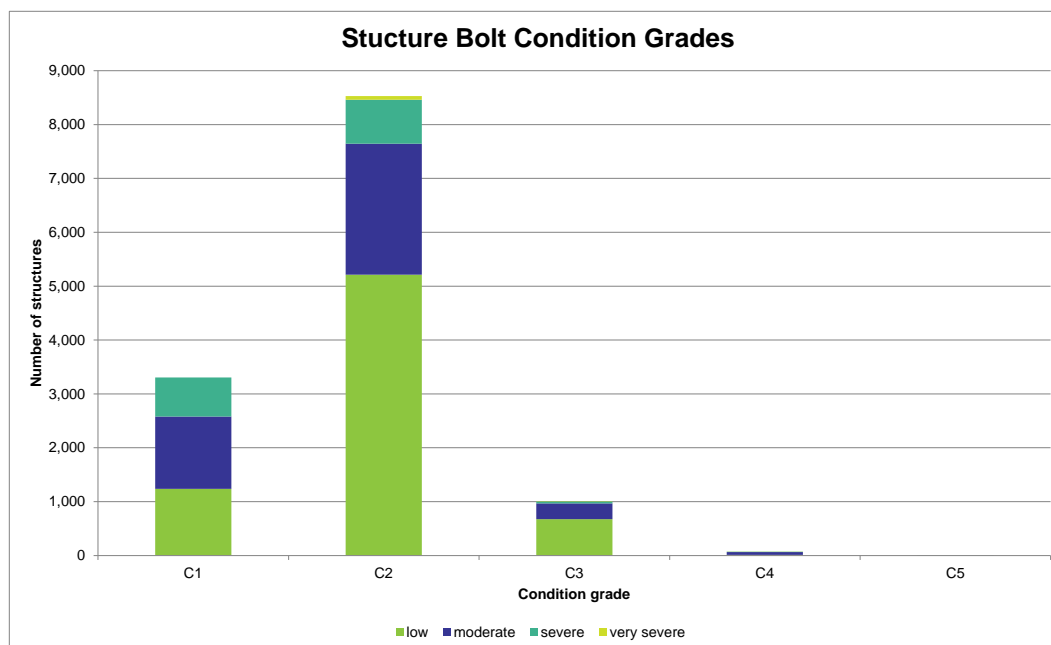
Figure 12 shows the condition of structure bolts. Ninety-two per cent of structures contain bolts which are exhibiting condition grades C1 or C2 indicating that bolts are generally in very good or good condition. Condition grades of C3, C4 and C5 have been assigned to bolts on 1010, 72 and 2 structures respectively.

Figure 12 – Structure Bolt Condition Grades

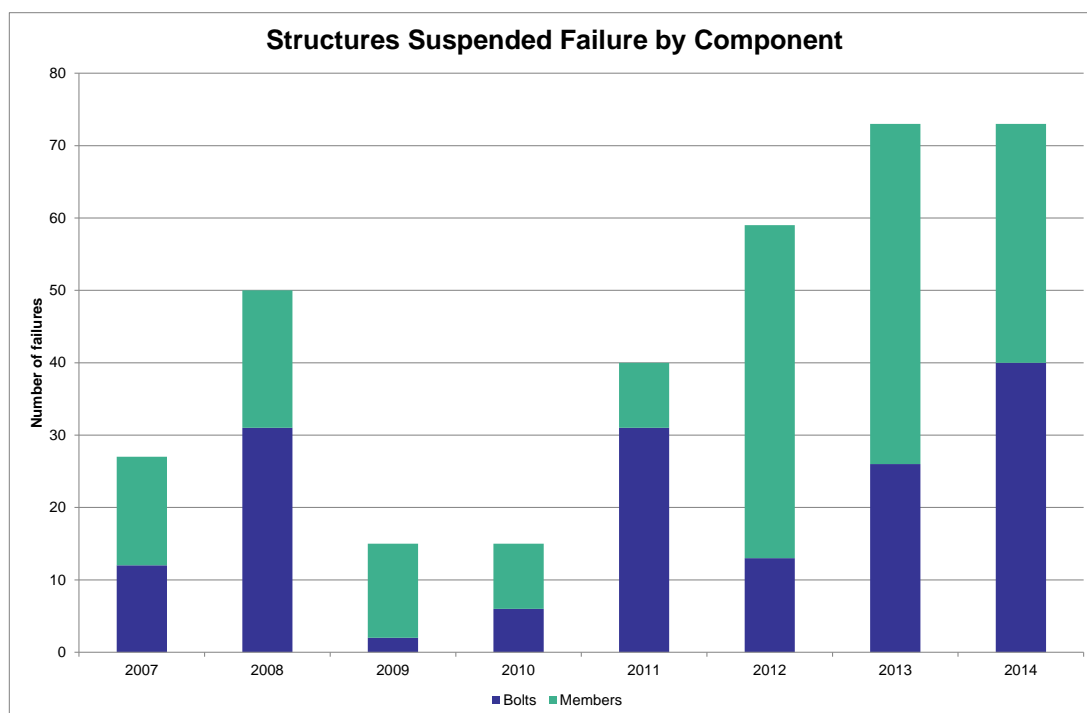
Over the last eight years there have been a total of 352 suspended failures of structure components as shown in Figure 13 below. Typical suspended failures include bent or missing members and corroded, exploded or missing bolts. There has been a noticeable increase in the number of work orders raised post 2010 when compared to the previous years mainly due to the increasing rigor of later condition assessments conducted.

Figure 13 – Structure suspended failures by component

The majority of suspended failures were caused by corroded bolts representing 49% of the total number of suspended failures in 2014. Bolts corrode first amongst the structure elements due to the damage on the zinc layer during tightening works at construction. Most of the corroded bolts replaced in 2014 were situated on structures on the YPS – ROTS 220 kV lines which were the subject of structure climbing inspections during this period.

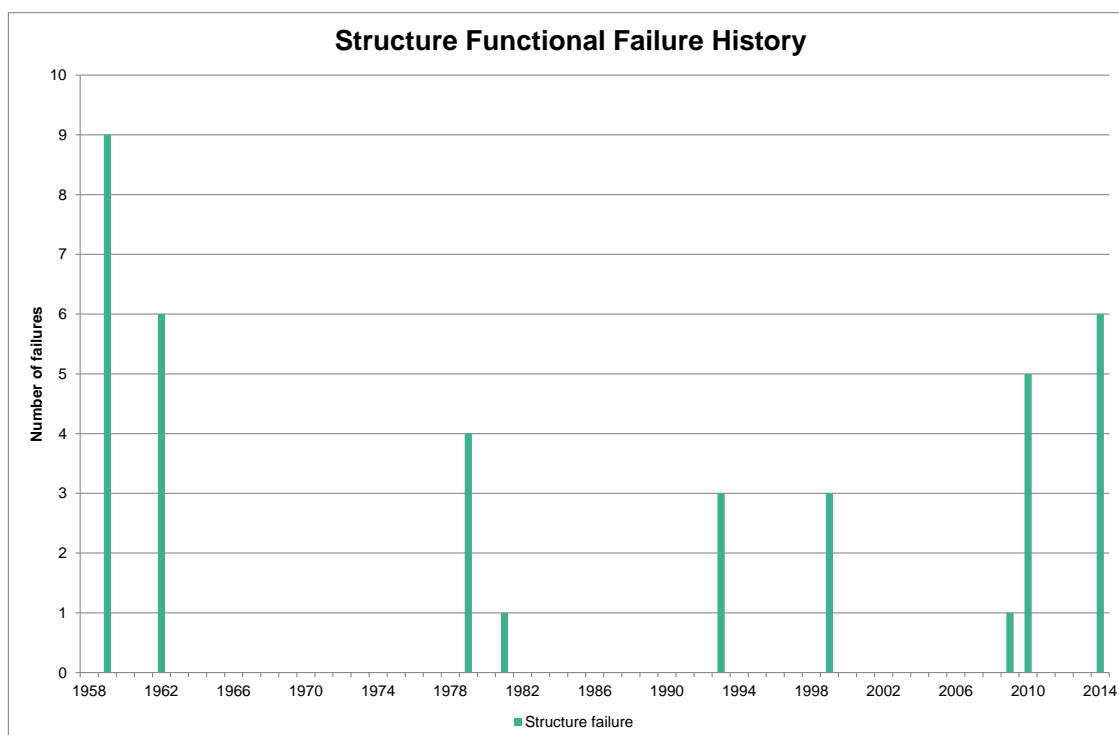
There have been 38 functional failures⁹ of structures since 1959. A functional failure of structure is an incident or event which prevents the safe flow of electricity from one terminal station to another. The safe flow of electricity is partly achieved by ensuring adequate clearance is maintained between live apparatus and the ground or objects on the ground. This definition qualifies any failure which prevents the structure from providing the mechanical support required to meet ground clearance regulations. A typical functional failure mode is structure collapse due to extreme weather conditions. Figure 14 illustrates the history of structure functional failures on the Victorian transmission network.

Figure 14 – Structure functional failure history

Ten separate events have led to the collapse or failure of 38 structures in 56 years as shown in Table 3 below. In most cases the collapse of one structure caused several other structures to fail with the worst multiple-failure event taking place in 1959 on the Geelong – Colac 220 kV line when a total of eight structures failed. The Bendigo to Kerang 220 kV line has experienced four tower collapse incidents due to the tower design structural inadequacy for high intensity winds since it was constructed in 1961. A total of 18 towers have failed from four separate events in 1979, 1993, 2010 and 2014.

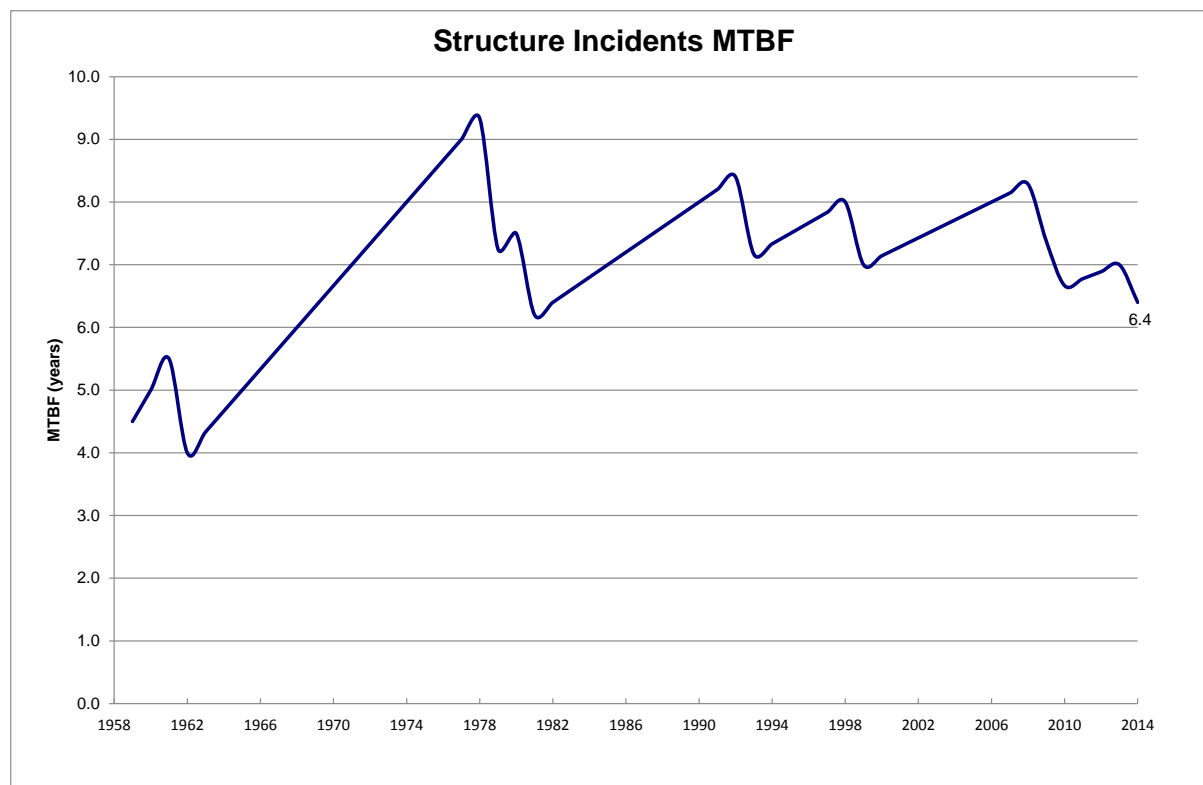
The mean time between failures (MTBF) of transmission line structures has declined since 1992 due to failures of low strength towers in extreme winds. The initial improvement since 1959 was due to an increasing population size of higher strength structures, in acknowledgement of the inadequacies in early design standards. MTBF was most recently recorded at 6.4 years following the conclusion of the 2014 calendar year, as shown in Figure 15.

Figure 15 – Transmission Line Structures MTBF

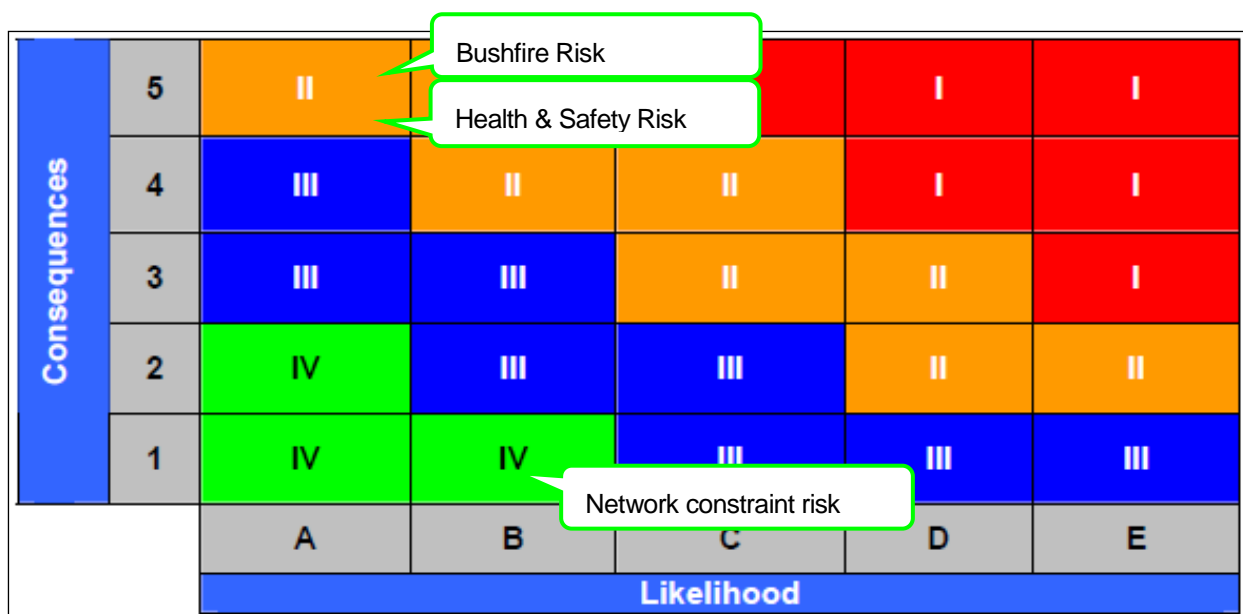
Functional failures of transmission line structures can result in structures and live conductors falling to the ground with significant effects or consequences. Major structure failures can lead to three different effects including health and safety, bushfire ignition and network constraint. These consequences can be quantified using the 1 – 5 scoring system shown on the vertical axis of AusNet Services' risk matrix which is displayed in Figure 17.

Figure 17 – AusNet Services' Risk Matrix¹³

Analysis of the MTBF for transmission line structure guides the likelihood scoring in an objective fashion. A MTBF of 6.4 years indicates that there have been functional failures once every 6.4 years on average which corresponds to an annual probability of approximately fifteen per cent. This probability aligns with a likelihood score of B on the AusNet Services risk matrix. This likelihood is applied to the network constraint risk caused by a transmission line structure functional failure. Not every major failure of a structure presents health and safety risk or bushfire ignition risk to the public; the event will have to occur under exceptional circumstances as discussed in section 3.4.3.1 and 3.4.3.2 below. The probability is very low and aligns with a likelihood score of A on the AusNet Services risk matrix.

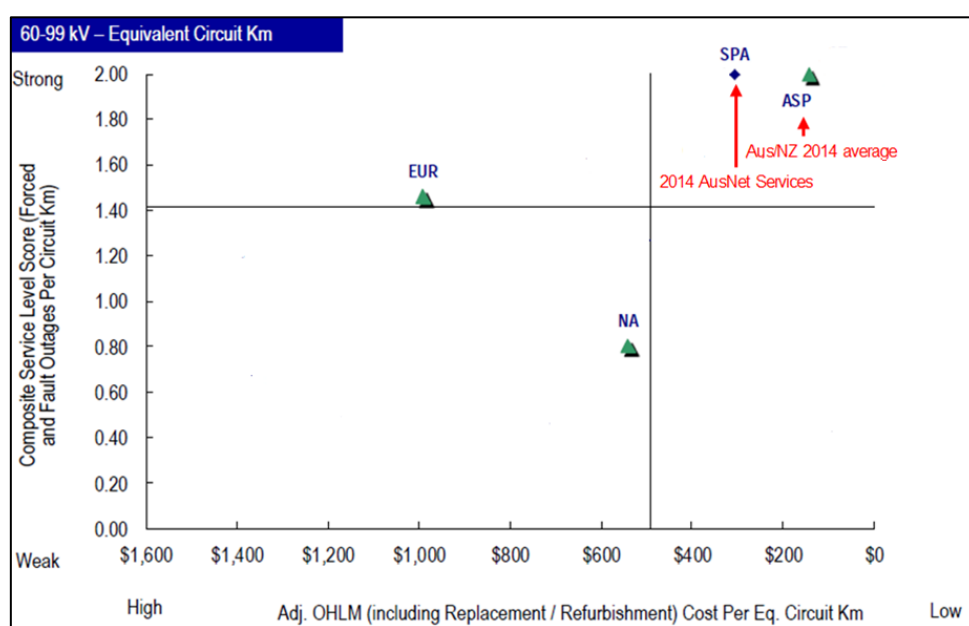
The survey indicates that the maintenance strategies and costs are appropriate for our network. Figure 18 and Figure 19 displays results in the 60-99 kV and 200 kV+ categories respectively.

Figure 18 – ITOMS benchmarking 66 kV transmission lines

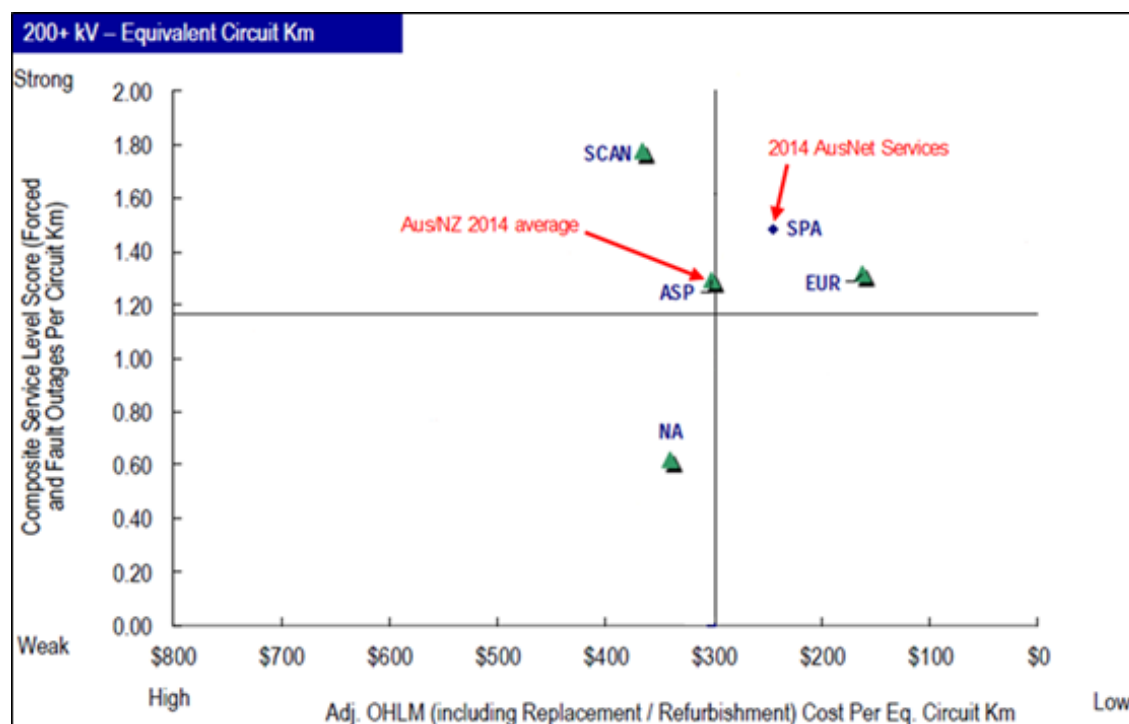
Figure 19 – ITOMS benchmarking 220 kV, 330 kV and 500 kV transmission lines
