AMS – Victorian Electricity Transmission Network

Transmission Line Structure Foundations

Document number	AMS 10-78
Issue number	2
Status	Approved
Approver	J. Dyer
Date of approval	23/06/2015

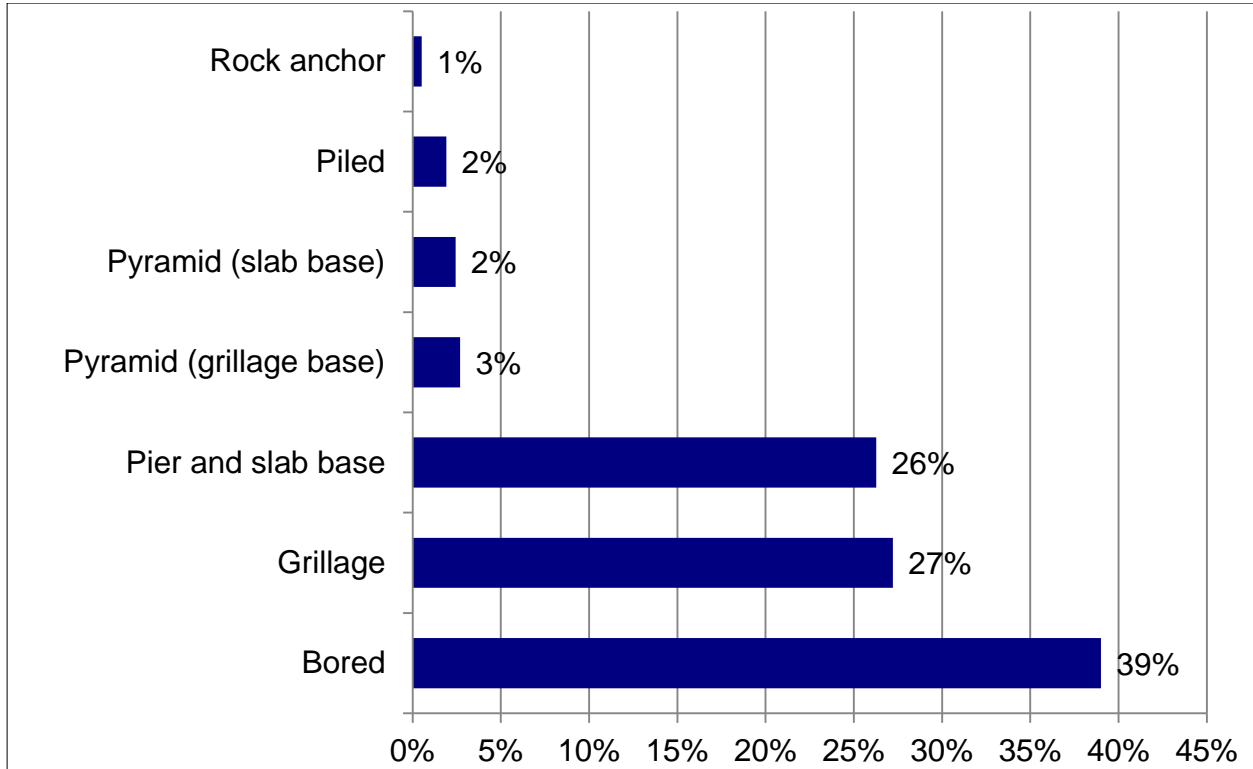
Figure 1 – Structure foundations by type

Bored or augured foundations are the most common types in use on the Victorian network comprising 39% of installations. This type of foundation is the most common due to its relative ease of construction, low cost and high reliability. Grillage and pier and slab base foundations make up the majority of the remaining foundation type, contributing to 27% and 26% respectively. Figure 1 displays the different types of structure foundations.

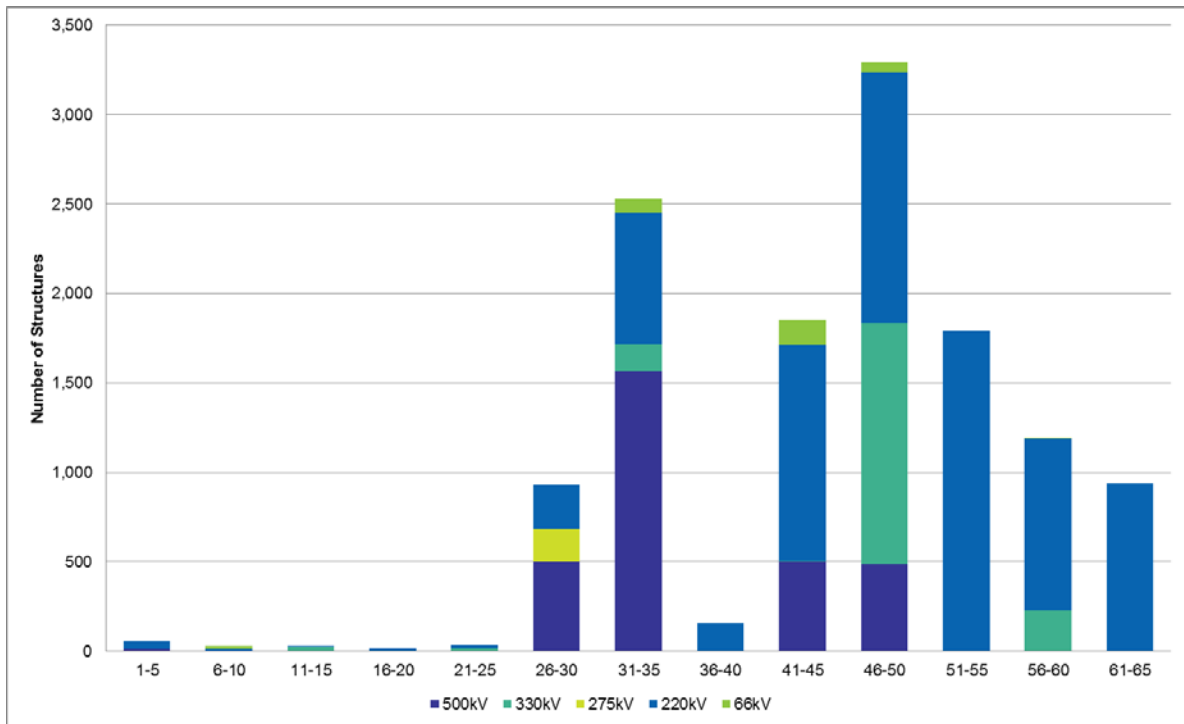
Figure 2 – Structure foundation age profile

The structure foundations age profile roughly reflects that of a normal distribution with a mean age of approximately 45 and a standard deviation of approximately 6 years. This is significant from an asset replacement perspective as subject to different environmental conditions it is possible that large proportions of the fleet may require replacement within relatively short time frames.

Figure 2 displays the age profile of transmission line foundations and their respective structures by voltage class.³

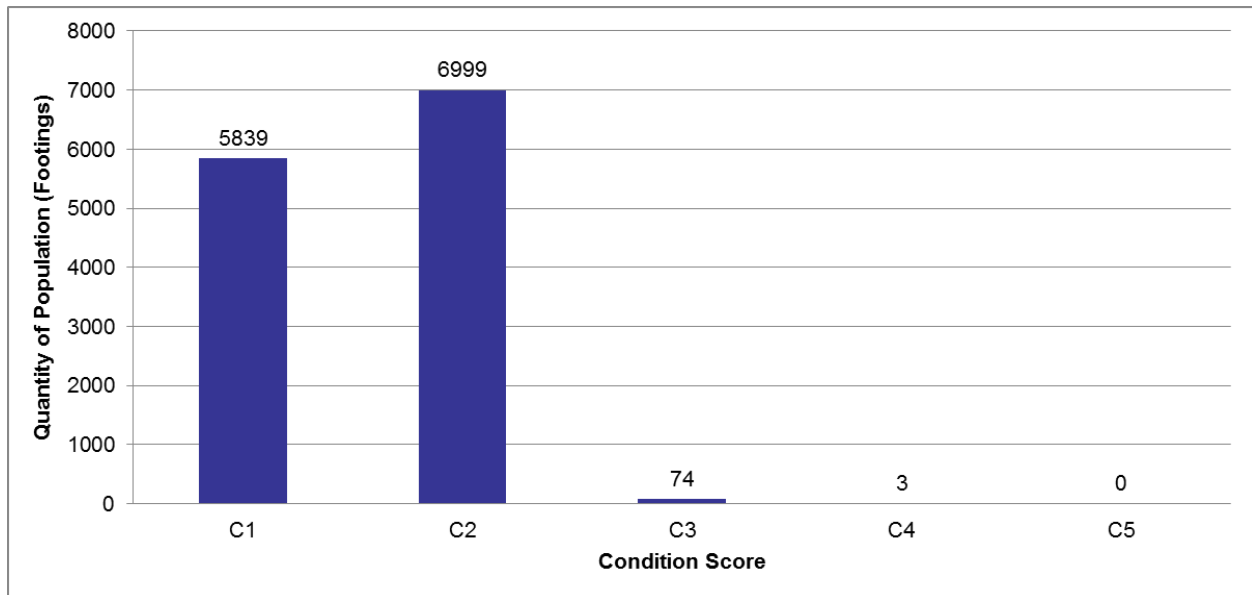
Figure 3 – Structure Footing Condition

Figure 3 above shows that over 99% of the footings are in a C1 or C2 condition with less than 1% of the fleet in a C3 or C4 condition. This is attributed to the SOXS program which has been effective in preventing any unexpected failures whilst improving the conditions of the footings.

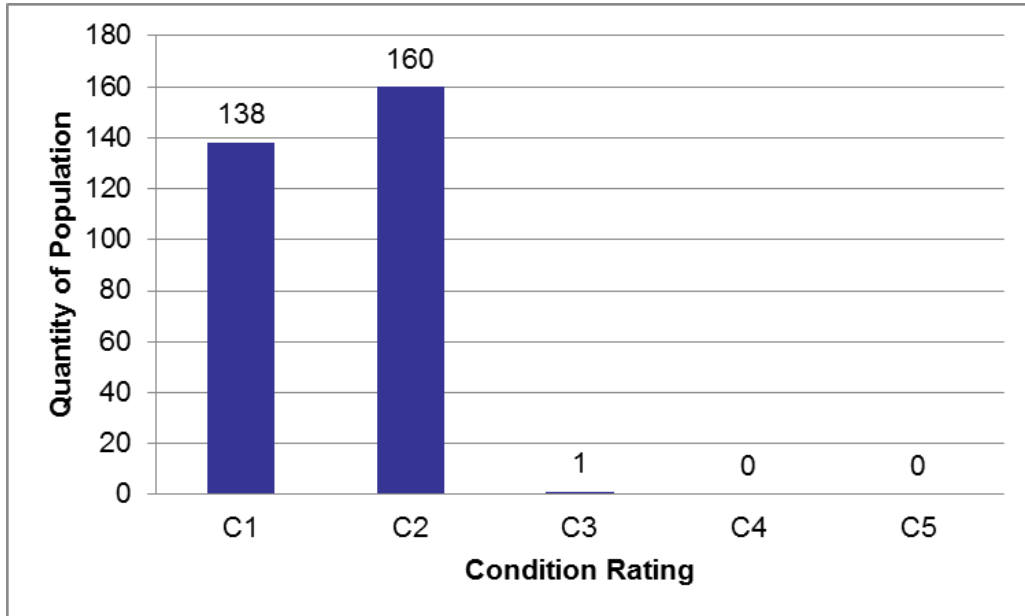
Figure 5 shows that the 66 kV transmission line structure footings are generally in good condition. The SOXS program, which has been effective in preventing any unexpected failures, has contributed to the good condition of 66 kV footings.

Figure 5 – Condition assessment of the 66 kV footings

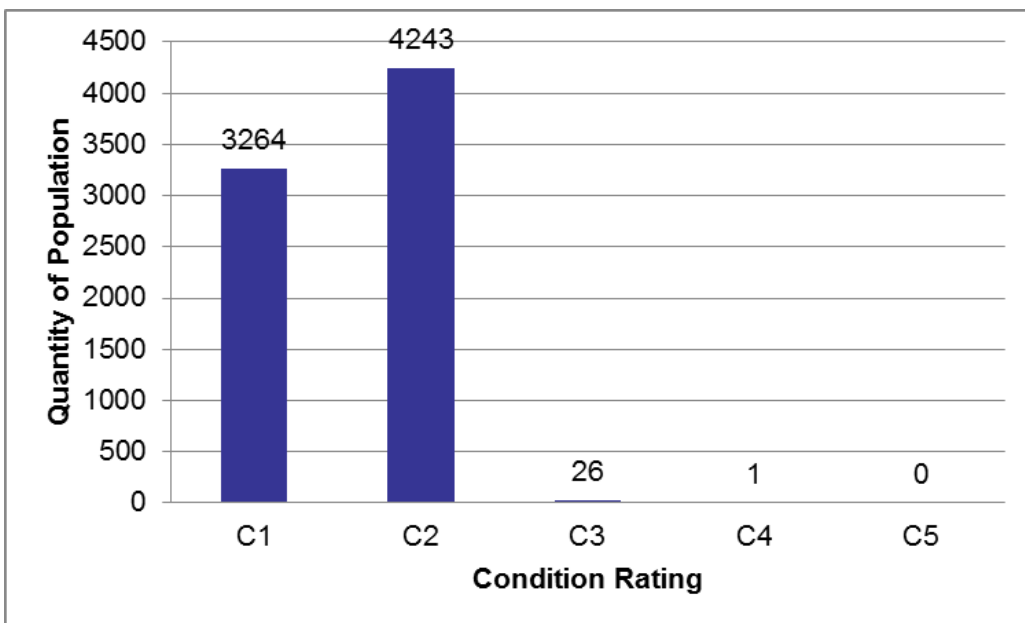
Figure 6 shows that in the 220 kV transmission line structure footings are generally in good condition. The SOXS program, which has been effective in preventing any unexpected failures, has contributed to the good condition of 220 kV footings.

Figure 6 – Condition assessment of the 220 kV footings

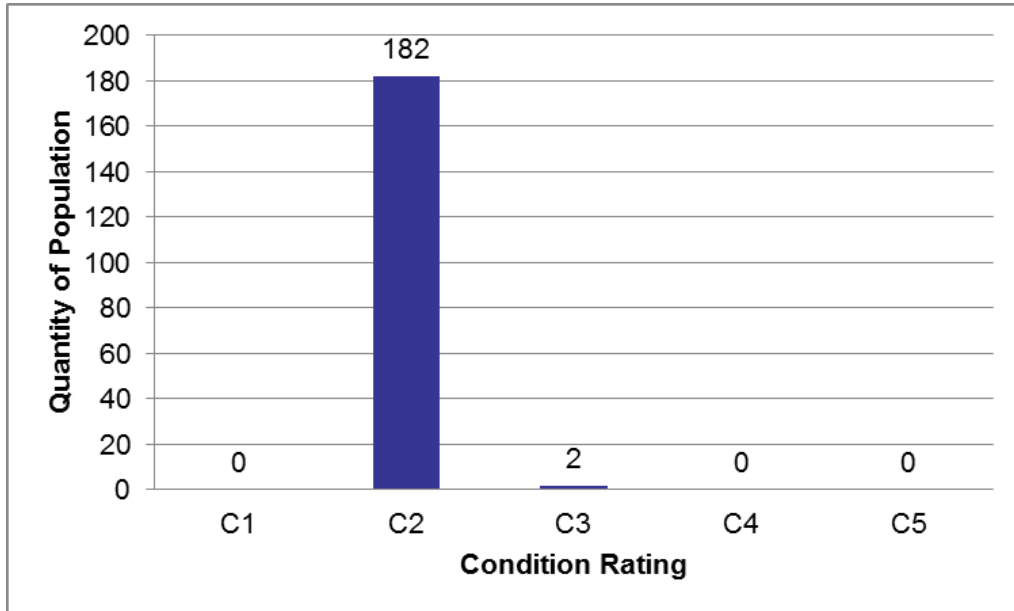
Figure 7 shows that the 275 kV transmission line structure footings are generally in good condition and showing first signs of rust. All 275 kV footings are located in the south west of Victoria in a benign environment. The good condition of these footings is expected in a non-aggressive environment like this.

Figure 7 – Condition assessment of the 275 kV footings

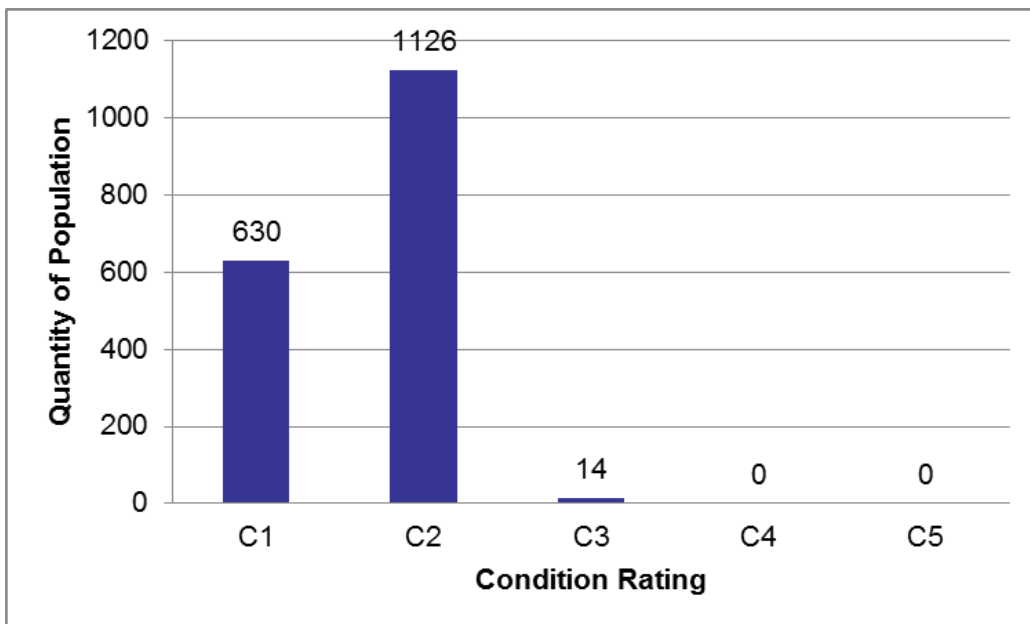
Figure 8 shows that the majority of the 330 kV transmission line structure footings are generally in good condition. The majority of the 330 kV footings are located in the northern area of Victoria in a benign environment. The good condition of these footings is expected in a non-aggressive environment like this.

Figure 8 – Condition assessment of the 330 kV footings

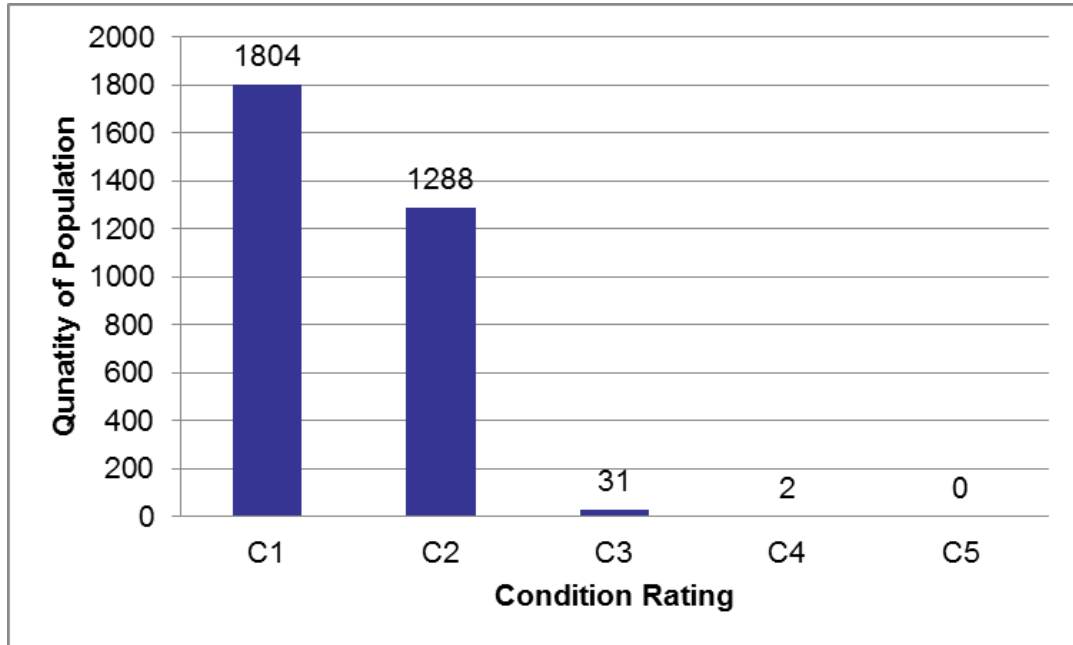
Figure 9 shows that majority of the 500 kV transmission line structure footings are generally in good condition. The SOXS program, which has been effective in preventing any unexpected failures, has contributed to the good condition of 500 kV footings.

Figure 9 – Condition assessment of the 500 kV footings

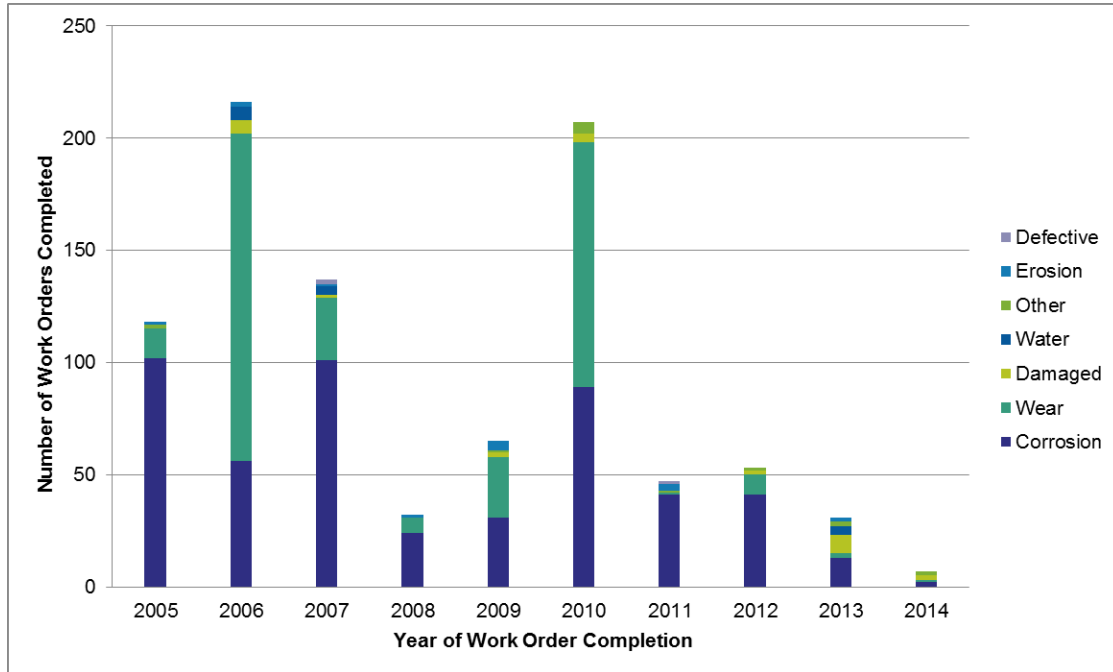
Figure 10 – History of suspended foundation failures

Figure 10 displays suspended failures by cause over the last ten years. Peaks in volumes of work orders reflect corrosion and wear based issues which formulated early project scopes at the beginning of the SOXS program. Failure rates for corroded tower legs and braces have reduced considerably over the last four years.

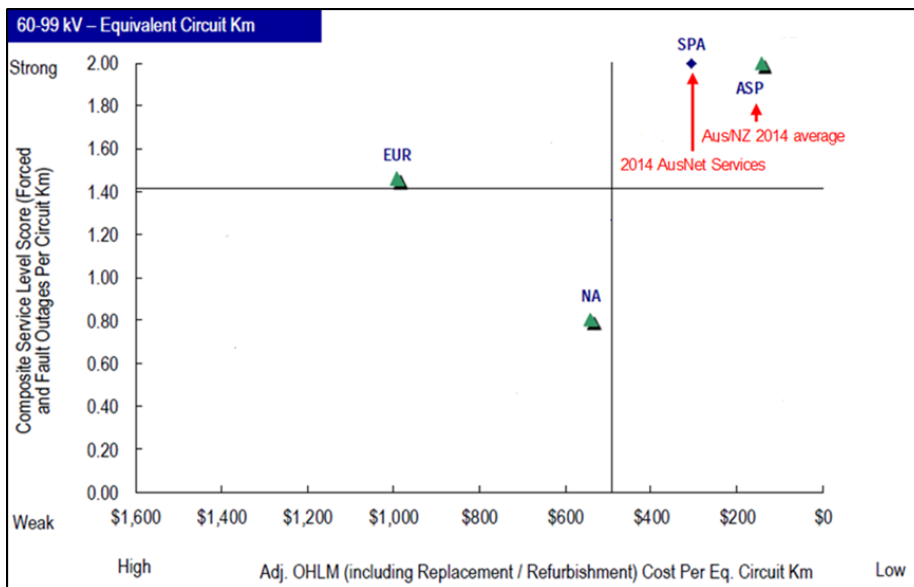
Figure 12 – ITOMS benchmarking 66 kV transmission lines.

Presented in Figure 12 and Figure 13, AusNet Services ranked above the average performance of other Australian and New Zealand transmission utilities in terms of service level (measured in fault/forced outages per circuit km) and cost level (measured in equivalent maintenance costs per circuit km) for 200 kV+ transmission voltage categories. However, the cost level for the 60-99 kV category is slightly higher than other Australian and New Zealand transmission utilities.

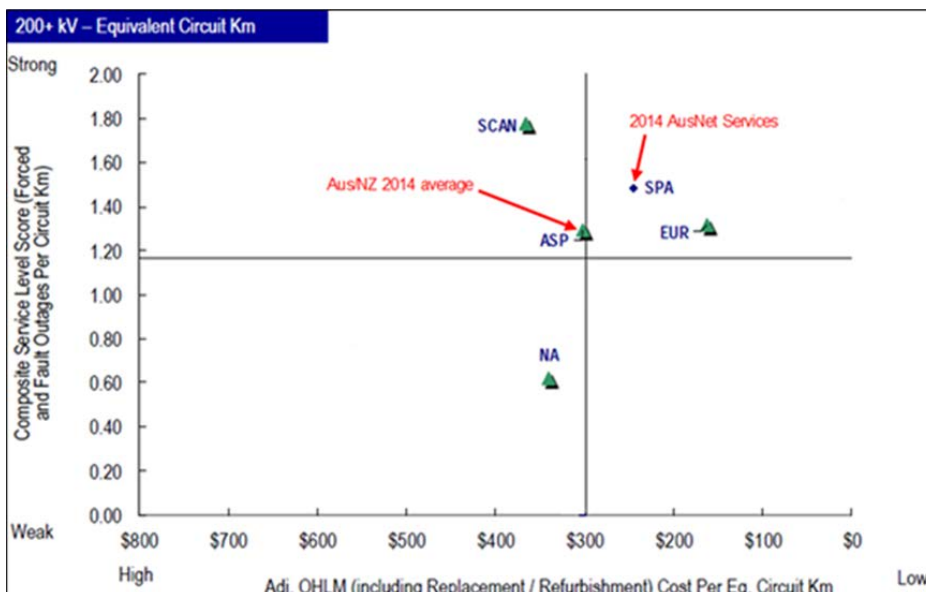
Figure 13 – ITOMS benchmarking 220 kV, 330 kV and 500 kV transmission lines.

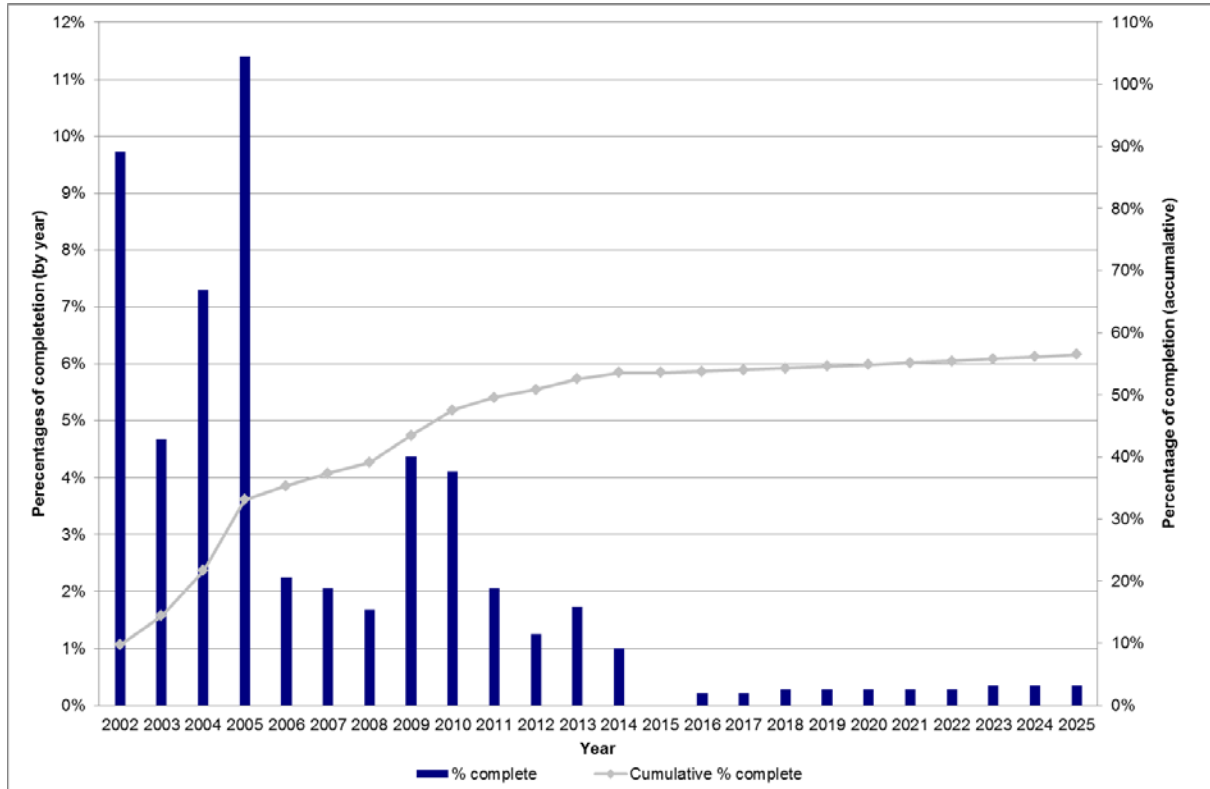
Figure 14 – SOXS program progress and forecast

Figure 14 illustrates the percentage of footings completed each year, as an accumulated fleet total and the future forecasts of the SOXS program. Approximately 50% of footings were completed by the end of the 2011/12 financial year. AusNet Services intends to continue the SOXS program over the upcoming years. The drivers and of the program are discussed in section 4.1.2.

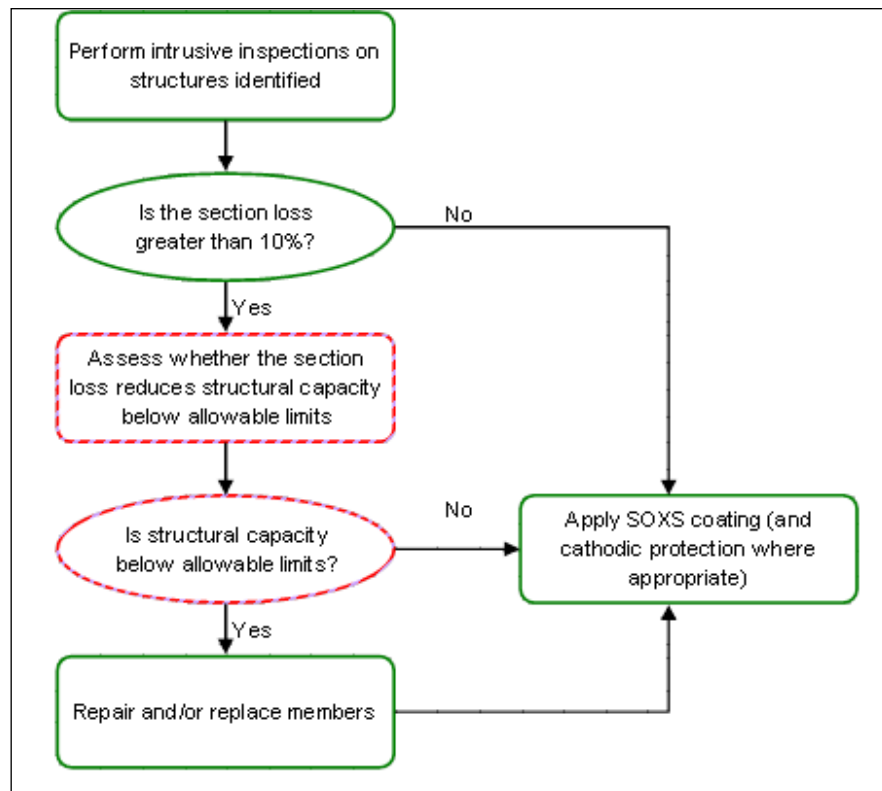
A process map of risk based decision making used as part of the intrusive and testing process is displayed in Figure 15.

Figure 15 – Intrusive inspection of structure foundations decision-making process
